PROJECT TITLE
NEW GOLD INC
RAINY RIVER
PROJECT

DRAWING TITLE
2022 EMRS
RECLAMATION CROSS
SECTIONS

EMRS RECLAMATION – DAILY PROGRESS

Panel Completion, Activities Summary, and Tulloch Daily Reports

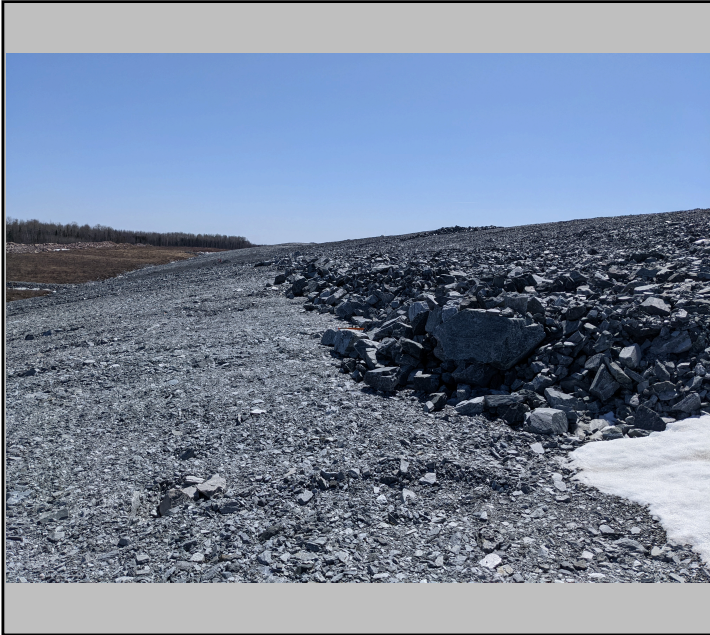
Photo #: 1

EMRS East Slope

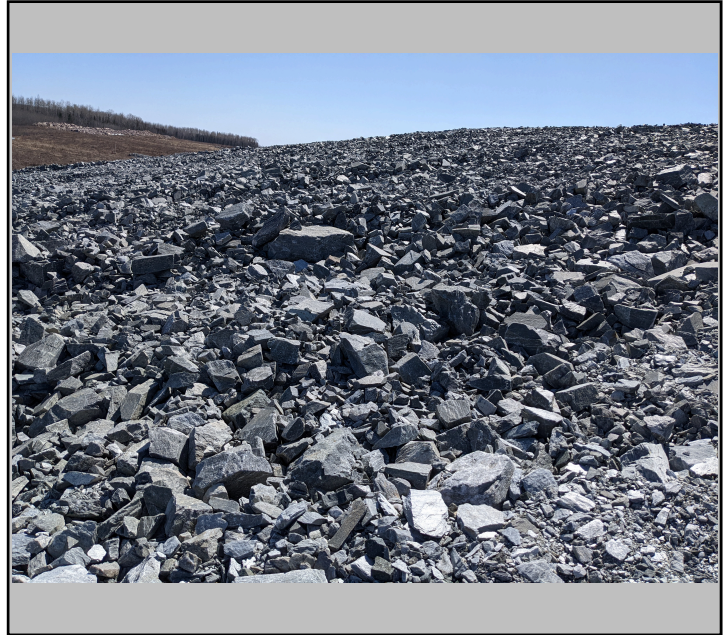
Photo #: 2

EMRS East Slope

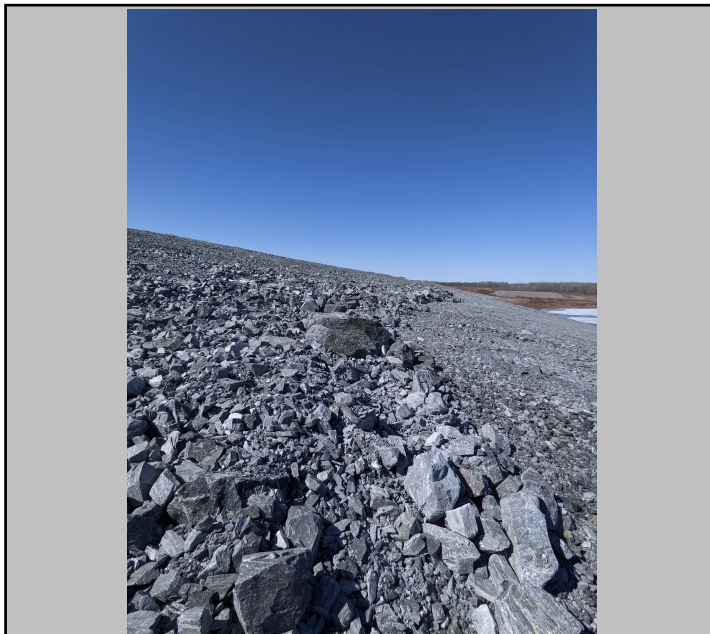
Photo #: 3

EMRS East Slope

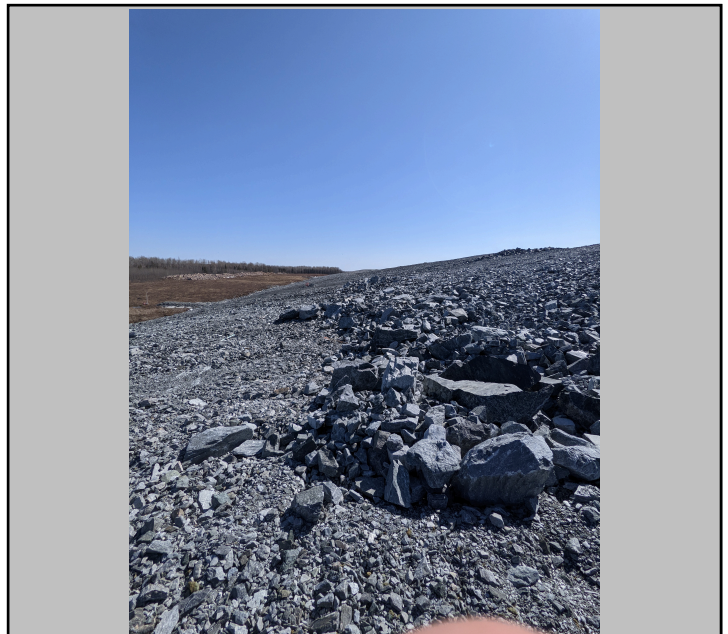
Photo #: 4

EMRS East Slope

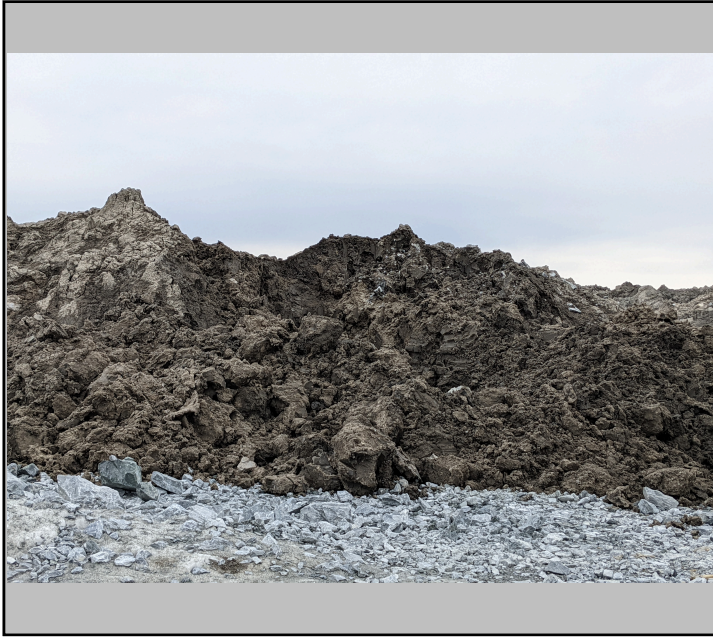
Photo #: 1

Stockpile sampling.

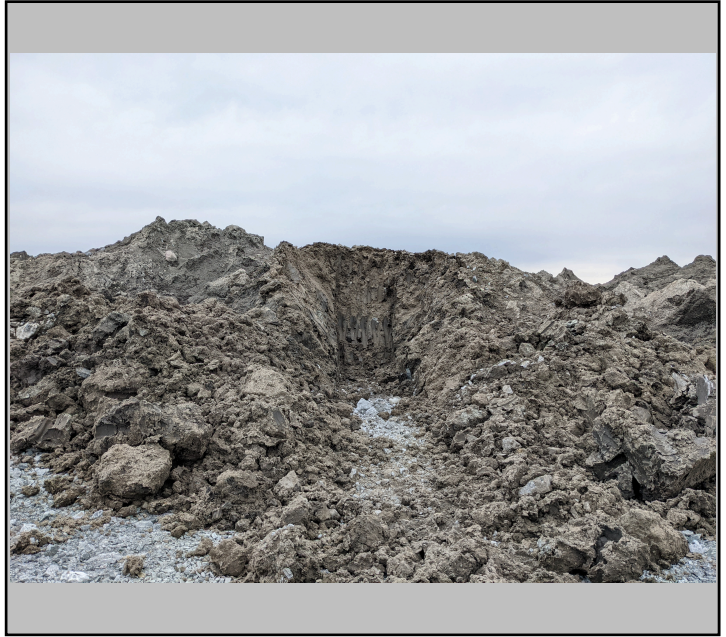
Photo #: 2

Stockpile sampling.

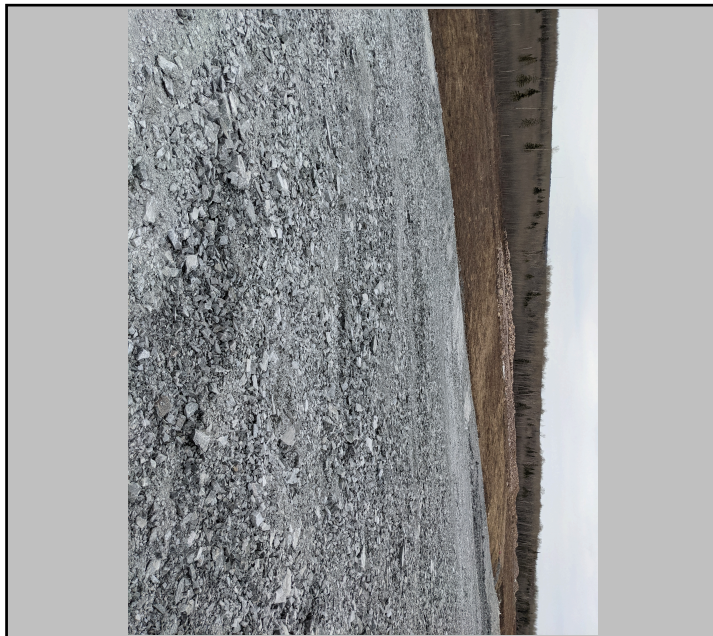
Photo #: 3

EMRS East Slope.

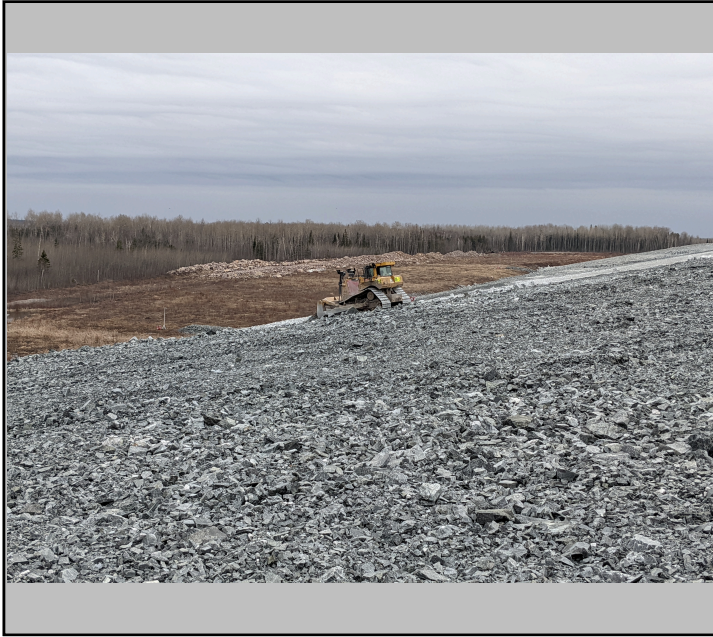
Photo #: 1

D8-2 preparing slope for reclamation.

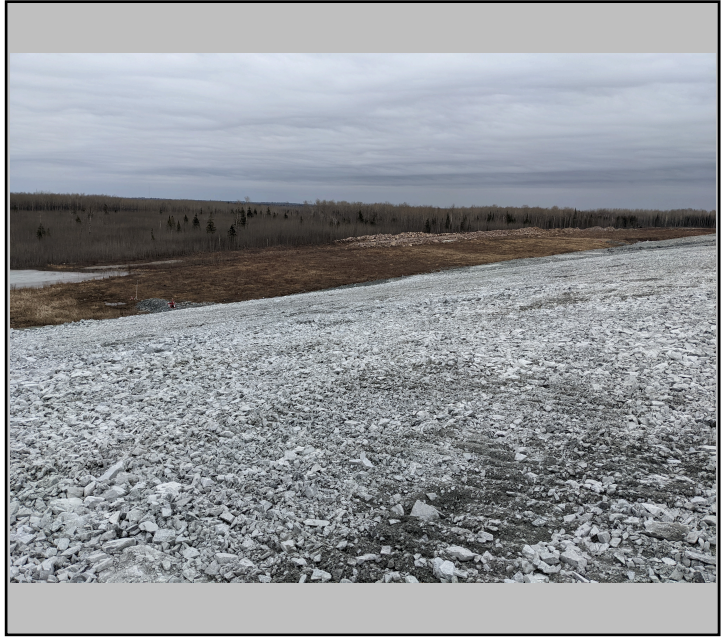
Photo #: 2

D8-2 preparing slope for reclamation.

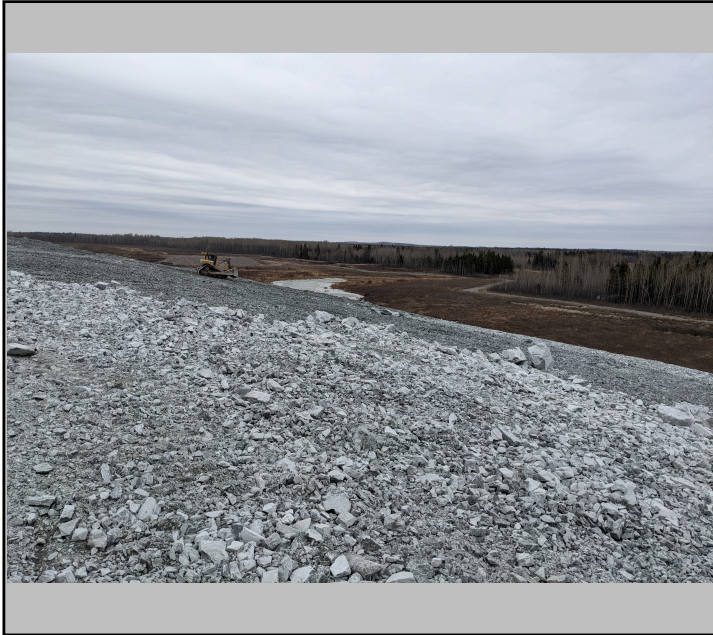
Photo #: 1

D8-2 preparing slope for reclamation work.

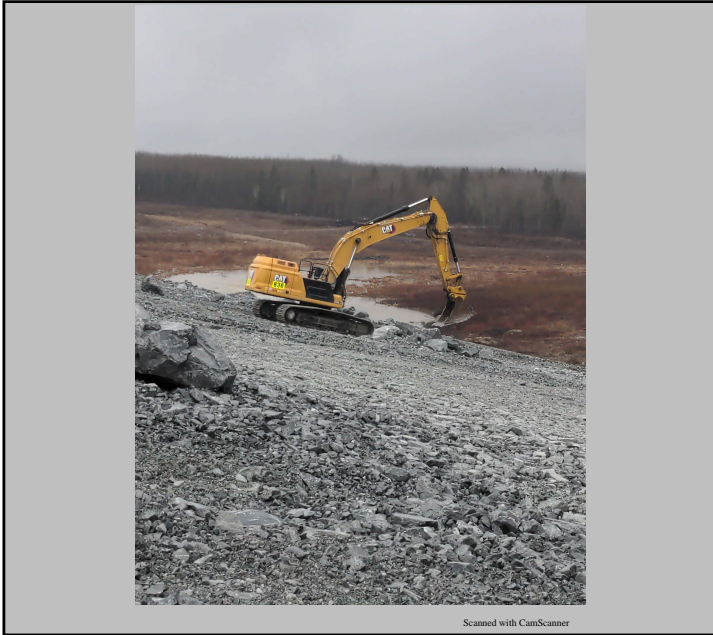
Photo #: 1

EMRS slope preparation for reclamation work.
