Date:	June 3, 2022	Owner/Client:	New Gold Inc.
Day:	Friday	OKC Project #:	1003-19
Prepared by:	Martin Moore	Project Location:	Rainy River - Ontario

Photo #: 1

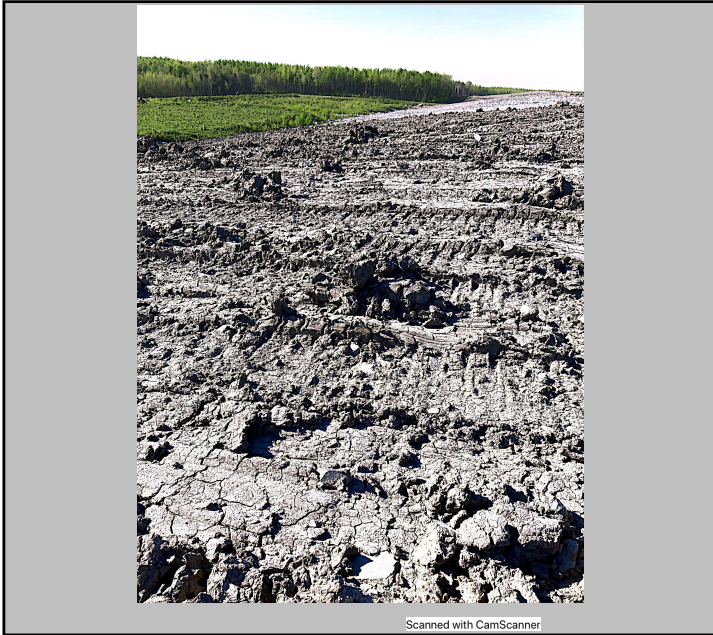
Panel 30 NCL Lift 3, Material has dried on the surface and has some sections retaining standing water.

Panel 30 NCL Lift 3

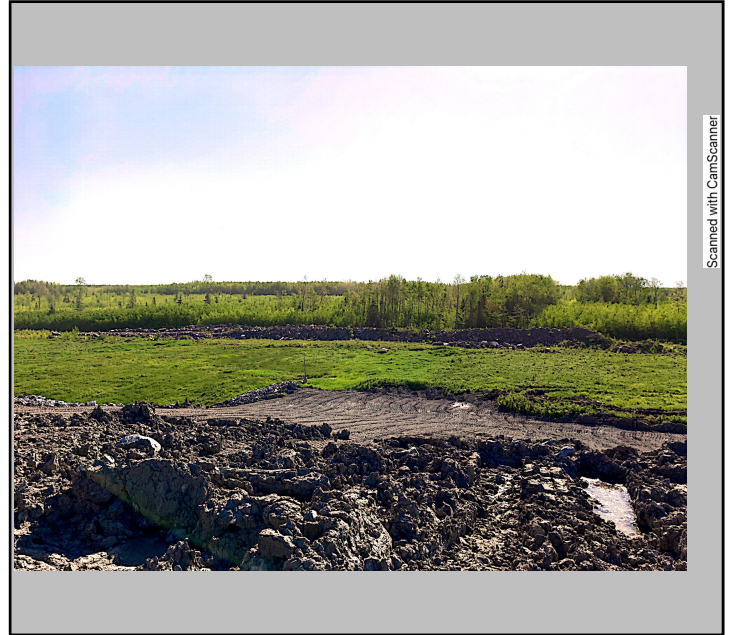
Photo #: 2

Panel 30 CCL Lift 2 has desiccation on the exposed portion.

Panel 30 NCL Lift 3 and CCL Lift 2

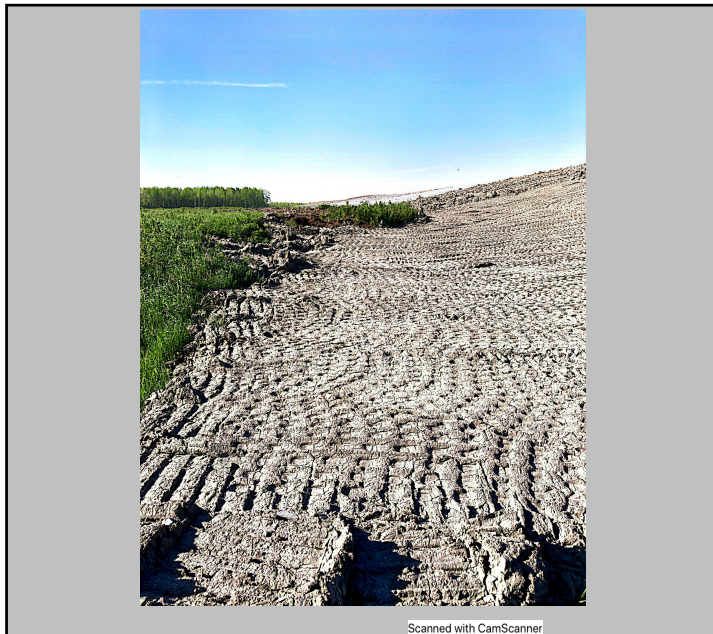
Photo #: 3

Panel 30 CCL Lift 2

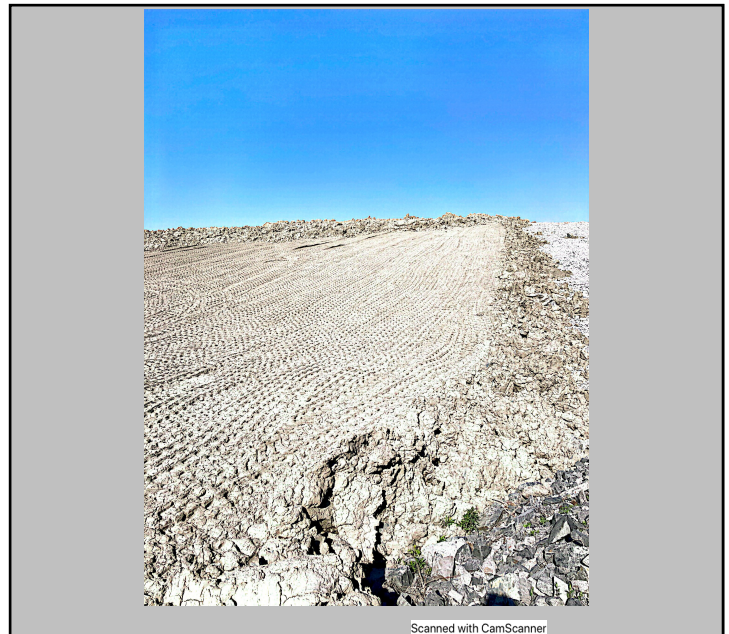
Photo #: 4

Panel 30 NCL Lift 3 and CCL Lift 2

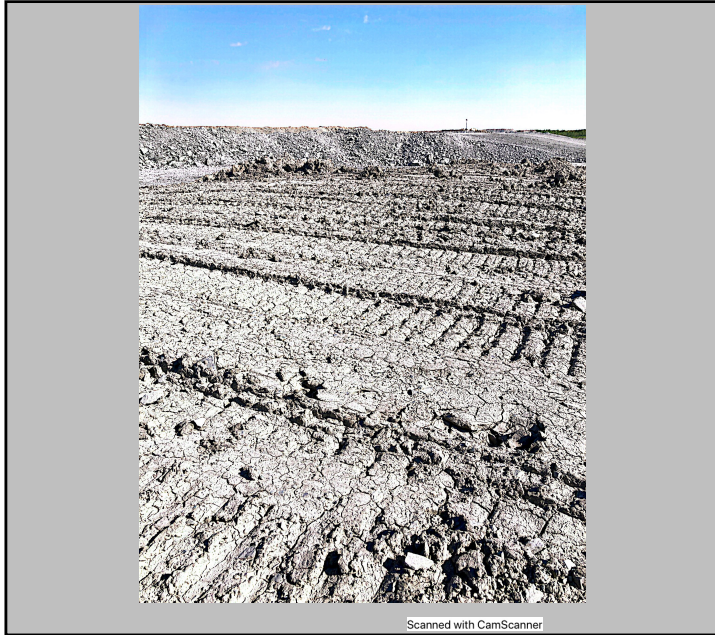
Photo #: 1

Panel 30 NCL Lift 3, Material has dried on the surface and has some sections retaining standing water.

Panel 30 NCL lift 3.

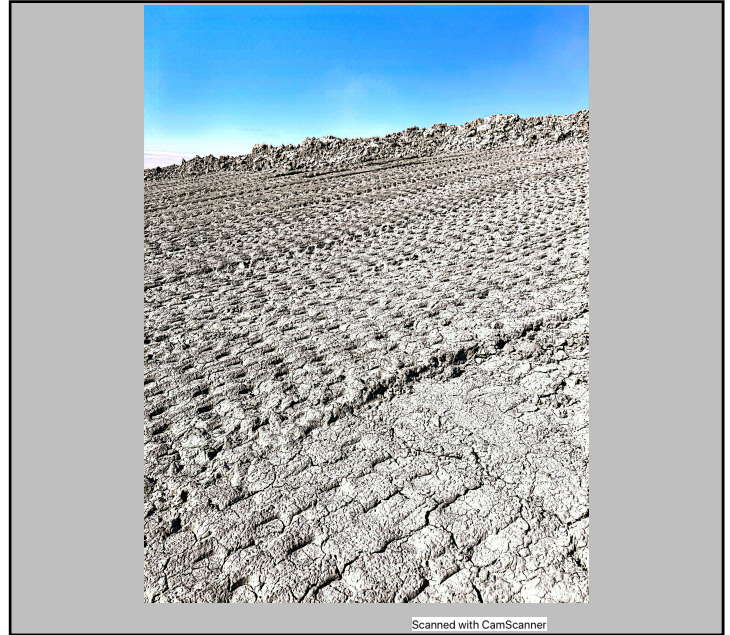
Photo #: 2

Panel 30 CCL Lift 2 has desiccation on the exposed portion.

Panel 30 CCL Lift 2.

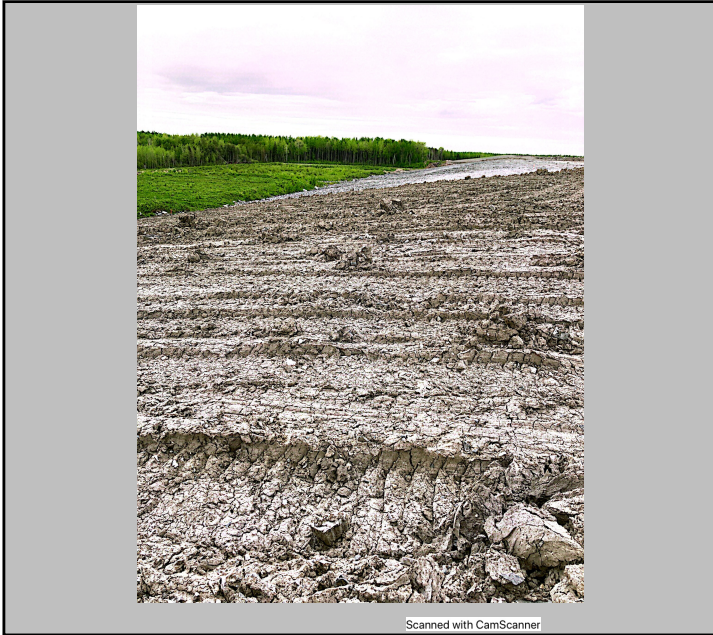
Photo #: 1

Panel 30 NCL Lift 3, Material has dried on the surface and has some sections retaining standing water.

Panel 30 NCL Lift 3

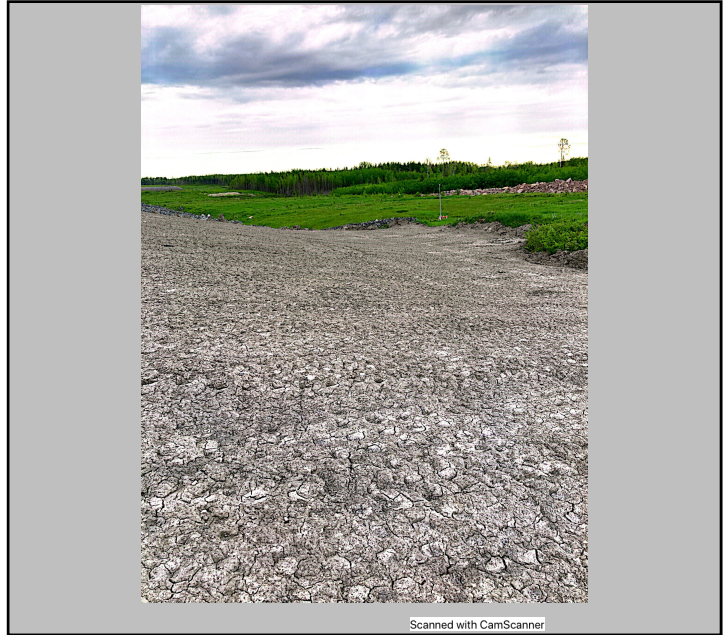
Photo #: 2

Panel 30 CCL Lift 2 has desiccation on the exposed portion.

Panel 30 CCL Lift 2

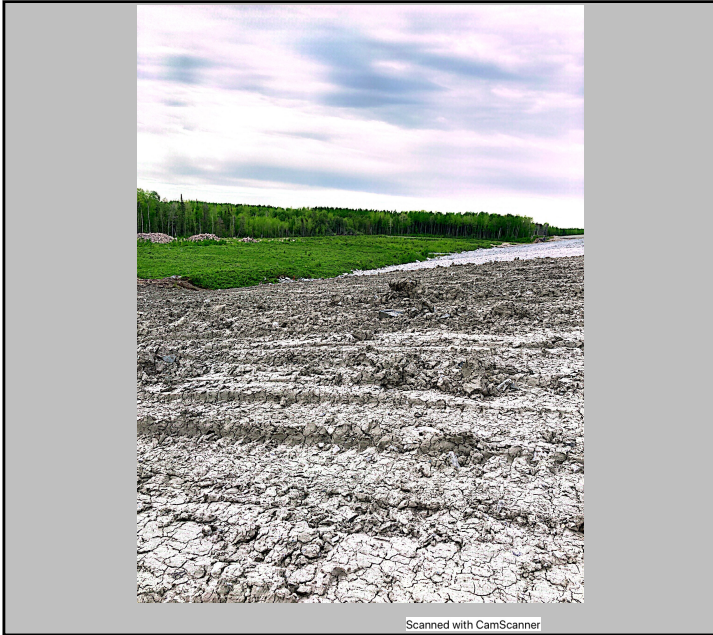
Photo #: 1

Panel 30 NCL Lift 3, Material has dried on the surface and has some sections retaining standing water.

Panel 30 NCL Lift 3

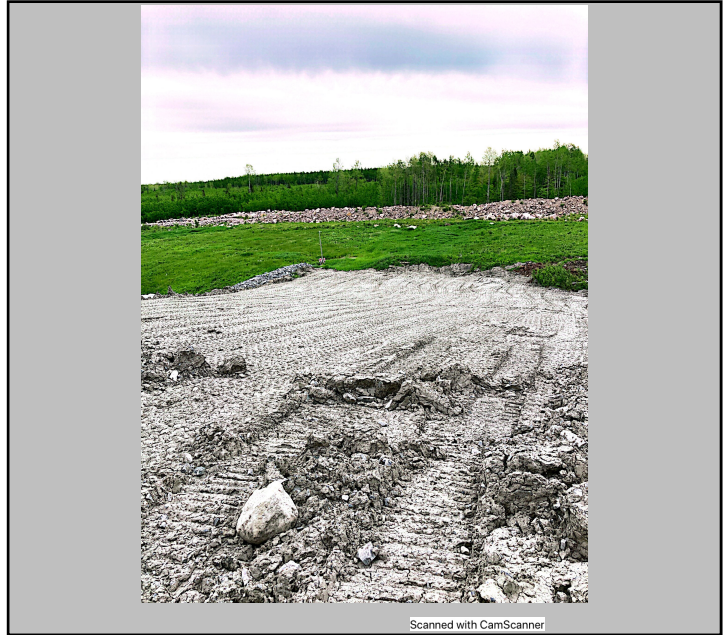
Photo #: 2

Panel 30 CCL Lift 2 has desiccation on the exposed portion.

Panel 30 CCL Lift 2

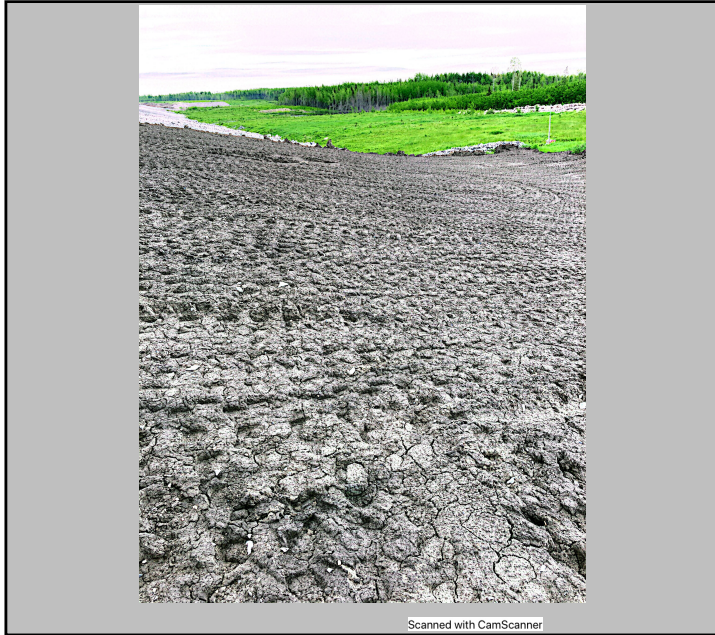
Photo #: 1

Panel 30 CCL Lift 2 has desiccation on the exposed portion. Rain visually added moisture to the surface.

Panel 30 CCL Lift 2

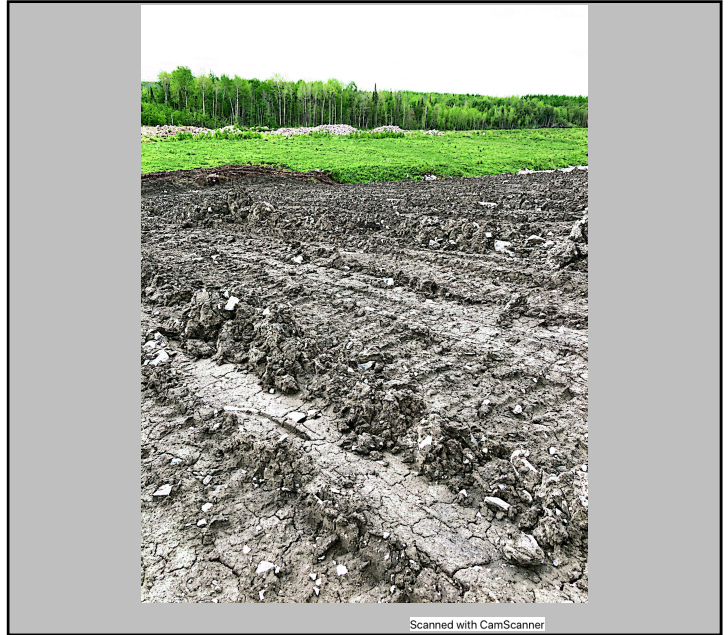
Photo #: 2

Panel 30 NCL Lift 3, Material has dried on the surface and has some sections retaining standing water. Rain visually added moisture to the surface.

Panel 30 NCL Lift 3

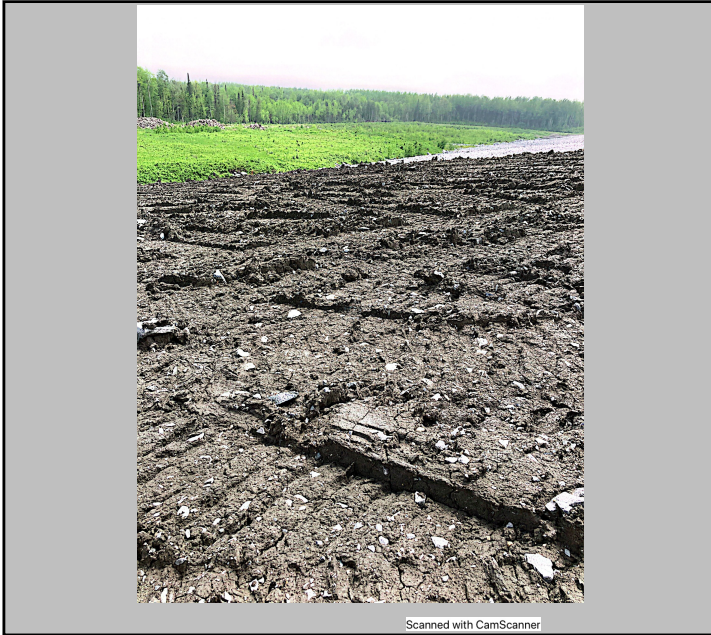
Photo #: 1

Panel 30 NCL Lift 3, Material had dried on the surface and has some sections retaining standing water. Rain visually added moisture to the surface.

Panel 30 NCL Lift 3

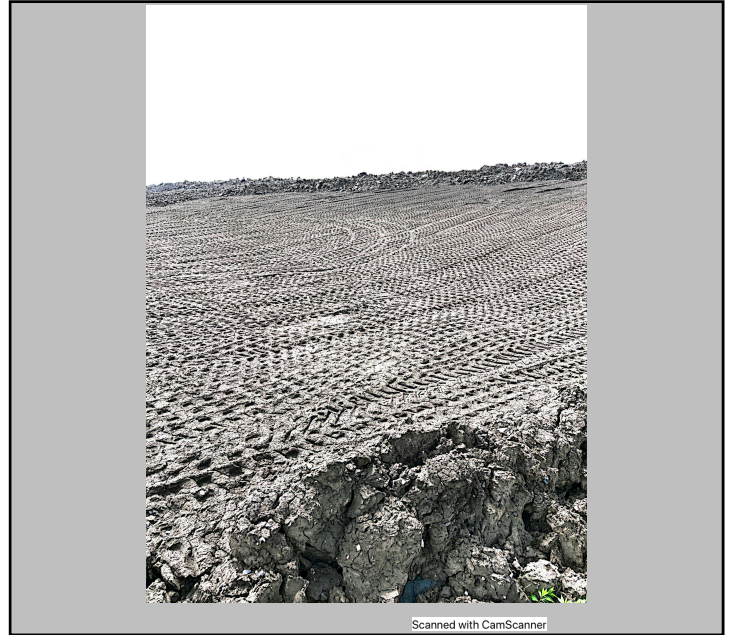
Photo #: 2

Panel 30 CCL Lift 2 has desiccation on the exposed portion. Rain visually added moisture to the surface.

Panel 30 CCL Lift 2

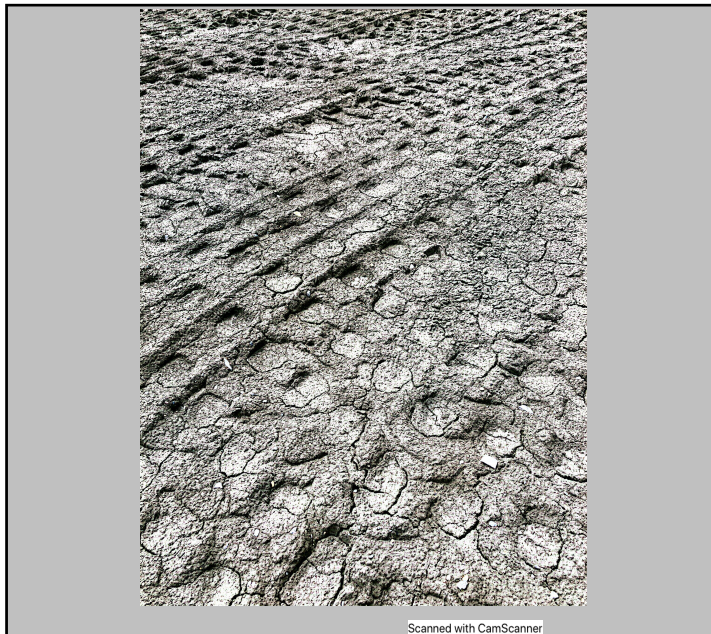
Photo #: 3

Panel 30 CCL Lift 2

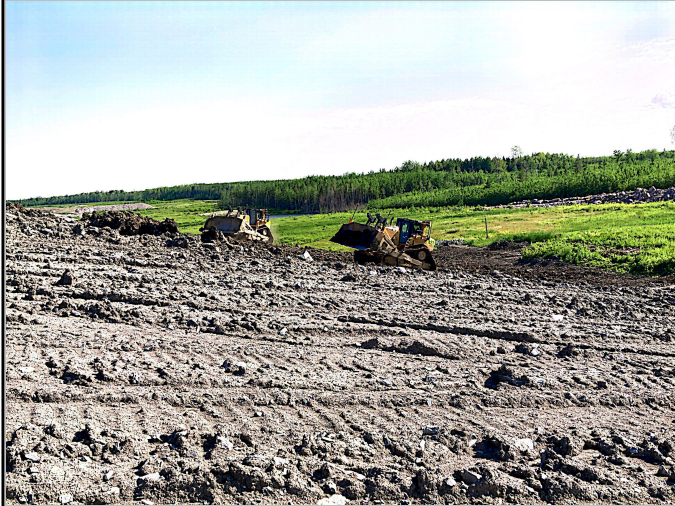
Photo #: 1

Dozer 420 and 421 re-working exposed CCL L2 in P30.

Nuclear gauge was used to complete moisture content testing to ensure that a sufficient amount of desiccated material was removed prior to NCL placement.

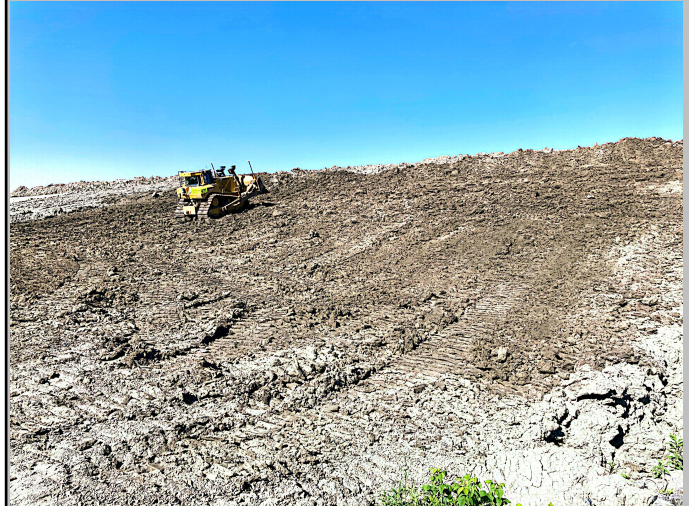
Photo #: 2

Dozer 421 re-working exposed CCL L2 in P30.

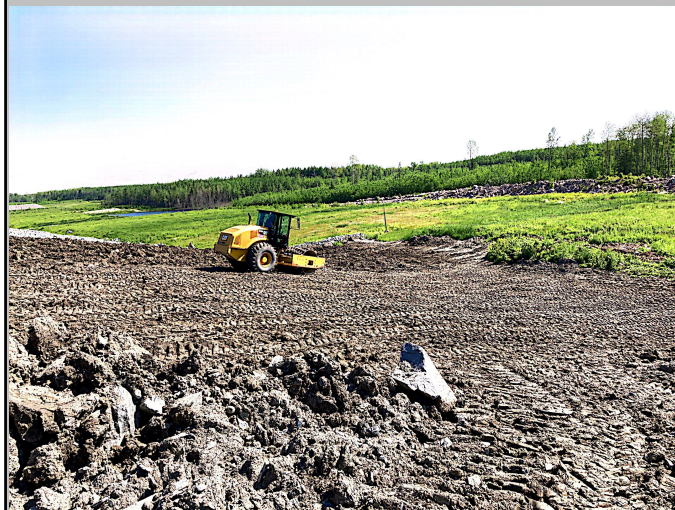
Photo #: 3

Packer on exposed section of CCL L2 in P30.
