PHOTOGRAPHS

Date:	July 21, 2022	Owner/Client:	New Gold Inc.
Day:	Thursday	OKC Project #:	1003-19
Prepared by:	Martin Moore	Project Location:	Rainy River - Ontario

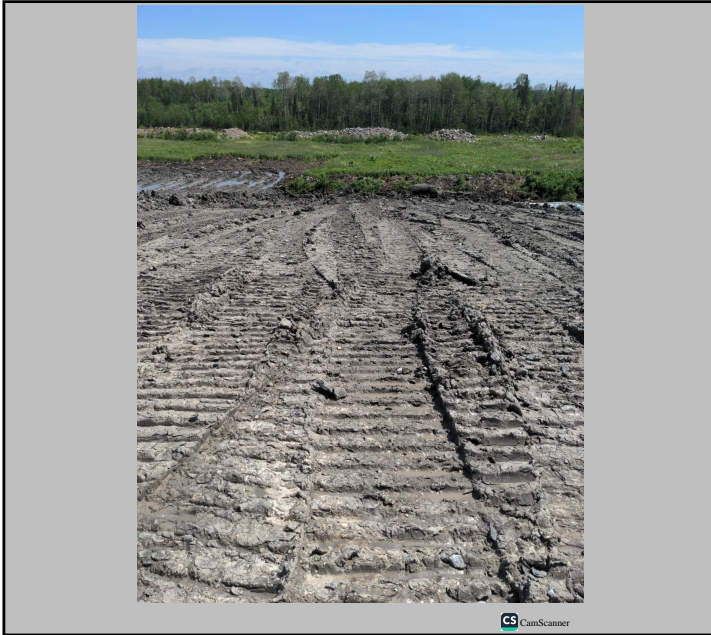
Photo #: 1

Panel 33 CCL Lift 1

Panel 33 CCL Lift 1: Dozer track packing and disturbing the lift due to visually high moisture in the material in order to speed up the drying process.

Panel 33 CCL Lift 1 visually saturated. Appears to be a mixture of dark brown and grey.

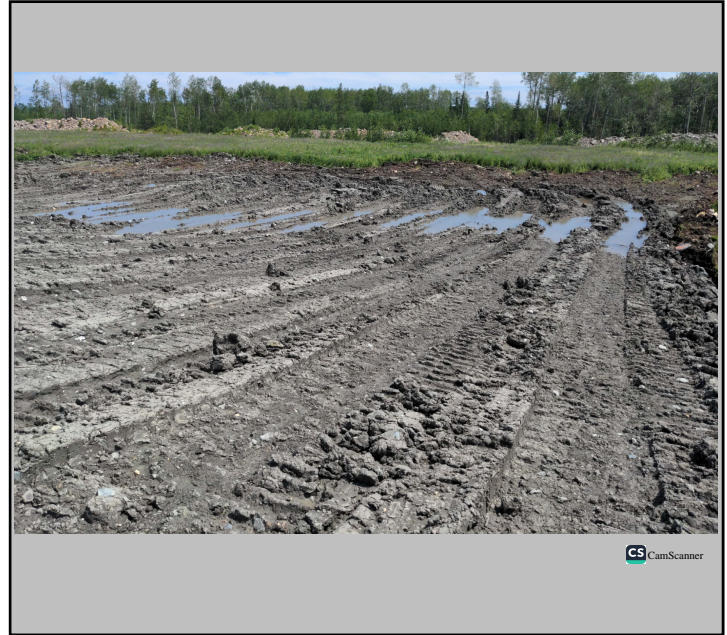
Photo #: 2

Water pooling at toe of Panel 32 NCL Lift 3.

Tulloch and Okane discussed the excessive water pooling at the toe of Panels 30 to 32. Tulloch laid out the key trench for the operators to ensure positive drainage beyond the location of the key trench.

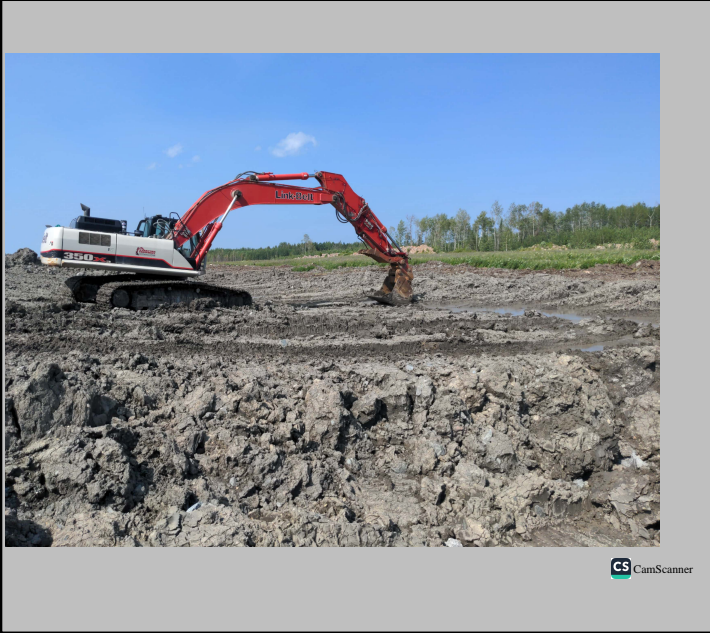
Photo #: 5

Creating positive drainage at the toe of Panel 32.

Excavator used to create positive drainage outside of the key trench to allow water to drain and the material to dry prior to placing the next lifts.

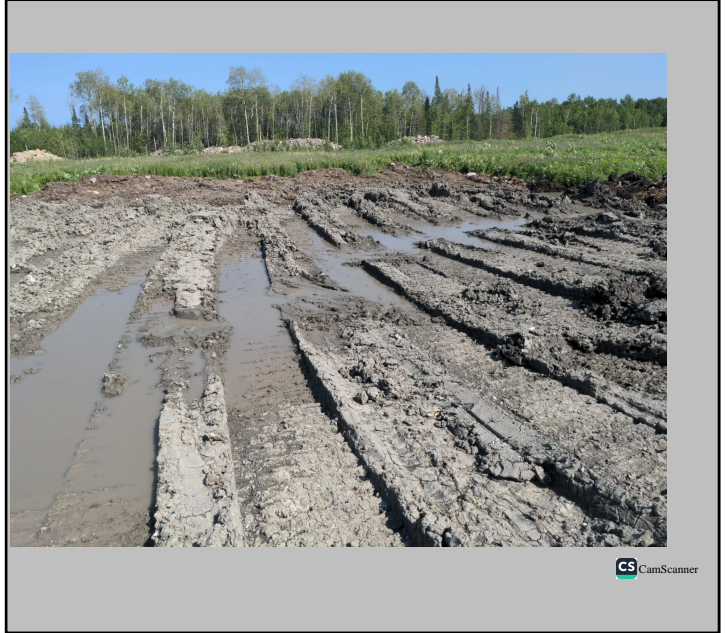
Photo #: 6

Water draining away from the toe of the panels.

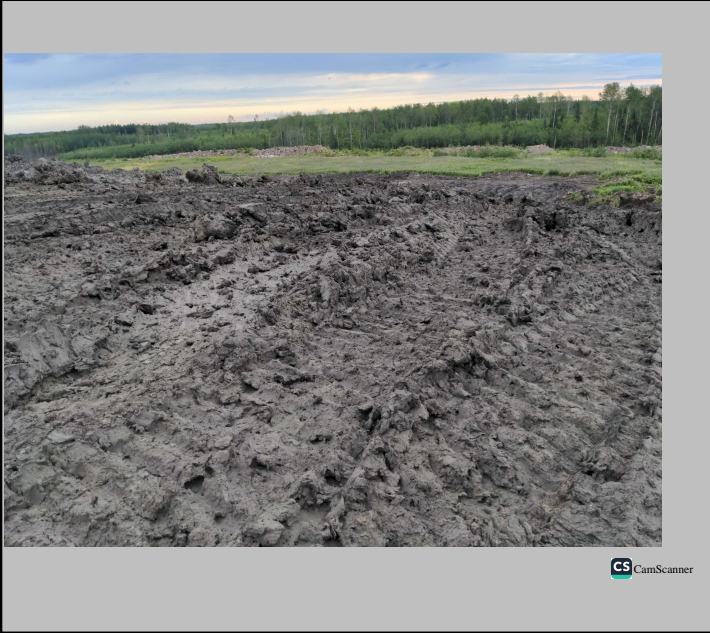
Photo #: 1

Panel 33 CCL Lift 2:
Excavator loading trucks with clay material from the North stockpile. Dozers continued placing CCL Lift 2 to grade. Material visually wet and difficult to place. Dozers switched to Panel 32 NCL Lift 3 in order to let material dry for Panel 33. Trucks continuing to stockpile clay material at Panel 33 to allow further drying.

Panel 33 CCL Lift 2. Material from North Stockpile visually wet and difficult to place.

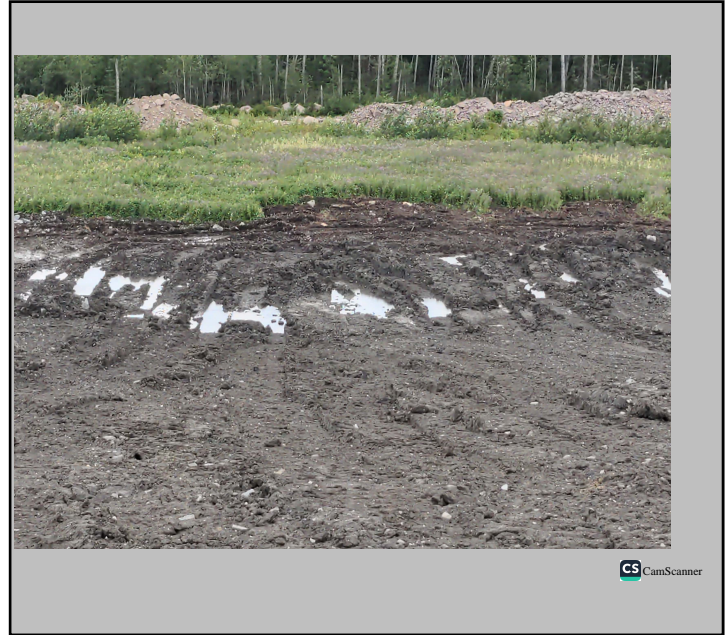
Photo #: 2

Panel 32 toe pooled water.

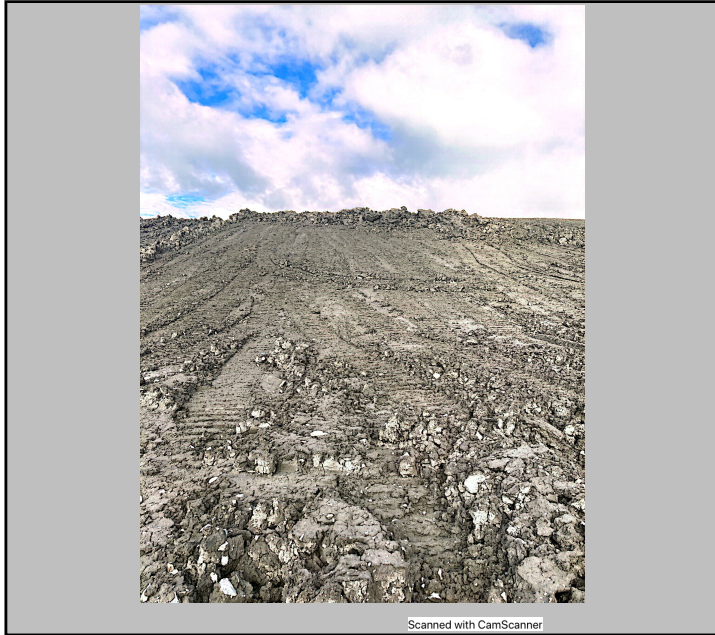
Photo #: 1

Some standing water present throughout the panel in the morning.

P32 NCL L4 (In Progress), morning.

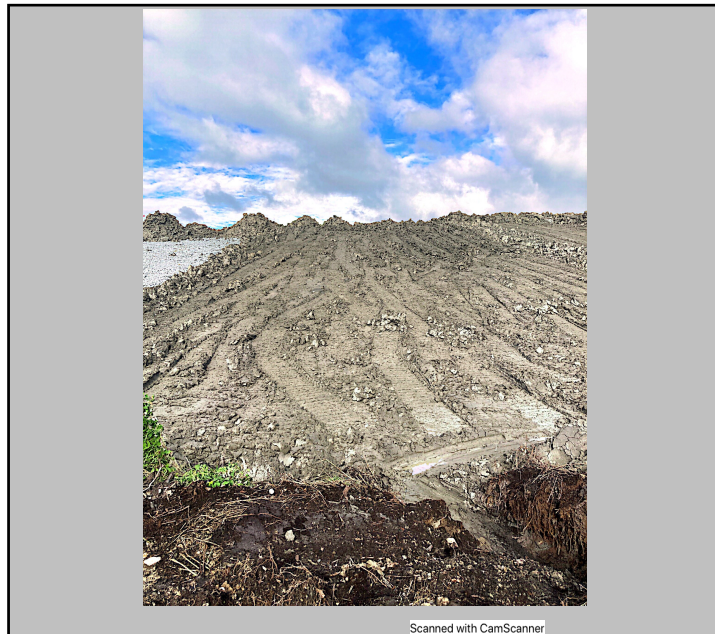
Photo #: 3

Some standing water present throughout the panel in the morning.

P33 CCL L2 (In Progress), morning.
