Date:	July 30, 2022	Owner/Client:	New Gold Inc.
Day:	Saturday	OKC Project #:	1003-19
Prepared by:	Keith Naumann	Project Location:	Rainy River - Ontario

Date:	July 31, 2022	Owner/Client:	New Gold Inc.
Day:	Sunday	OKC Project #:	1003-19
Prepared by:	Keith Naumann	Project Location:	Rainy River - Ontario

Date:	August 1, 2022	Owner/Client:	New Gold Inc.
Day:	Monday	OKC Project #:	1003-19
Prepared by:	Keith Naumann	Project Location:	Rainy River - Ontario

Date:	August 2, 2022	Owner/Client:	New Gold Inc.
Day:	Tuesday	OKC Project #:	1003-19
Prepared by:	Keith Naumann	Project Location:	Rainy River - Ontario

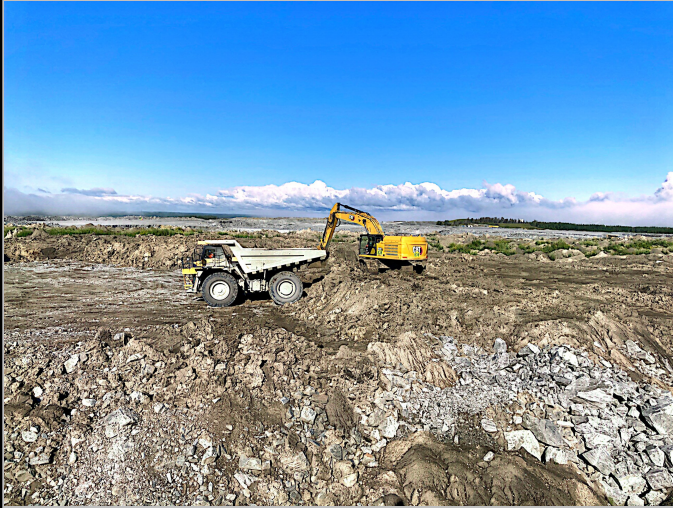
Photo #: 1

Excavator 836 loading Truck at Central Stockpile.

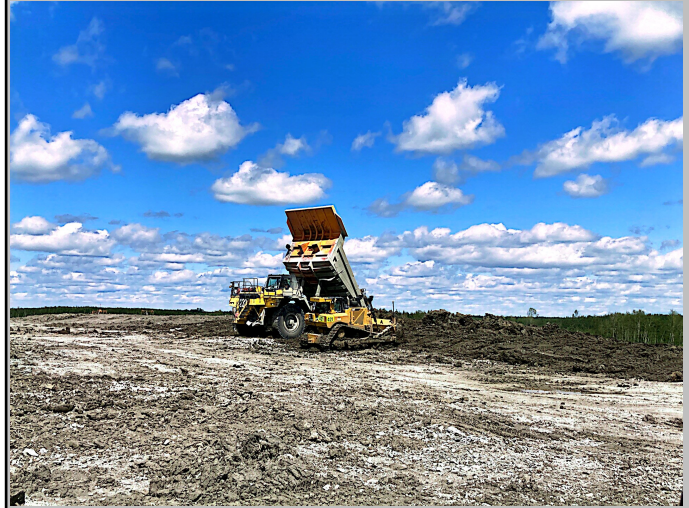
Photo #: 2

Truck dumping clay material on the crest of P32.

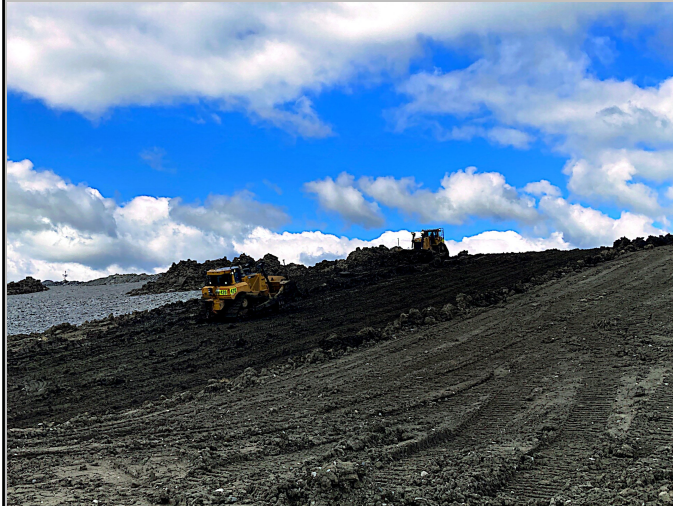
Photo #: 3

Dozer 420 and 421 placing CCL L2 P33.

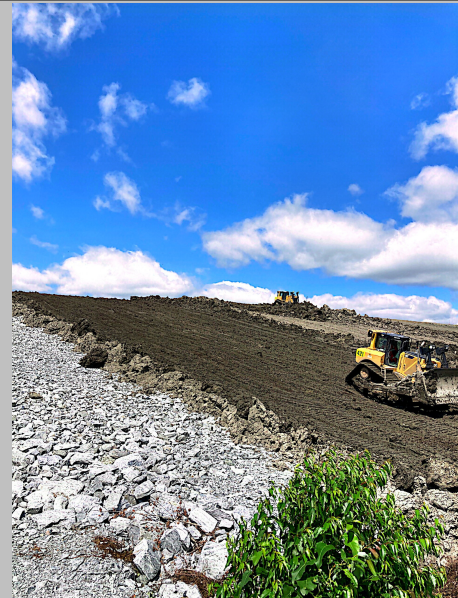
Photo #: 4

P33 CCL L2 up to grade.

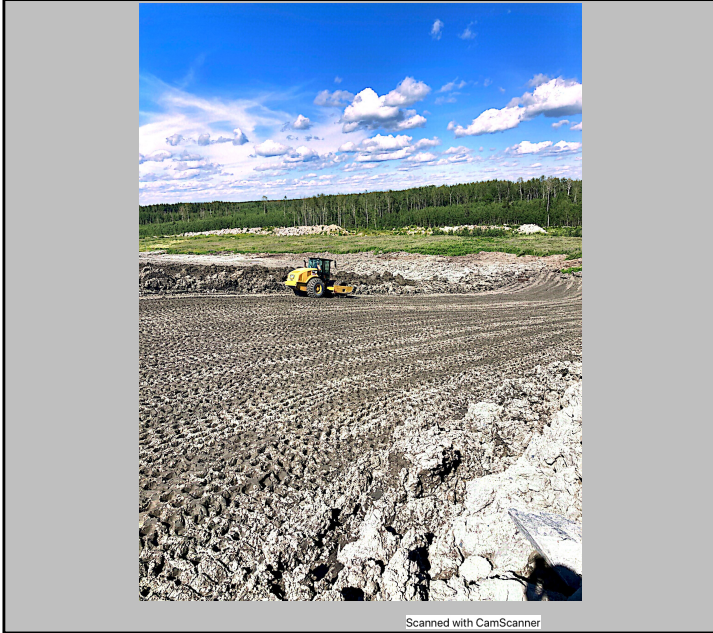
Photo #: 5

P33 CCL L2 compacted by Cat CP56B packer.

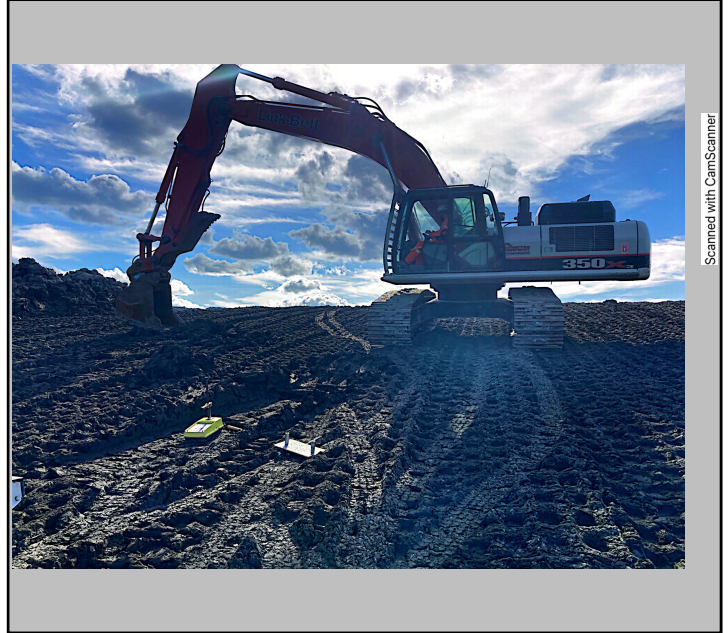
Photo #: 6

Excavator LB350 made test pads on P33.

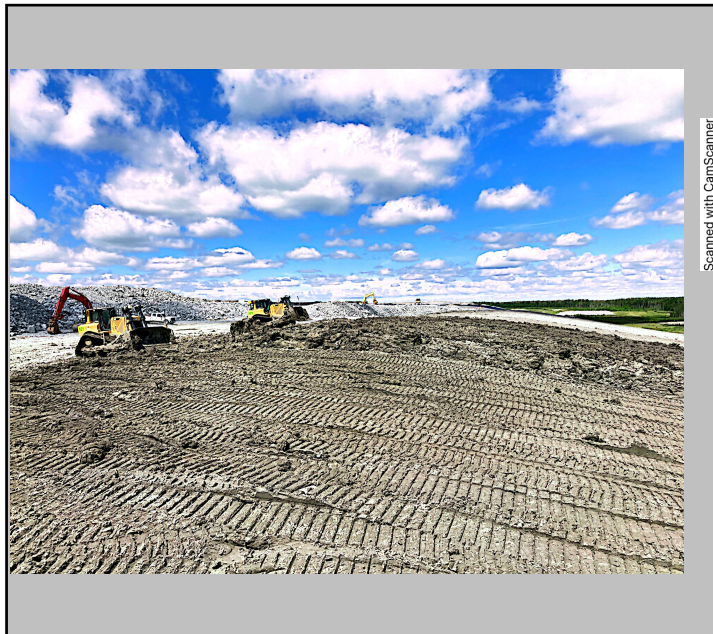
Photo #: 7

Dozer 420 and 421 placing NCL L4 P32

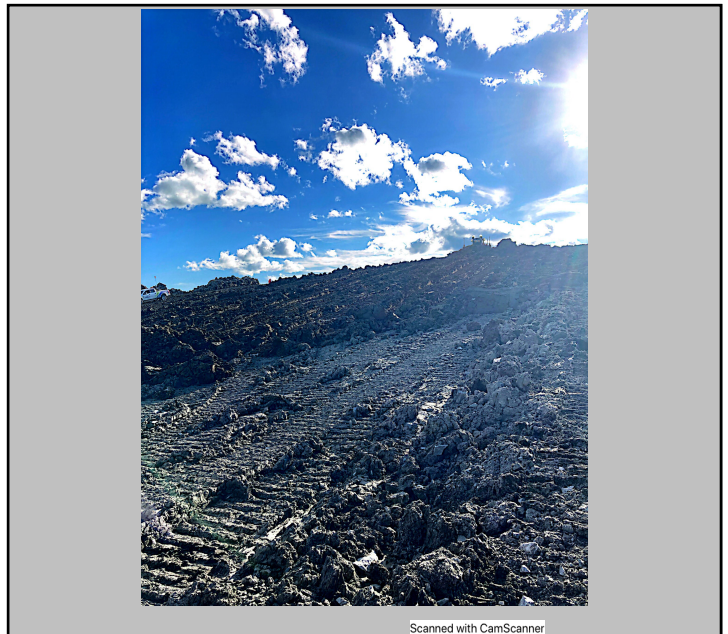
Photo #: 8

P32 NCL L4 end of day placement.

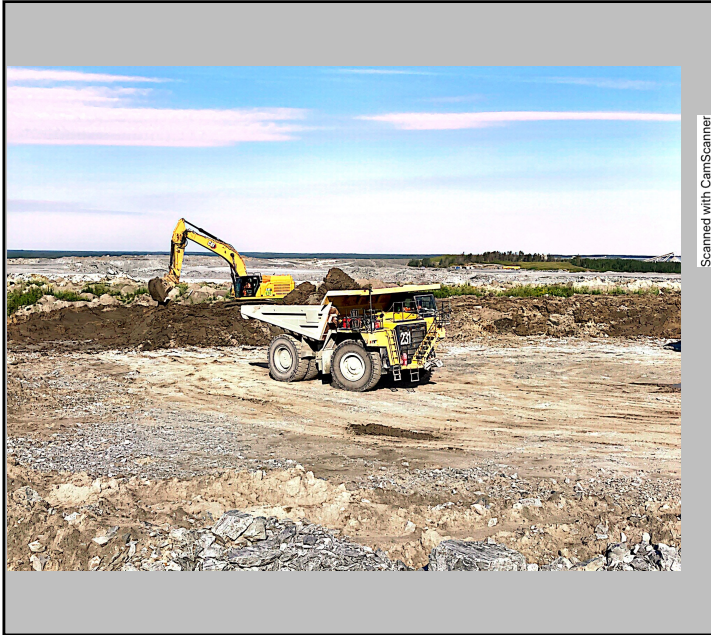
Photo #: 1

Excavator 836 loading Truck 231 at Central Stockpile.

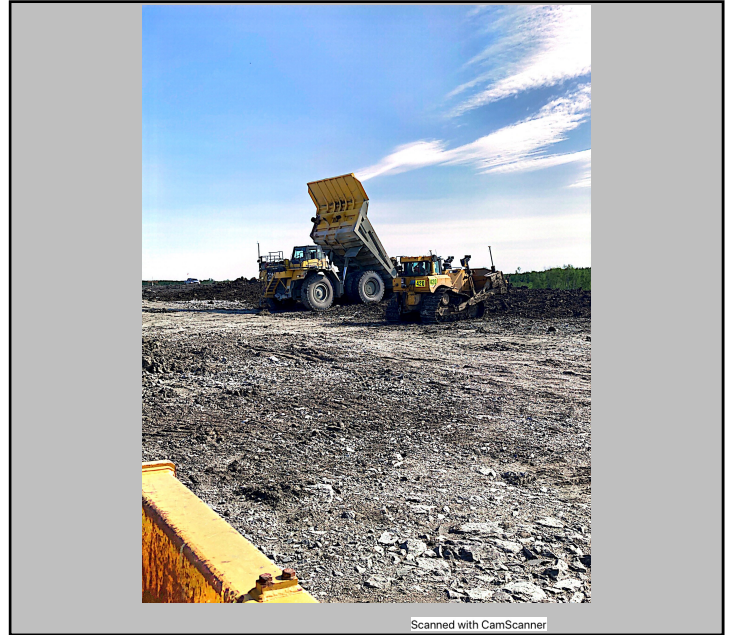
Photo #: 2

Truck 231 dumping clay material on the crest of P33.

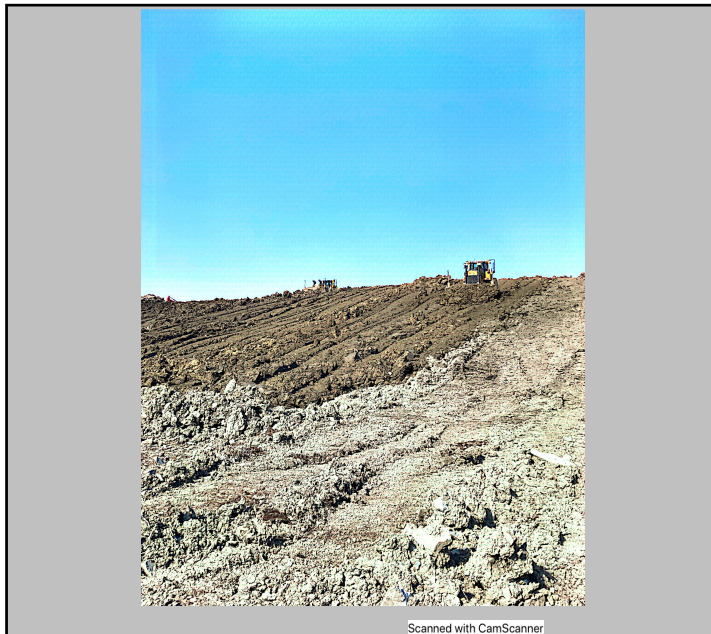
Photo #: 3

Dozer 421 placing NCL L4 P32.

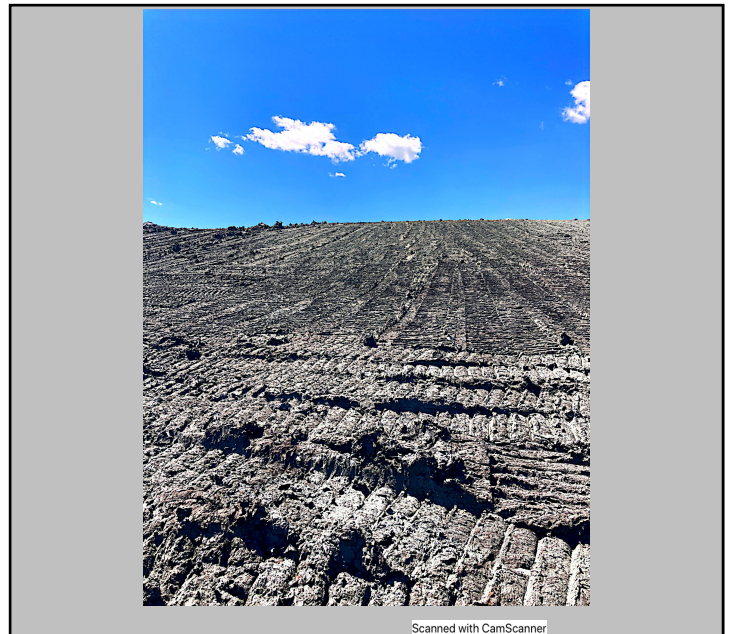
Photo #: 4

P32 NCL L4 complete.

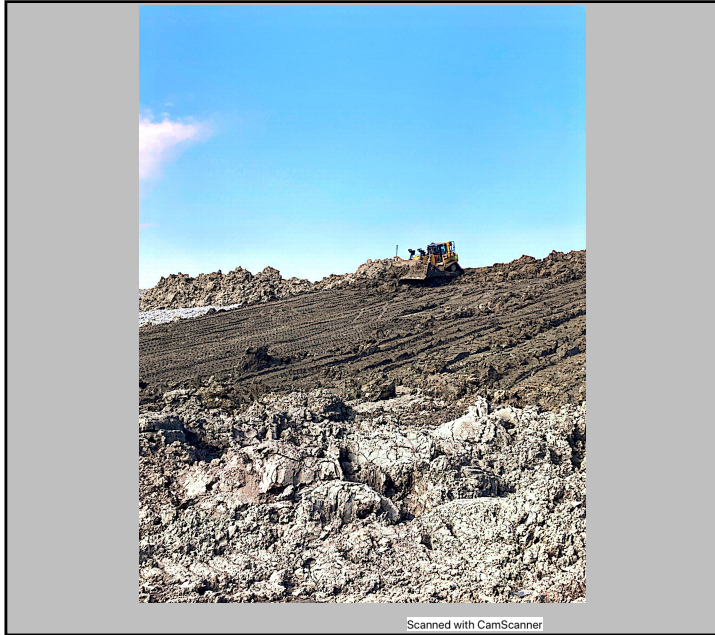
Photo #: 5

Dozer 421 placing NCL L3 P33.

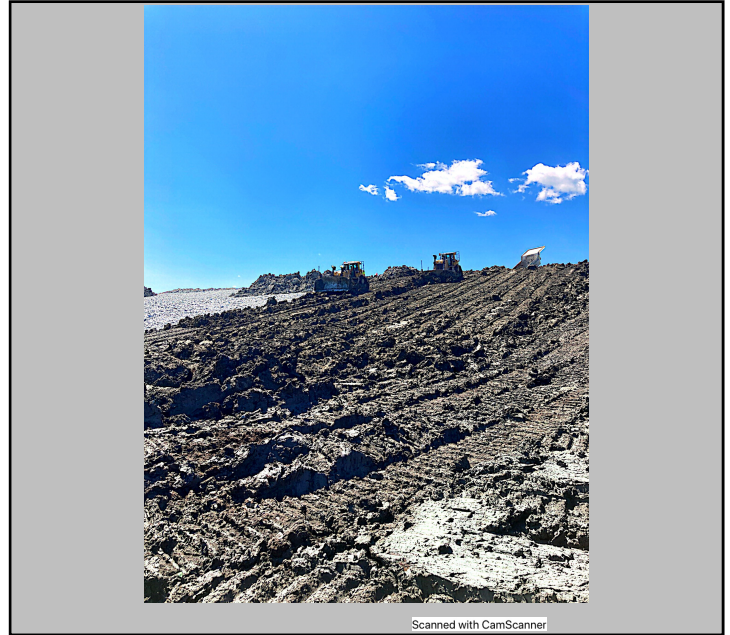
Photo #: 6

Dozer 420 and 421 placing NCL L3 P33.

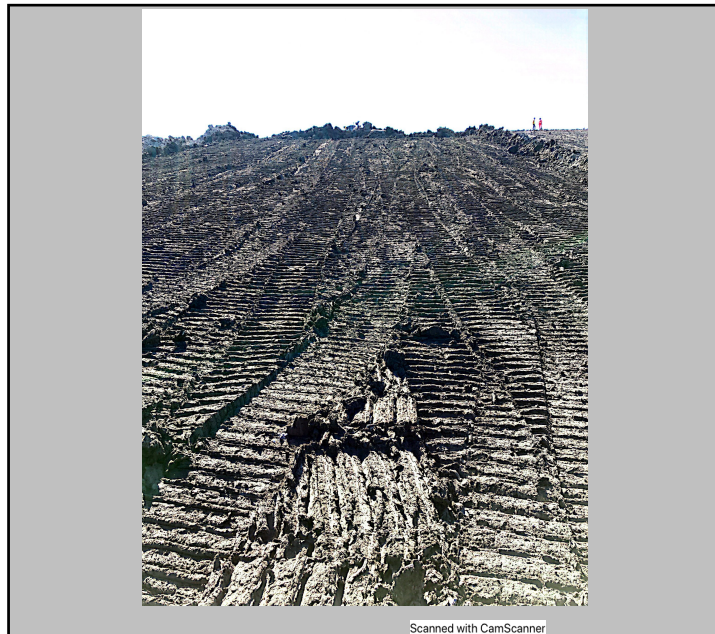
Photo #: 7

P33 NCL L3 Complete

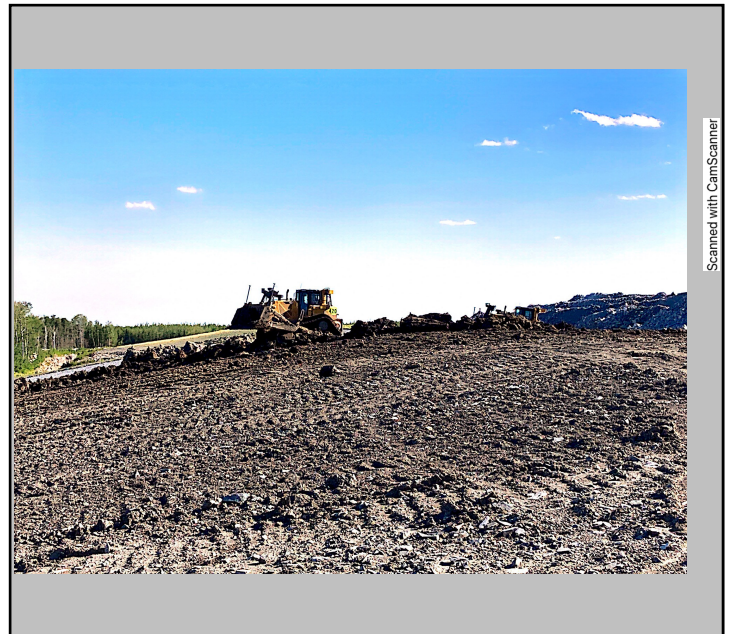
Photo #: 8

Dozer 420 and 421 placing NCL L4 P33.

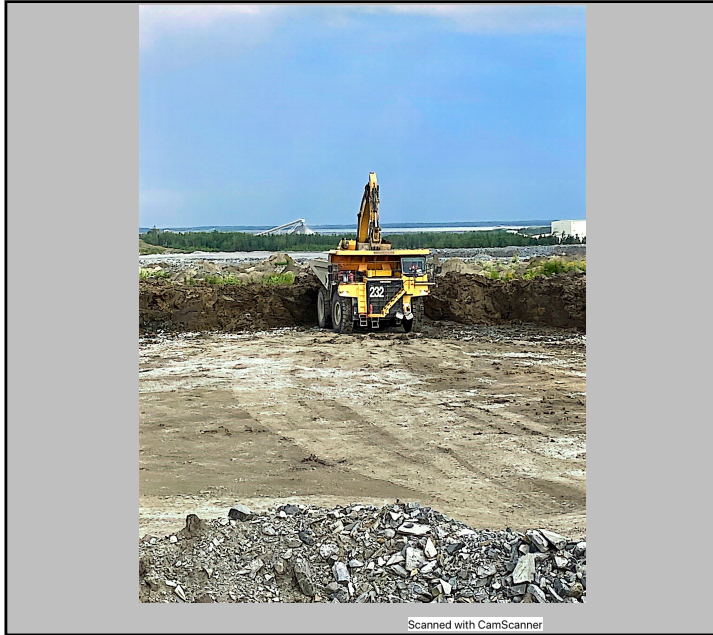
Photo #: 1

Excavator 836 loading Truck 232 at Central Stockpile.

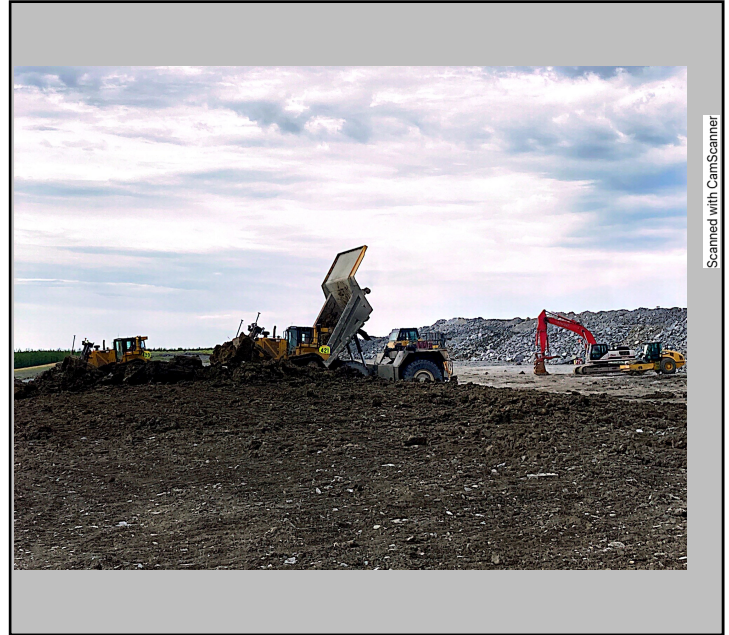
Photo #: 2

Truck 232 dumping clay material on the crest of P33.

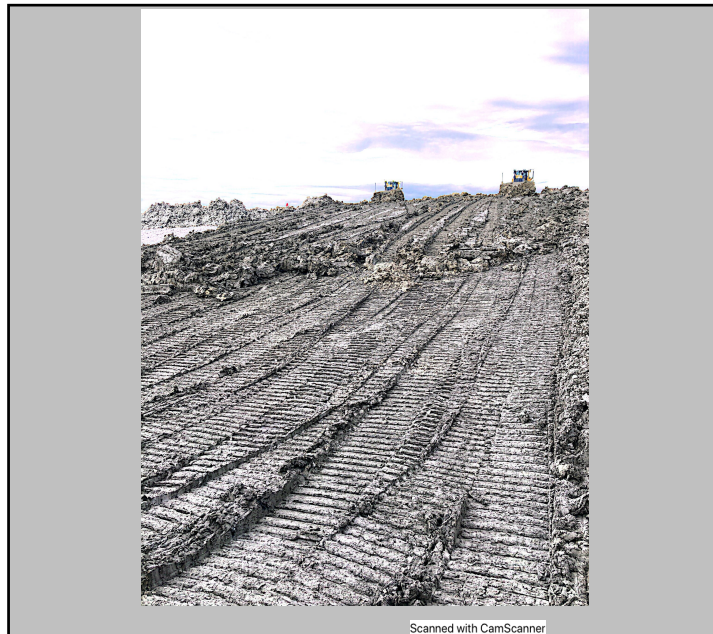
Photo #: 3

Dozer 420 and 421 placing NCL L4 P33.

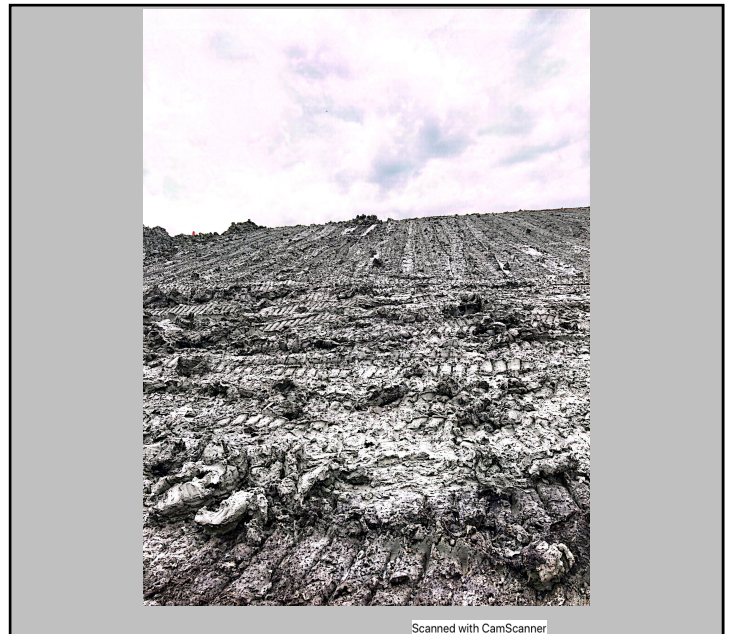
Photo #: 4

Panel 33 NCL L4 (In Progress)
Truck 231, 231, and 233 hauled clay material from Central Stockpile to the crest of the panel.
Dozer 420 and 421 placed clay material as NCL L4 on the panel.
Clay material has been placed, rain prevented the panel from being cut to final grade.
Dozer 420 sloped the south edge of the panel to promote drainage.

NCL L4 P33 placed, awaiting final grading.

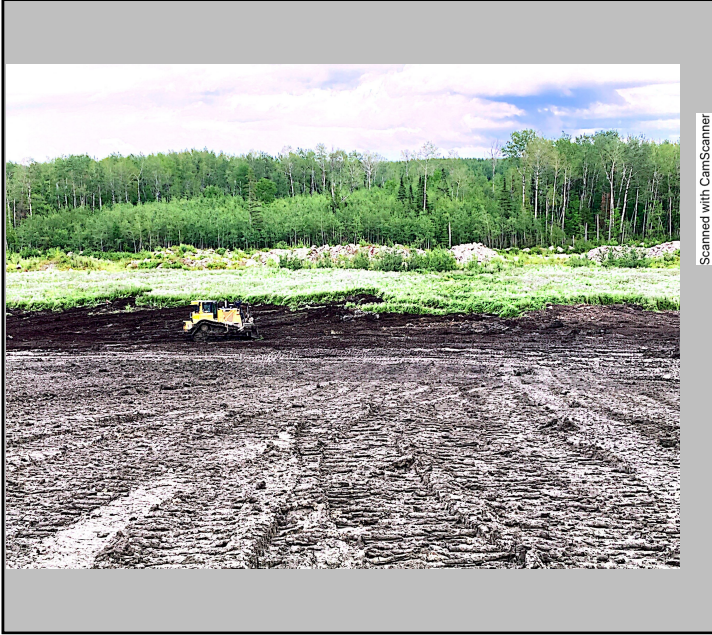
Photo #: 5

Toe of Panels 30-33:
Dozer 420 sloped the toe of the panels to allow drainage of water away from the cover system.

Dozer 420 sloping toe of P30-P33 for drainage.

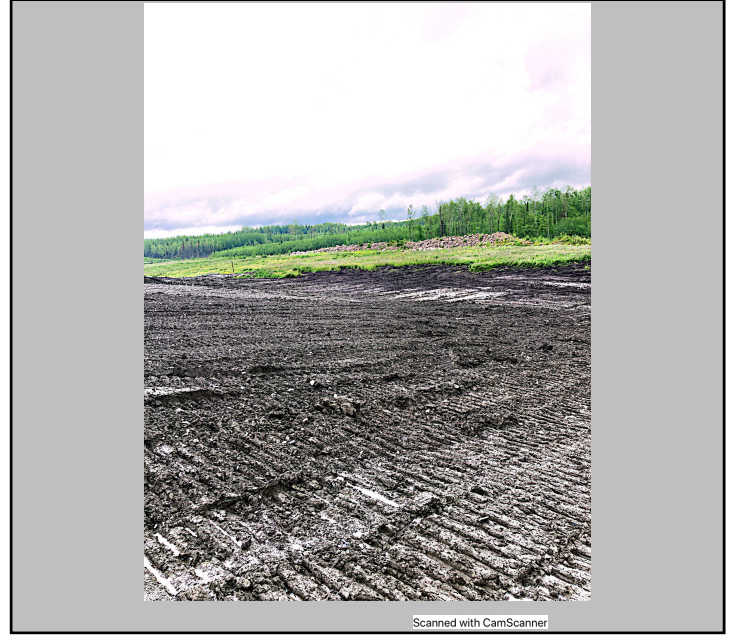
Photo #: 6

Complete toe slope south end of P30.

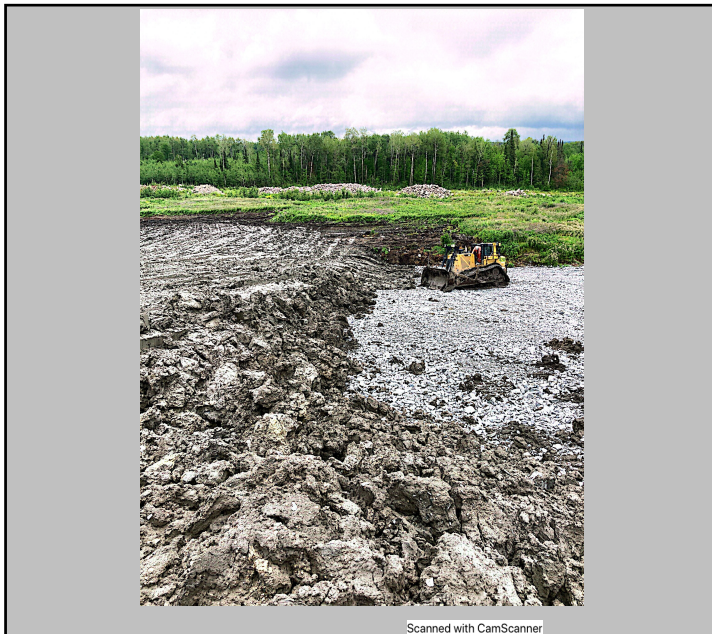
Photo #: 7

Dozer 420 sloping the edge of P33 for side drainage.

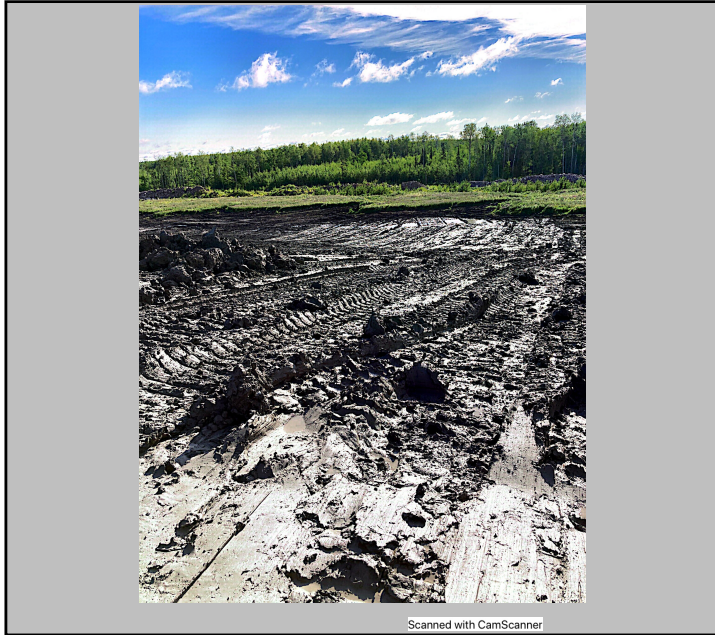
Photo #: 1

Panel 33 NCL L4 (In Progress):
 Panel had standing water in the morning from yesterday and overnight rainfall.
 Mid Afternoon Dozer 420 began track packing the panel and then graded the panel.

P33 morning.

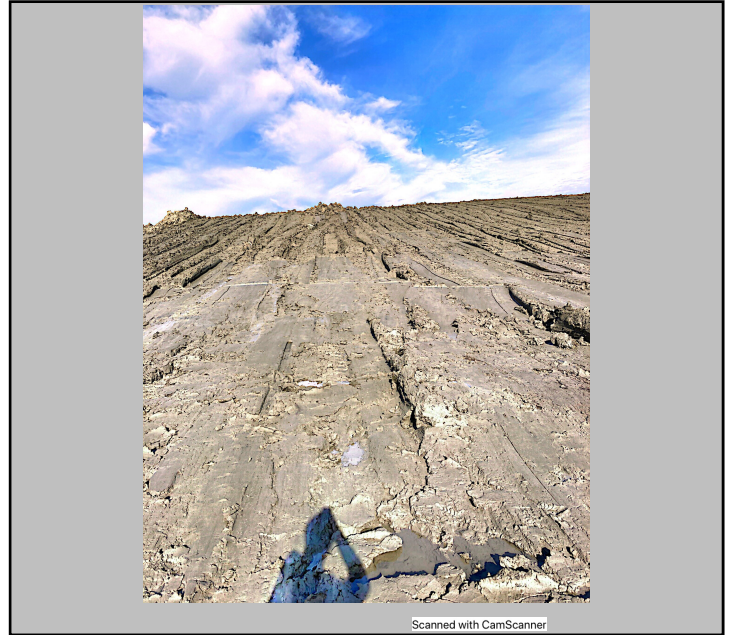
Photo #: 2

P33 morning.

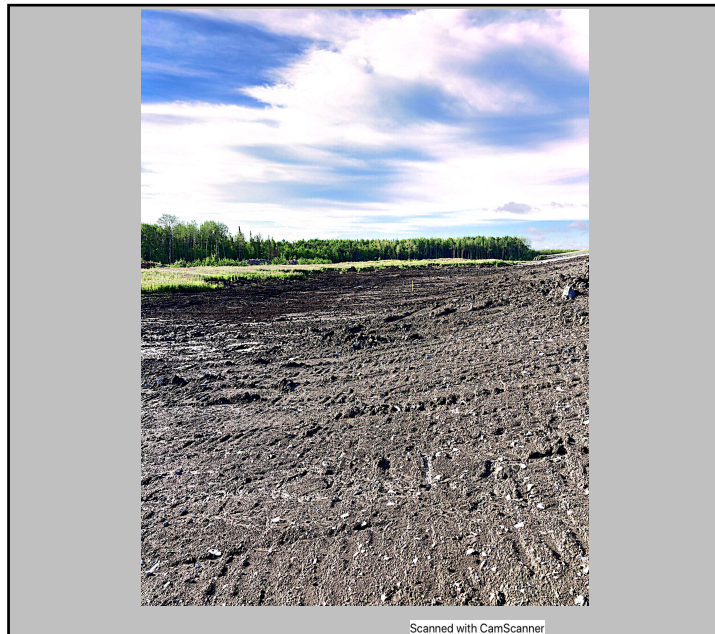
Photo #: 3

Toe of P30-P33.

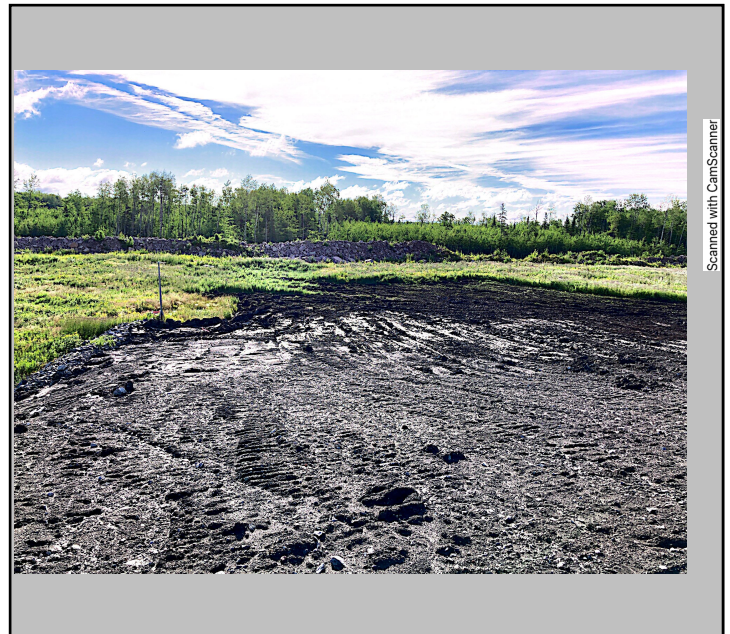
Photo #: 4

Toe of P30.

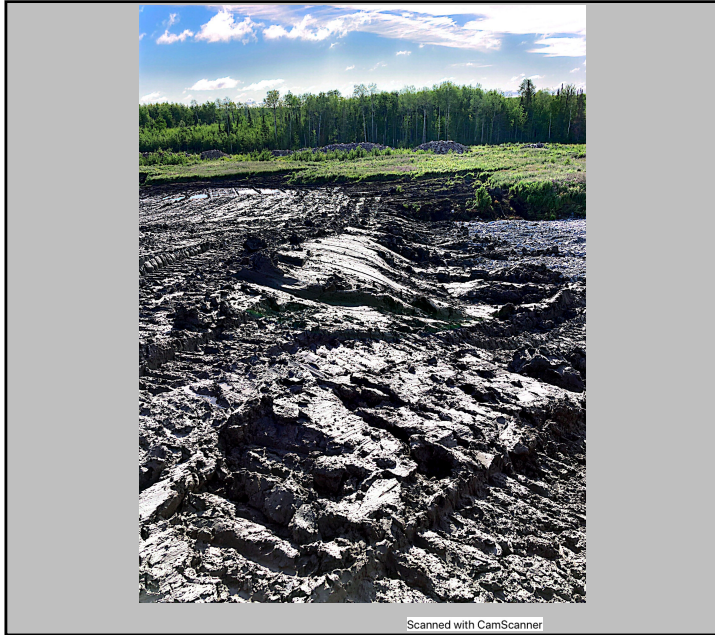
Photo #: 5

South edge of P33 sloped.

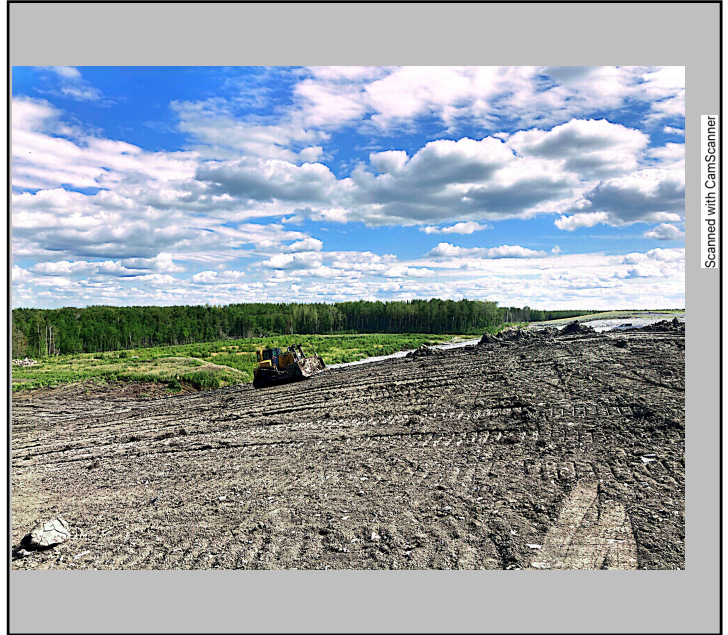
Photo #: 6

Dozer 420 track packing P33

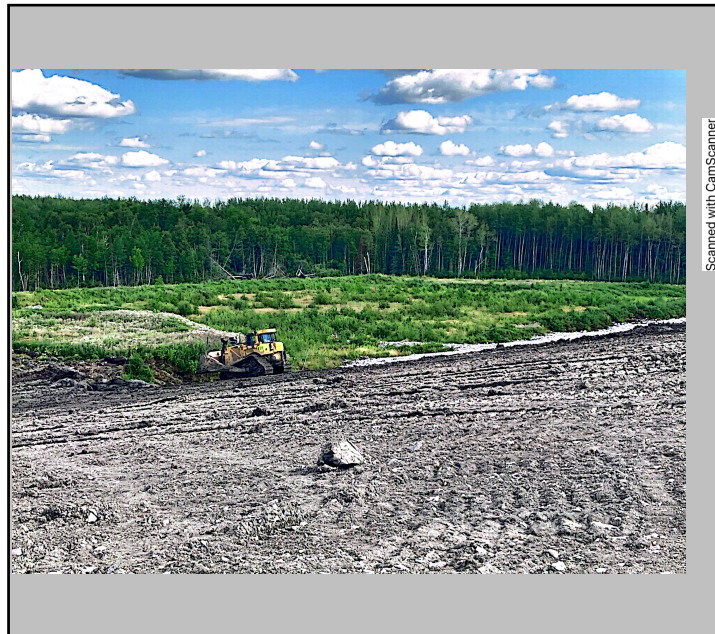
Photo #: 7

Dozer 420 grading P33.

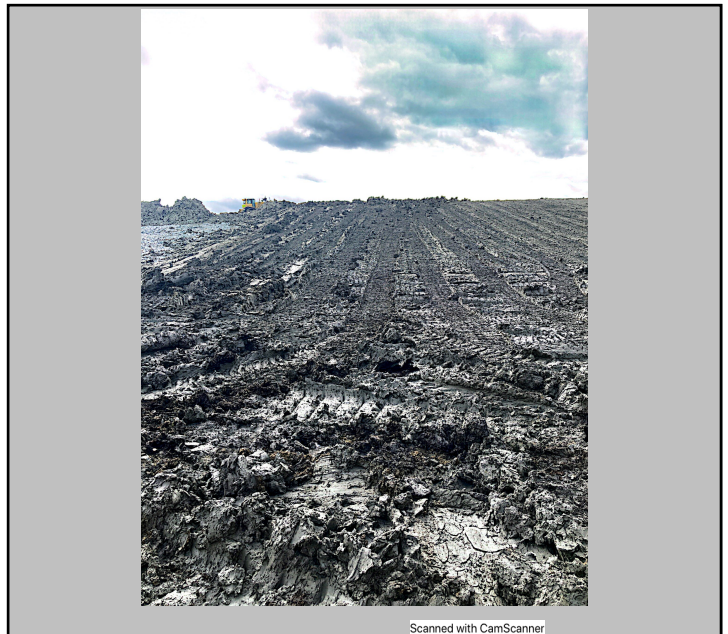
Photo #: 8

P33 end of day.

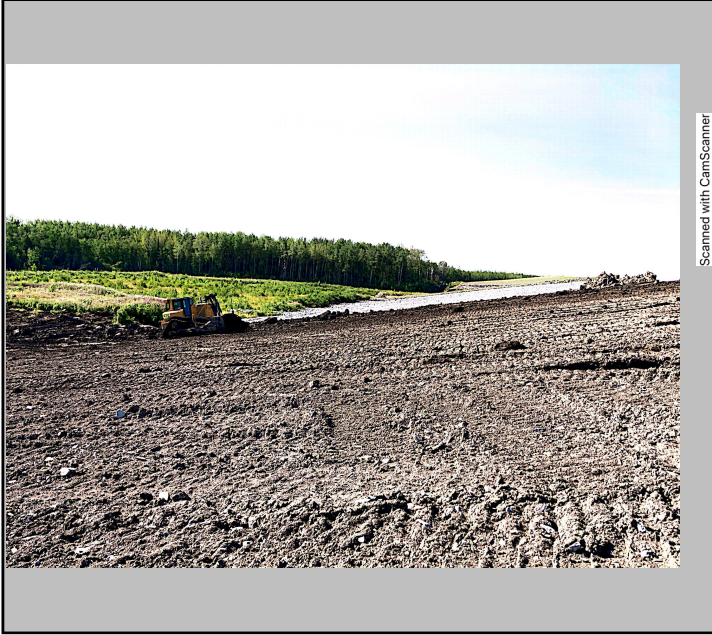
Photo #: 1

Dozer 420 grading P33 NCL L4.

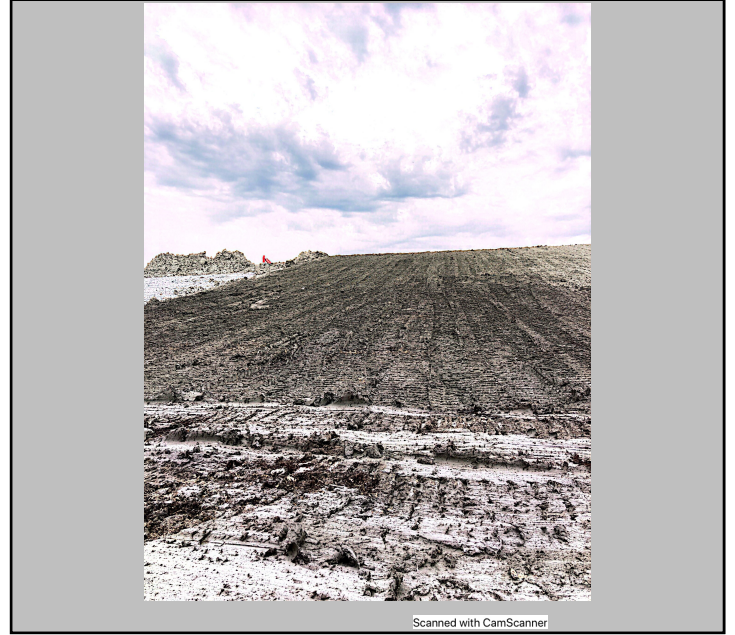
Photo #: 2

P33 NCL L4 complete.

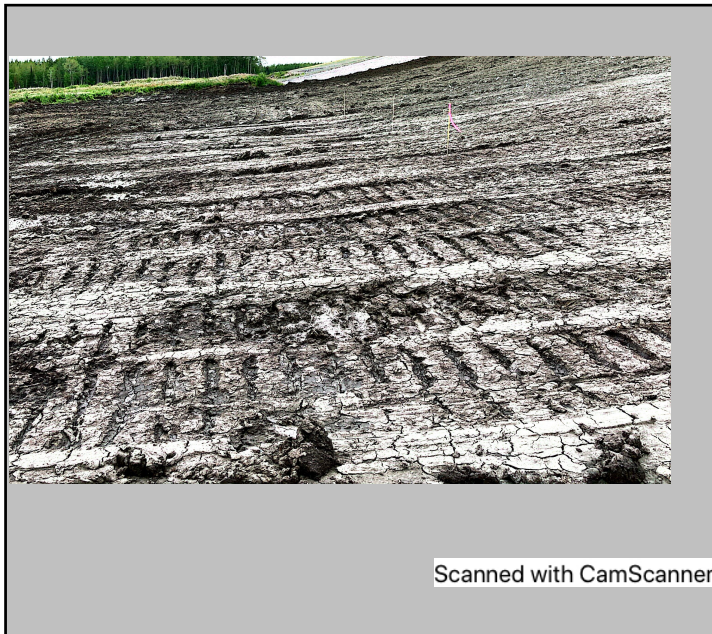
Photo #: 3

The adequacy of the drainage on Panels 30-33 was discussed with Okane. Drainage was deemed adequate.

P30 Toe sloped to drain past the key trench.

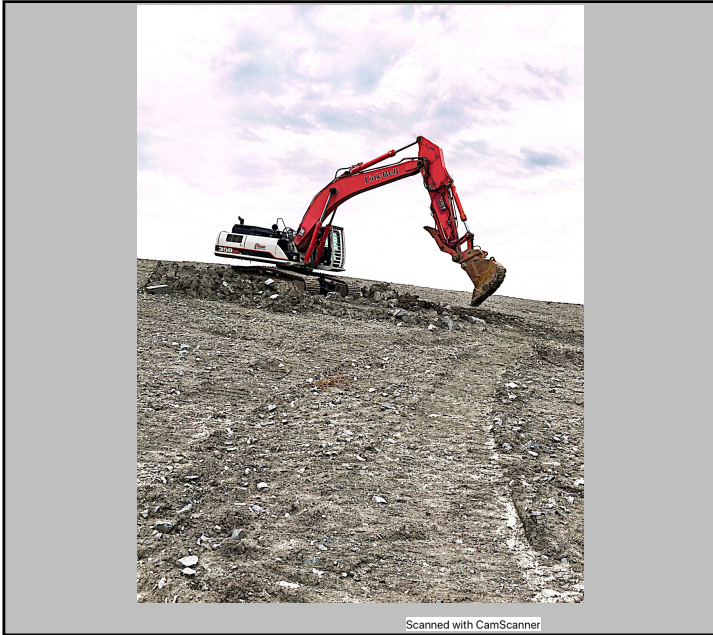
Photo #: 5

LB350 filling Okane's bore hole test pits.

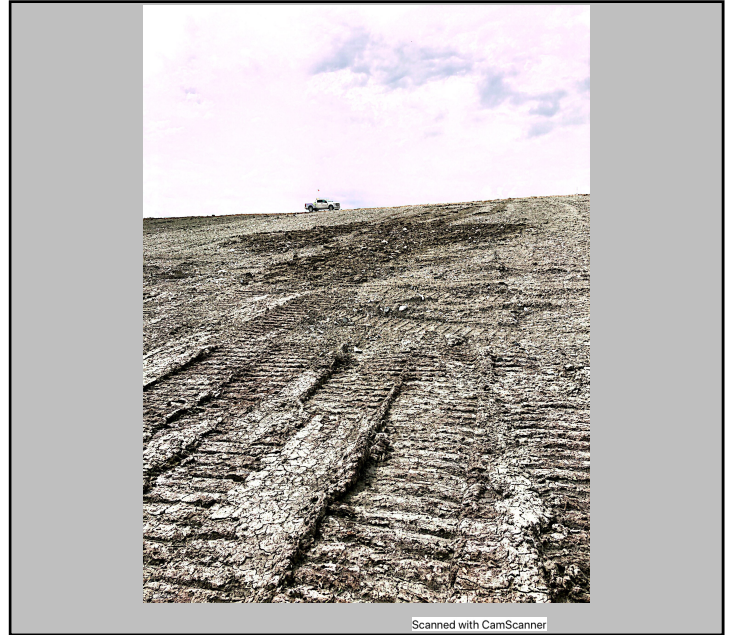
Photo #: 6

Bore hole test pits filled.
