<b>Date:</b>	June 13, 2022	<b>Owner/Client:</b>	New Gold Inc.
<b>Day:</b>	Monday	<b>Okane Project #:</b>	1003-027
<b>Prepared by:</b>	Blake Weinrauch	<b>Project Location:</b>	Ontario

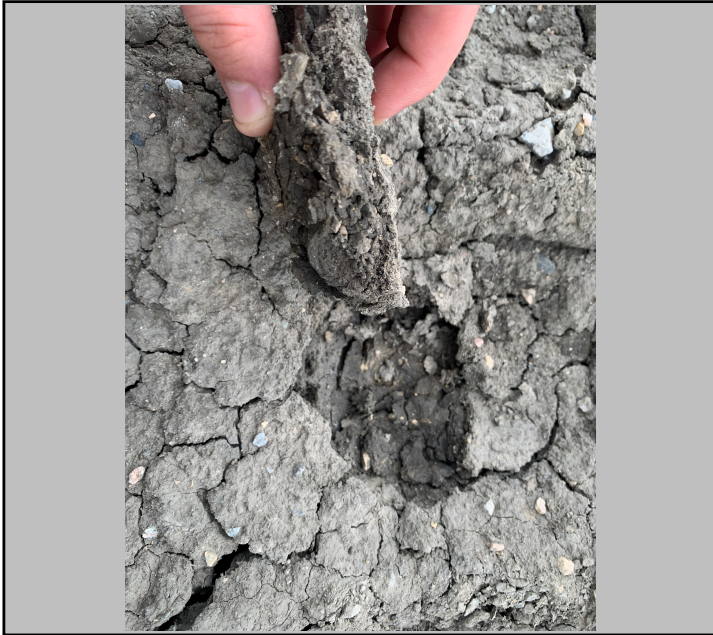
Photo #: 1

Minimal crusting on P30 L2

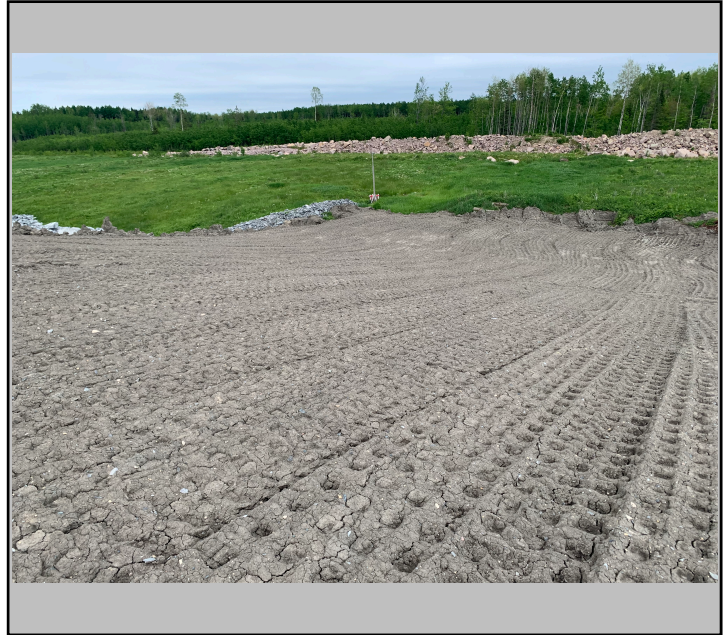
Photo #: 2

- Intermittent showers kept P30 L2 moist.
- Minimal dry material still present underneath moist top layer.
- Cracking of L2 still present as a result of previous extreme drying.

P30 L2 cracking present

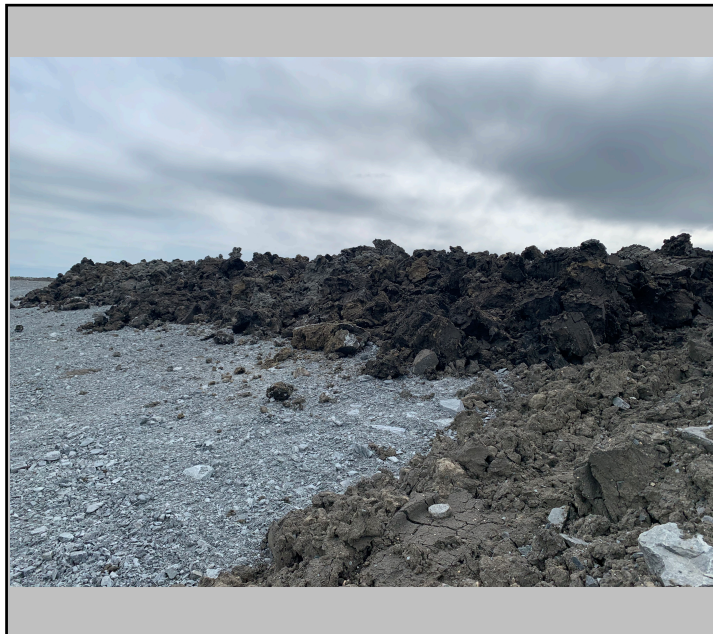
Photo #: 3

- No cover system construction completed.
- Material stockpiled at crest of slope ahead where P31 and P32 will be constructed. Material appeared to be dark brown and plastic with pockets of lighter brown material. Minimal rock appeared to be present.

Material stockpiled on crest of slope where P31 and P32 will be placed

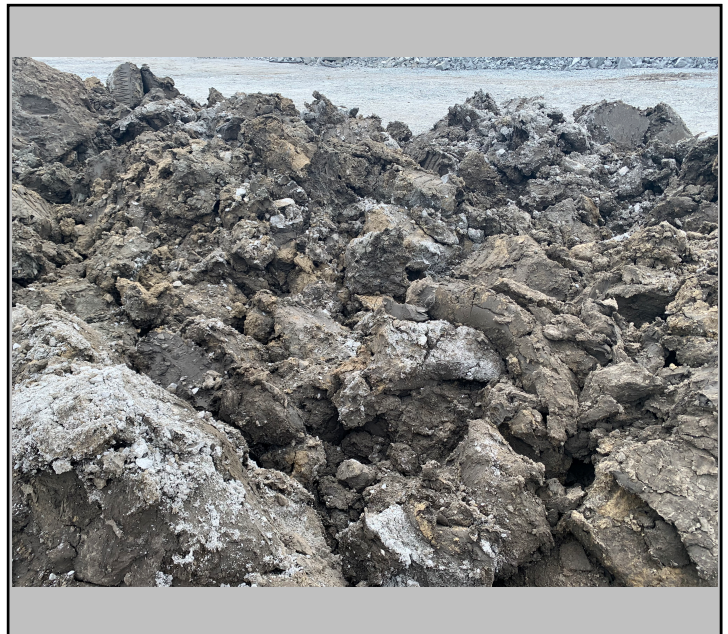
Photo #: 4

Stockpiled material varying in colour

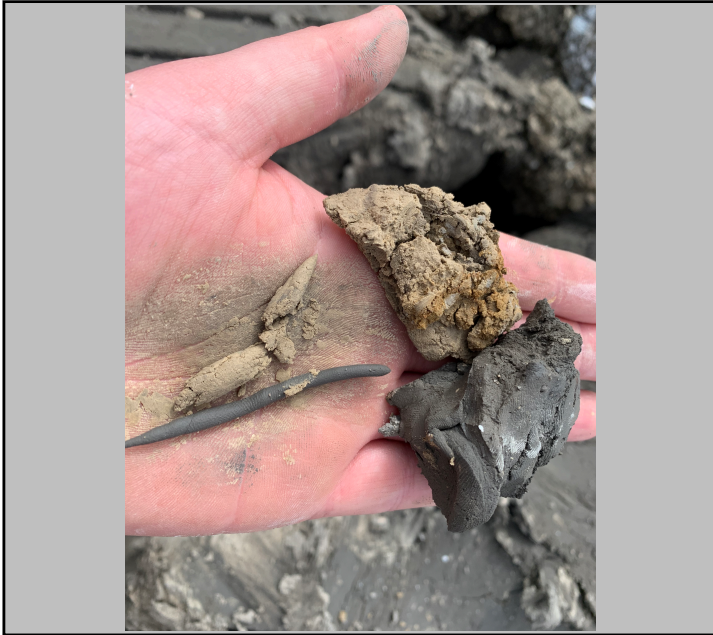
Photo #: 1

Dark brown plastic material (Bottom)  
Light brown non-plastic material (Top)

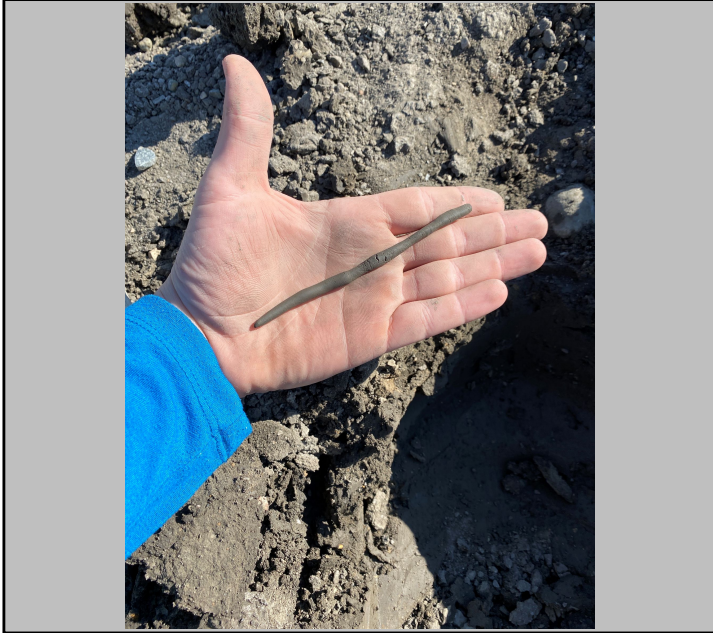
Photo #: 1

- Three spot checks completed on the exposed areas of L2. Brownish grey, moist, pliable material was reached at a depth of approximately 150mm in all three locations.

P30, L2 spot check #1 material

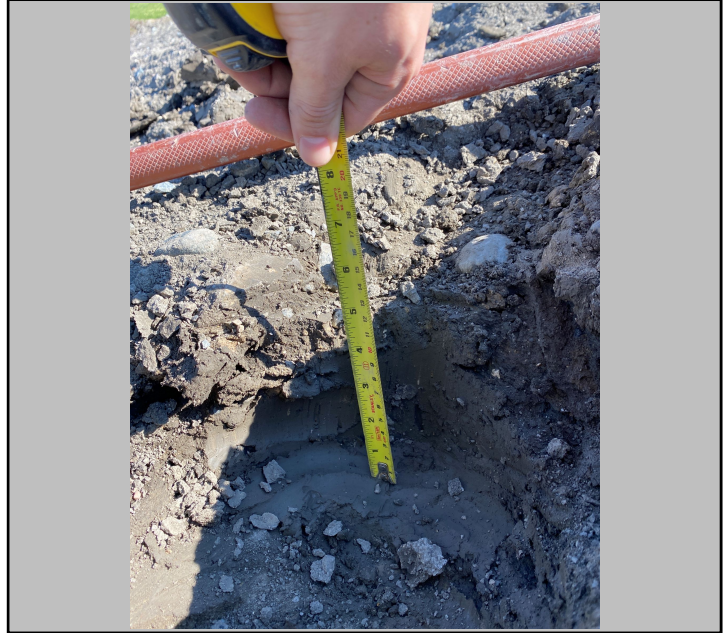
Photo #: 2

P30, L2 spot check #1 depth

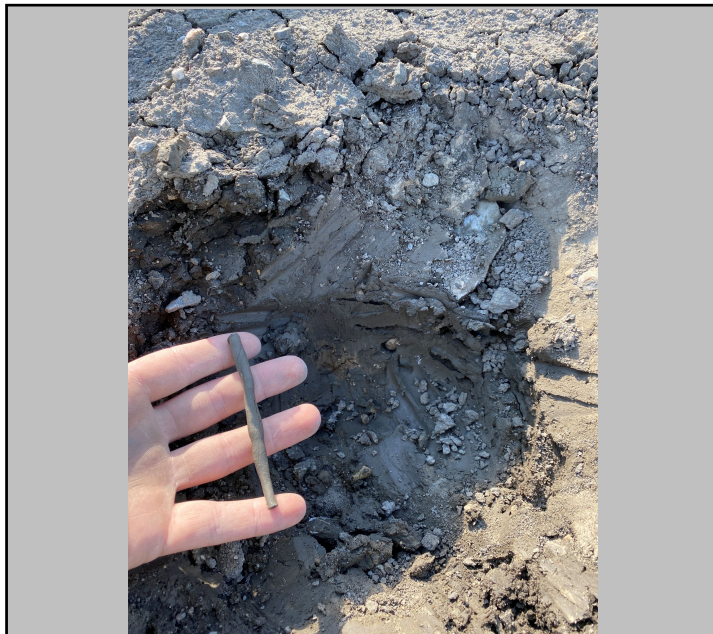
Photo #: 3

P30, L2 spot check #2

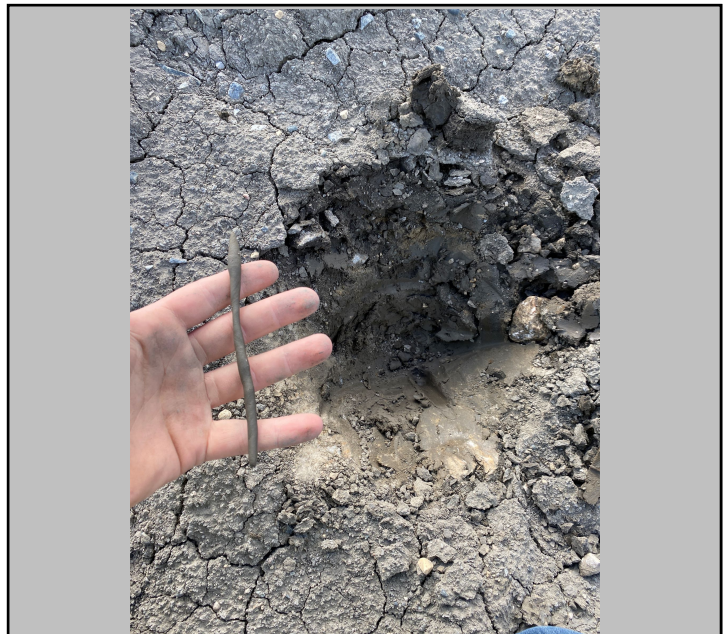
Photo #: 4

P30, L2 spot check #3

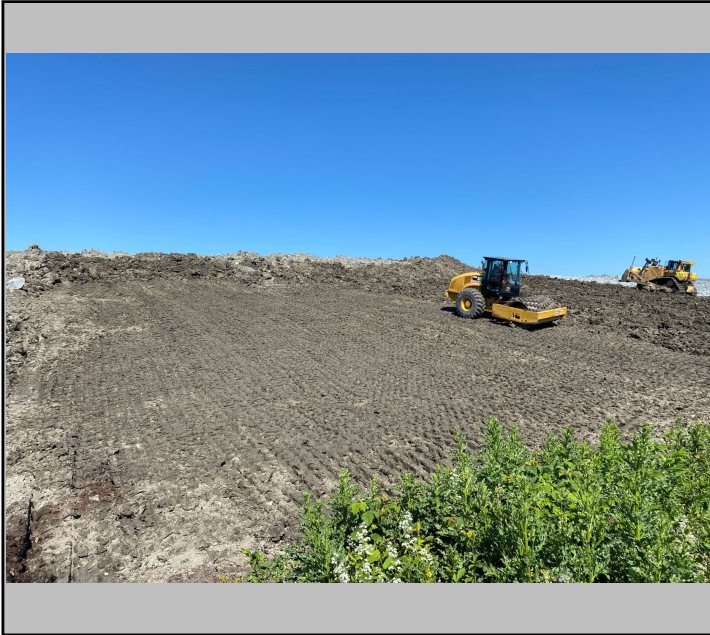
Photo #: 1

- Dozers utilized to rework L2 by skimming a top layer of material and mixing/track packing the material below.
- Following rework of L2 CQA requested CQC complete a moisture check with the nuclear gauge prior to compaction to ensure the optimum moisture content of 20.6% was achieved. A moisture content of 21% was achieved and compaction was initiated with vibration to aid in bringing moisture to the surface.

P30, L2 compaction following rework

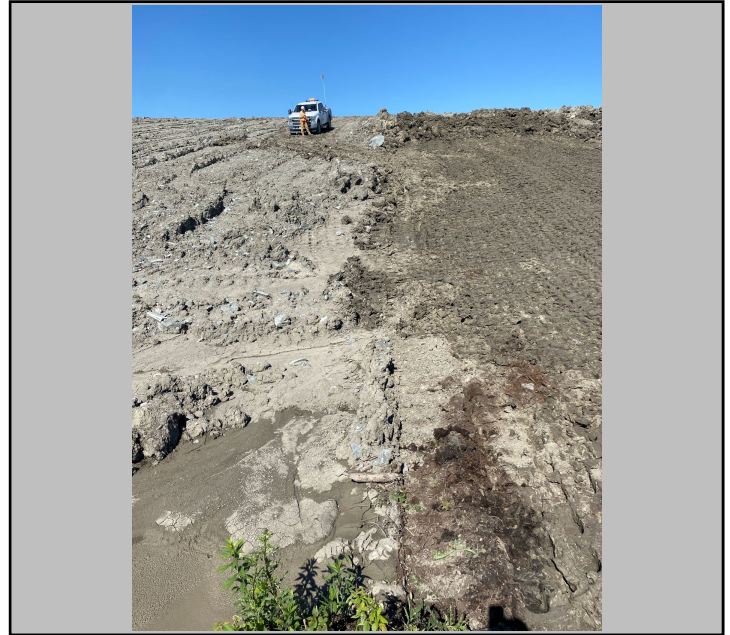
Photo #: 2

South edge of reworked area prior to being extended 1m for tie in

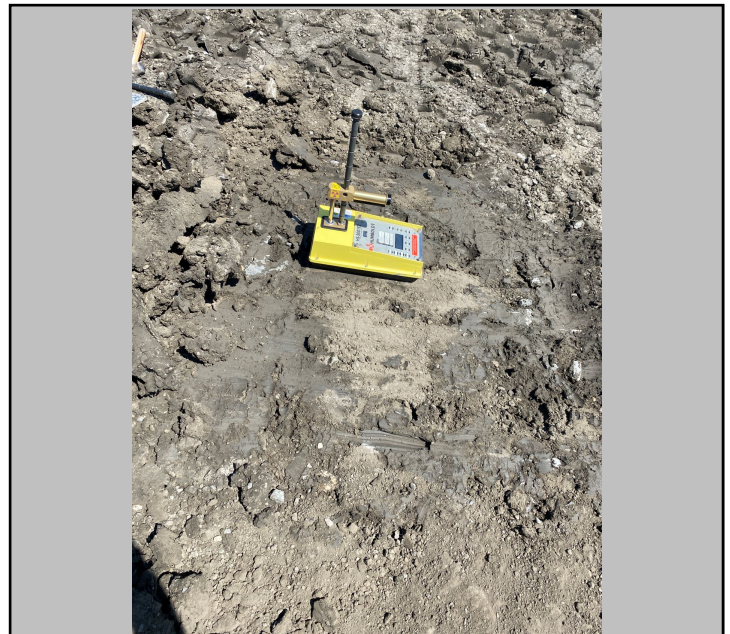
Photo #: 4

- Small areas containing scattered dry spots among moist pliable material noted during compaction. CQA requested D488 be completed within the largest of these areas (approximately 6'x10') where a testing surface could be created. D488 yielded a 26.4% moisture content on the edge of the dry material. The dry spots noted appeared to have suitable material further below the surface and the area was flagged for borehole permeameter testing.

D488

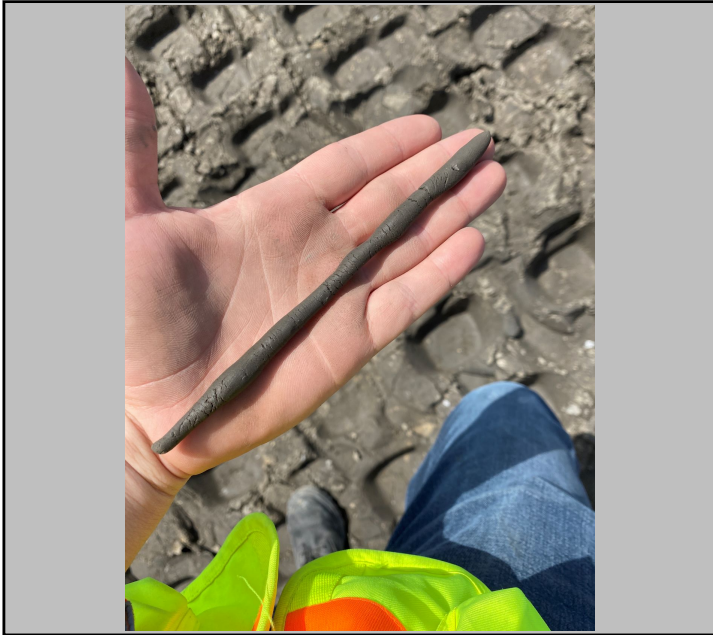
Photo #: 5

D488 material

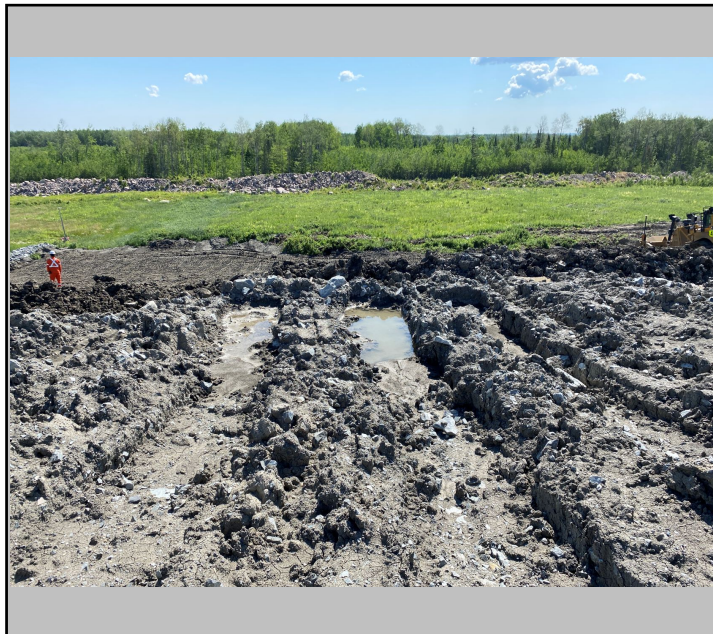
Photo #: 7

Pockets of water on P30, L3 prior to mixing material

- CQA recommended utilizing moist material to place directly over top of L2 to aid in the re-hydration of any of any dry spots present in the reworked CCL.
- With areas of standing water still present in pockets of L3, operators mixed the wet spots with the previously placed L3 material for placement over L2.
- L3 placed at a reduced lift to promptly cover the reworked L2 before more NCL material began being hauled from the southern borrow source.

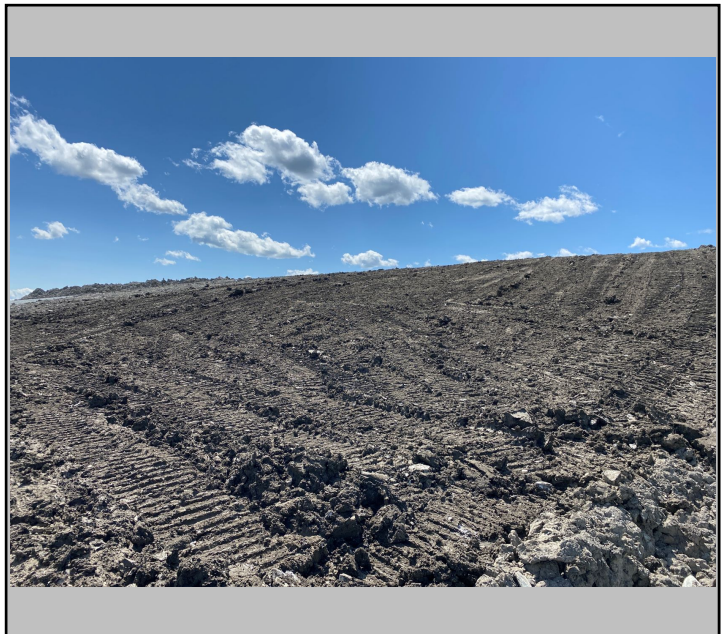
Photo #: 8

P30, L3 placed to cover reworked L2 material

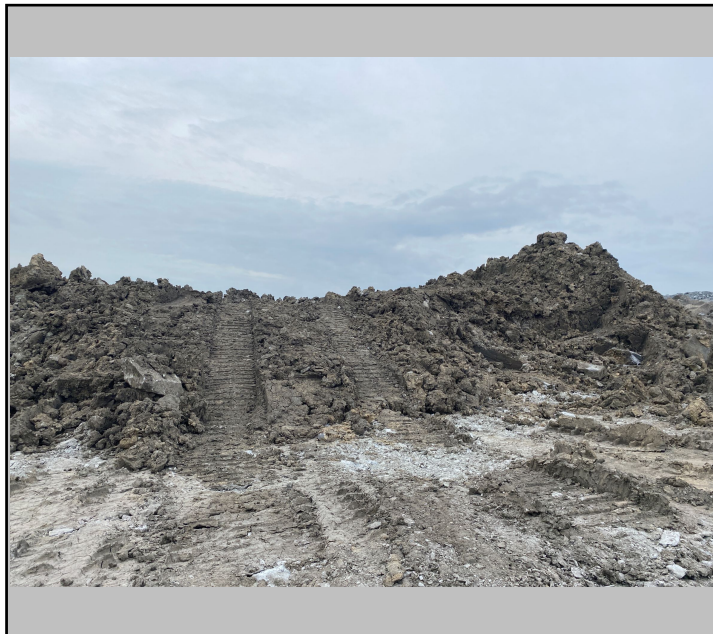
Photo #: 3

Area within southern stockpile with reduced rock content

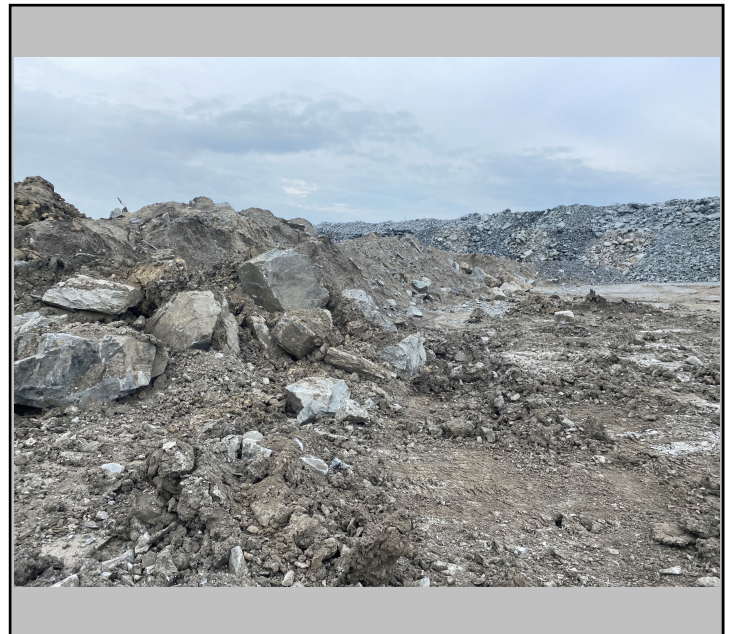
Photo #: 4

Area within southern borrow area with large volume of stone

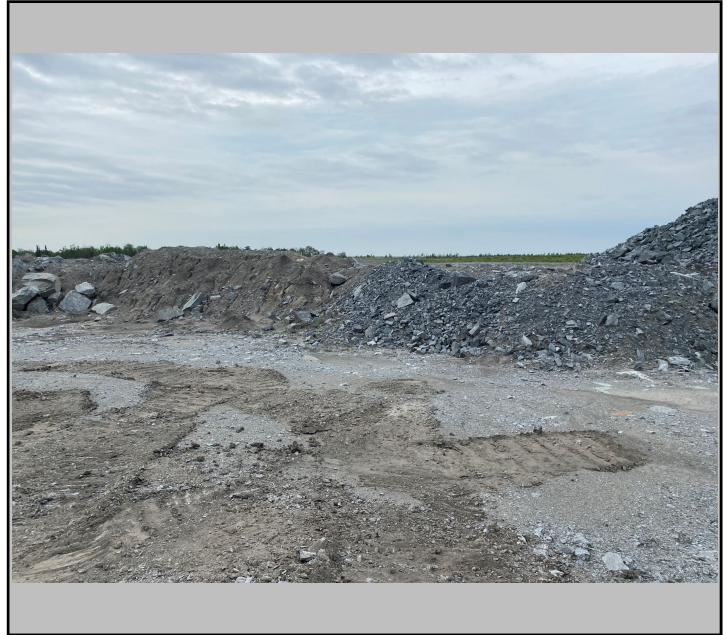
Photo #: 6

Area within southern borrow area with large volume of stone

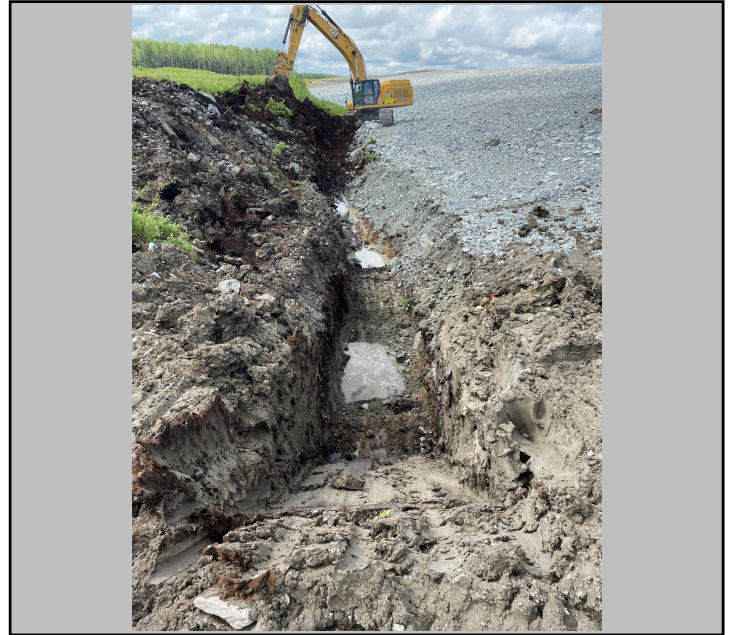
Photo #: 2

- Key trench dug to varying depths throughout the width of the panel with bedrock being reached consistently throughout. The depth of excavation became shallower while the trench progressed south as the elevation of the bedrock increased.
- Key trench excavation resulted in waste rock from the slope being piled outside the cover system due to the slope butting up to a topsoil berm. Following excavation the waste rock was removed by the excavator.

P31 key trench dug to varying depths with bedrock reached throughout

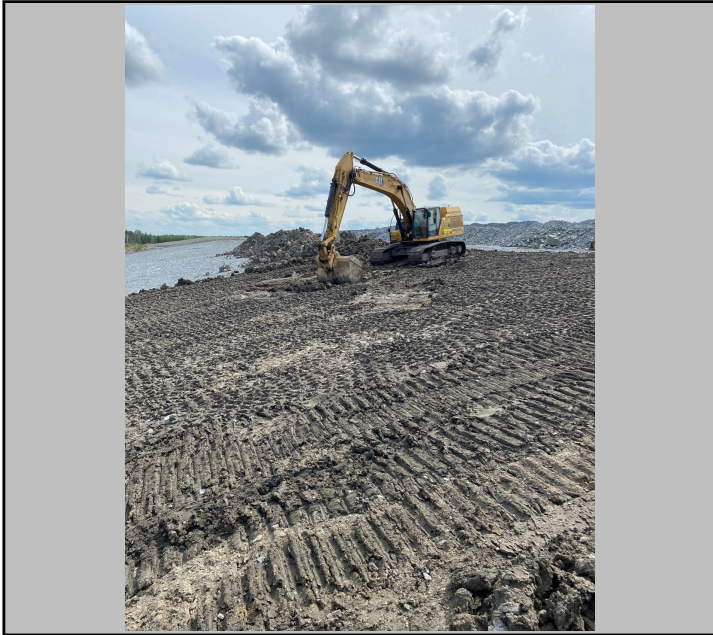
Photo #: 5

- L1 placed with material previously stockpiled on the bench. After mixing the stockpiled material it appeared brownish grey, moist and pliable with dry areas noted on the top quarter of the panel. CQC marked the dry areas and the excavator was utilized to remove the dry material and replace the excavation with moist material from the stockpile.
- Following placement to grade operators were able to remove over sized stone with the excavator and fill in a low spot prior to compaction. Four passes with the roller was utilized on L1.
- Nuclear density testing yielded adequate results, and proper thickness was confirmed by CQC.

Excavator replacing dry patches with moist material following over size stone removal

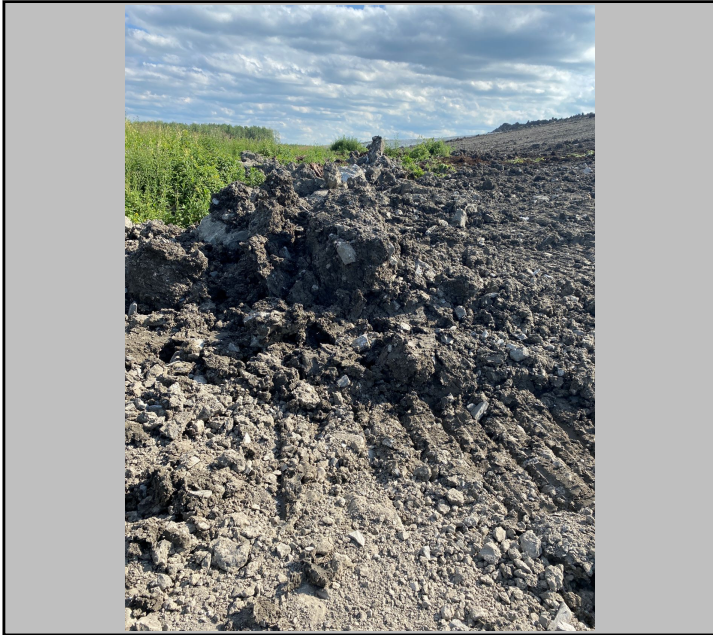
Photo #: 5

- Met with CQC to discuss P30, L4 following completion to grade. CQA noted areas of raised material at the toe to be flattened and excess coverage required on the north end of P30 to protect CCL material while construction progresses south.
- Elevation of topsoil berm greater than that of L4 in areas resulting in potential difficulty achieving drainage off the cover system. Once the raised material at P30 toe is flattened, P30 is to be monitored to evaluate runoff.

Raised material noted at P30 toe

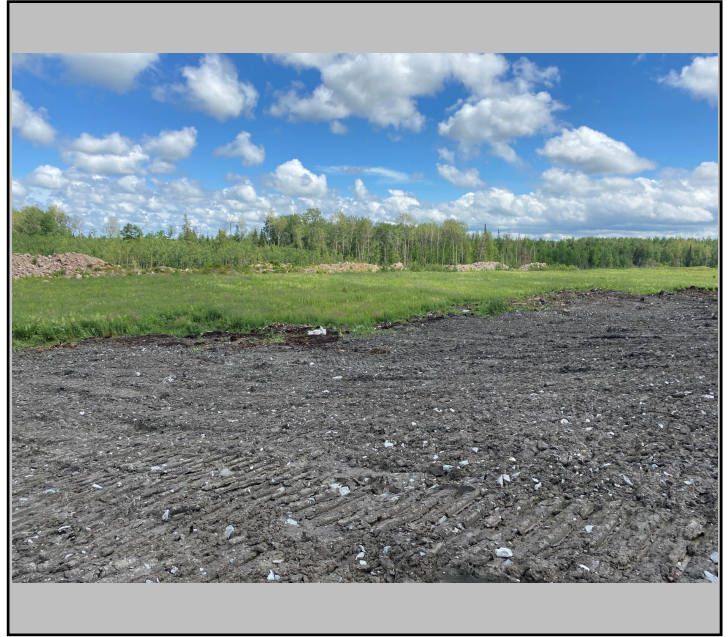
Photo #: 2

Raised material at toe flattened and blended in by dozer

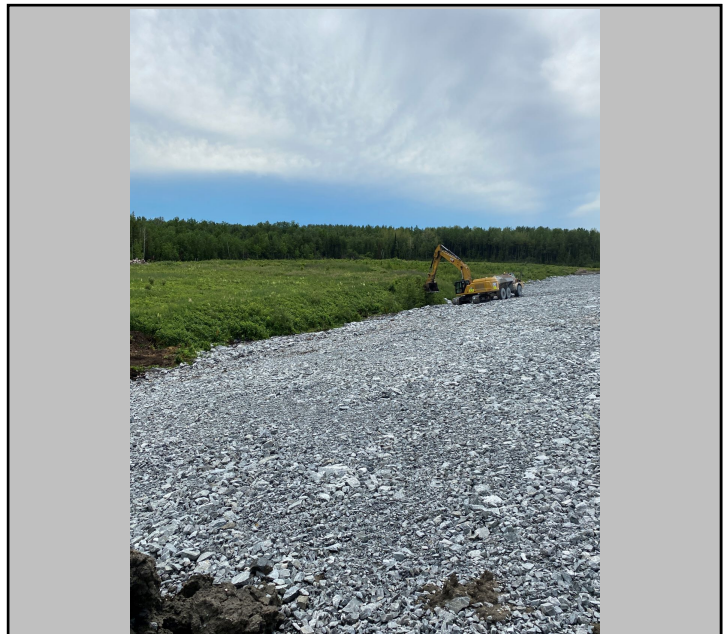
Photo #: 4

Excavator removing piled waste rock from toe south of P31
