PHOTOGRAPHS

Date:	Sept 24th, 2021	Owner/Client:	New Gold Inc.
Day:	Friday	OKC Project #:	1003-19
Prepared by:	Mitch Siciliano	Project Location:	Rainy River - Ontario

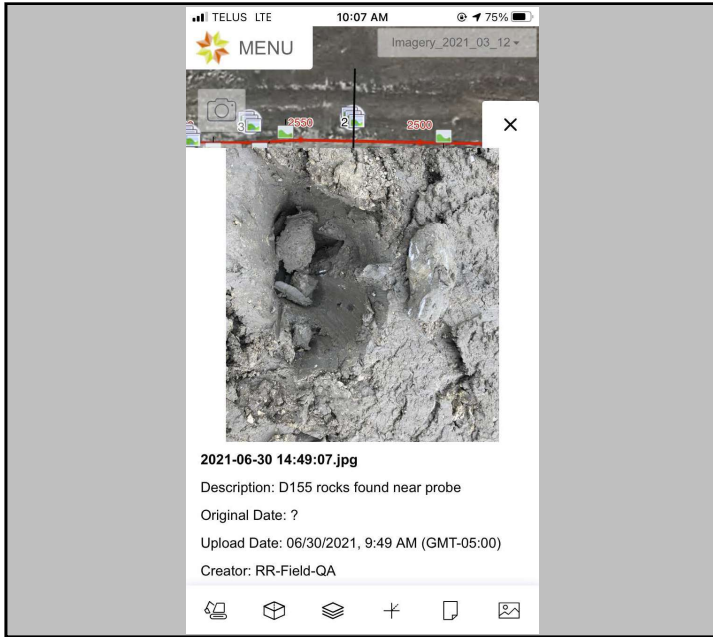
Photo #: 1

Rock found near D155 test

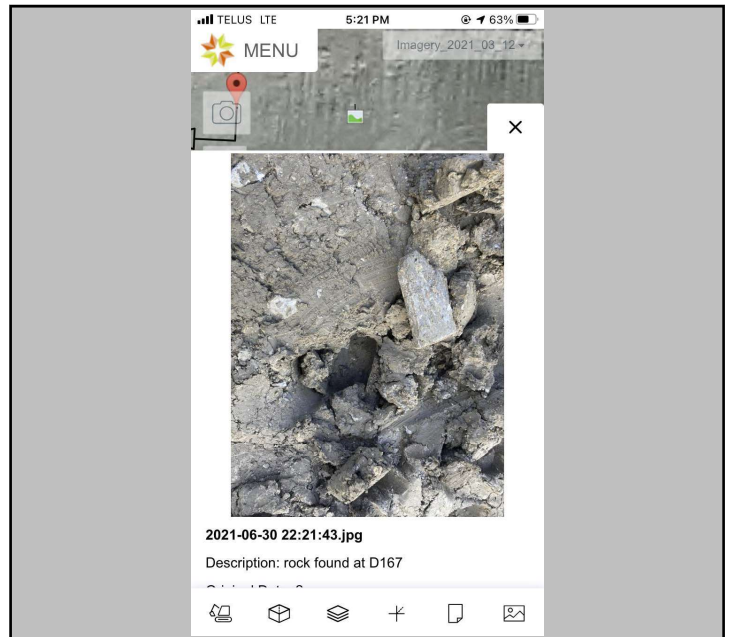
Photo #: 6

Rock found at probe for D167 test.

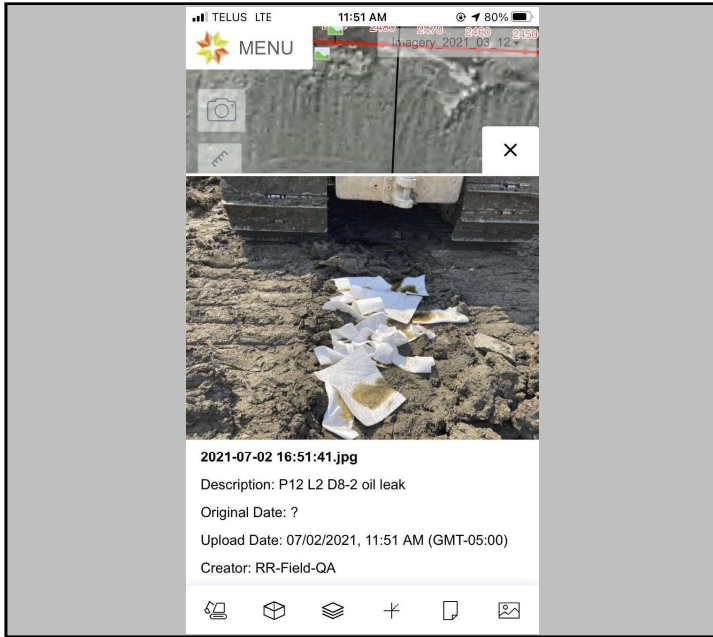
Photo #: 1

D8-2 hydraulic oil leak

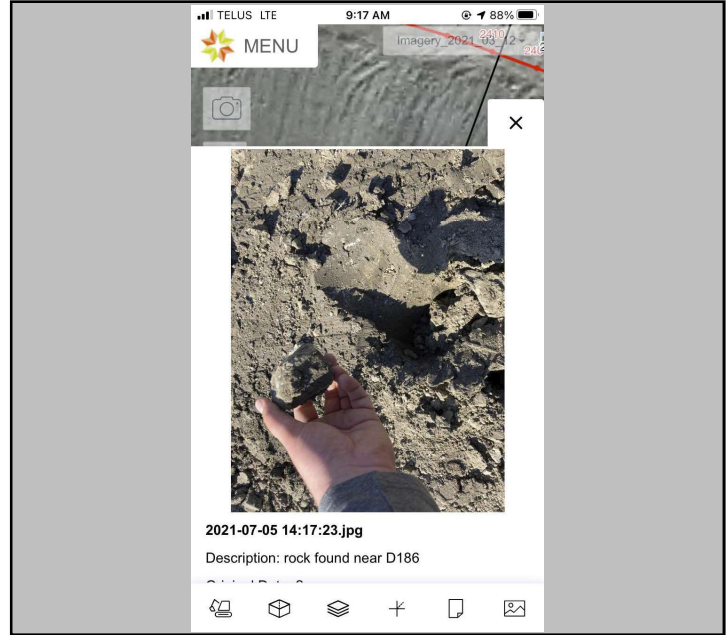
Photo #: 2

Rock found near D186

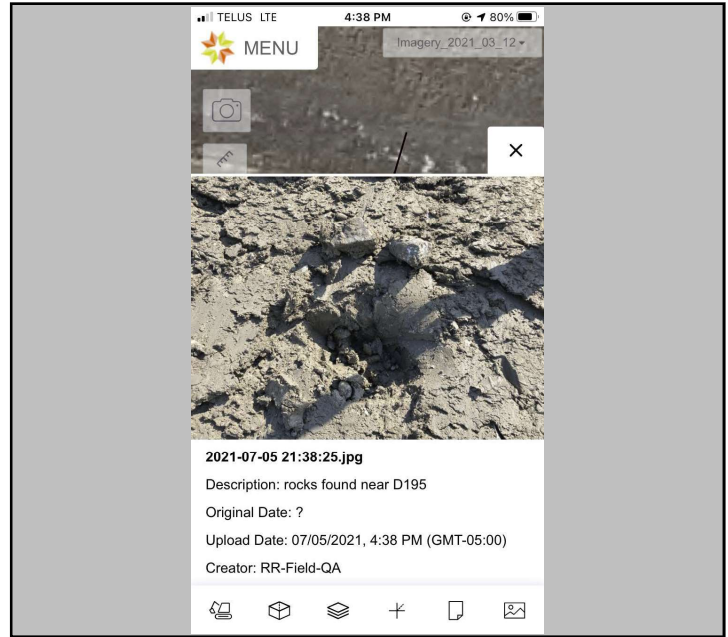
Photo #: 6

Rocks found near D195

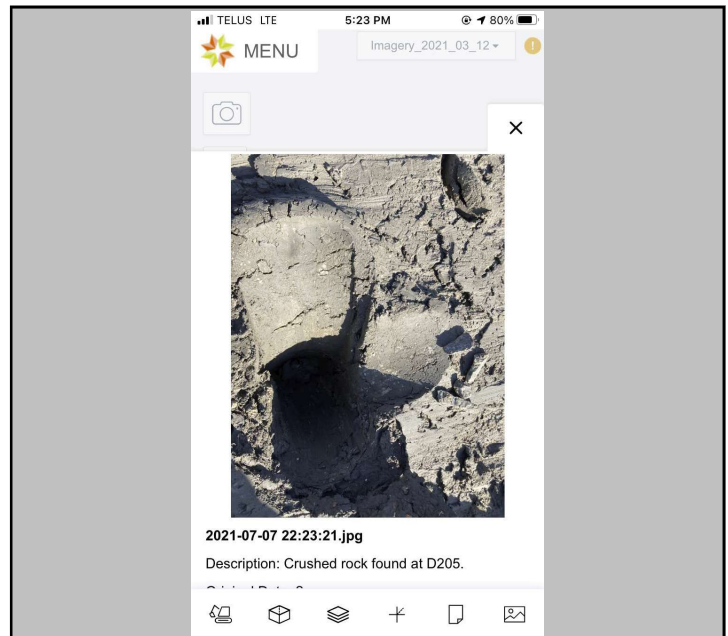
Photo #: 4

Few small rocks found near probe for D205

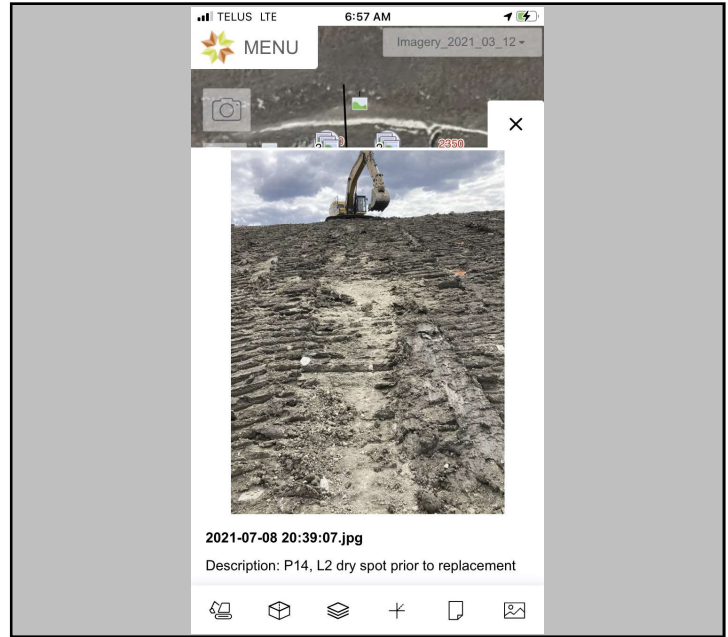
Photo #: 2

Area of dry material identified prior to replacement

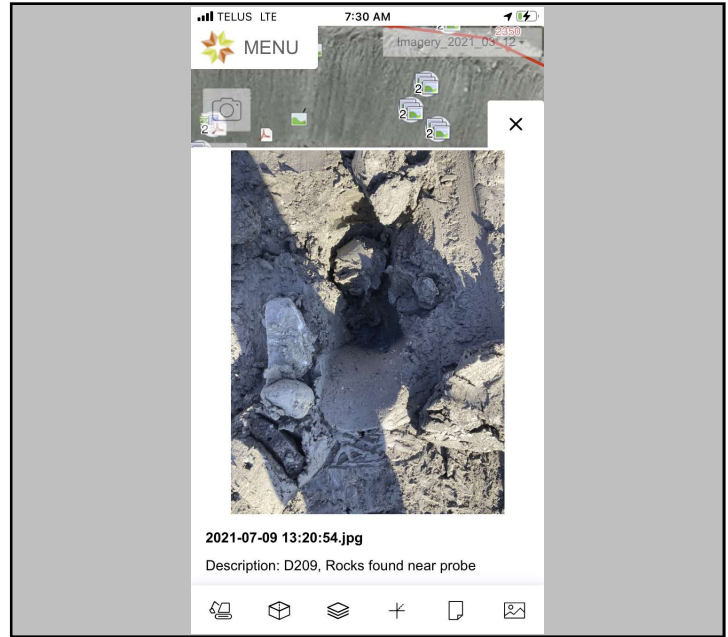
Photo #: 2

Rocks found near test probe

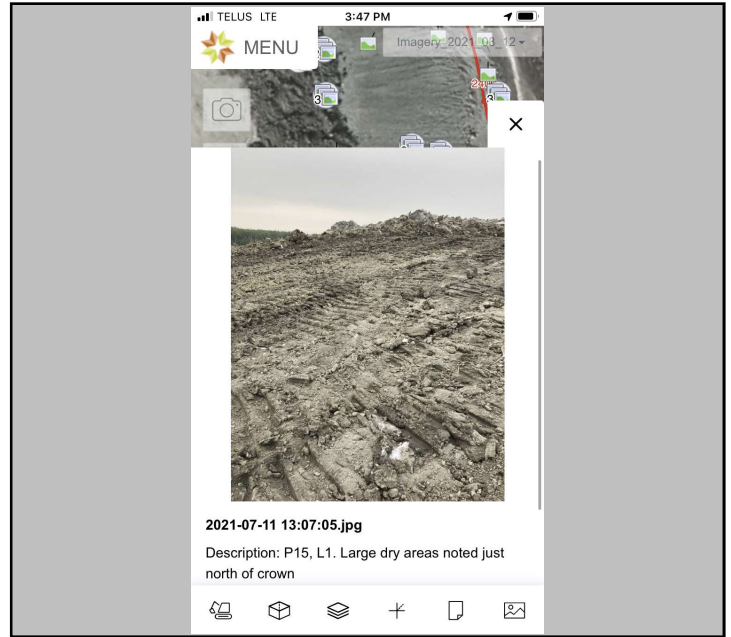
Photo #: 2

Large dry are North of crown prior to replacement

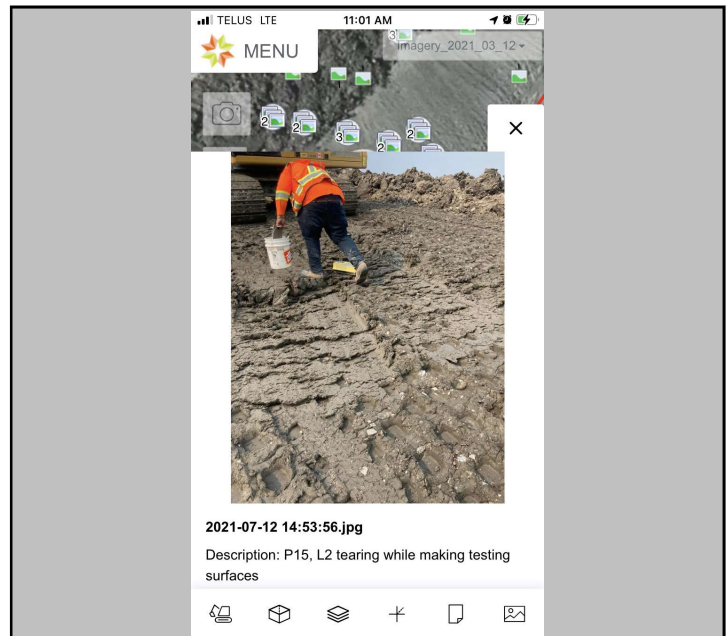
Photo #: 4

Difficulty creating a smooth testing surface

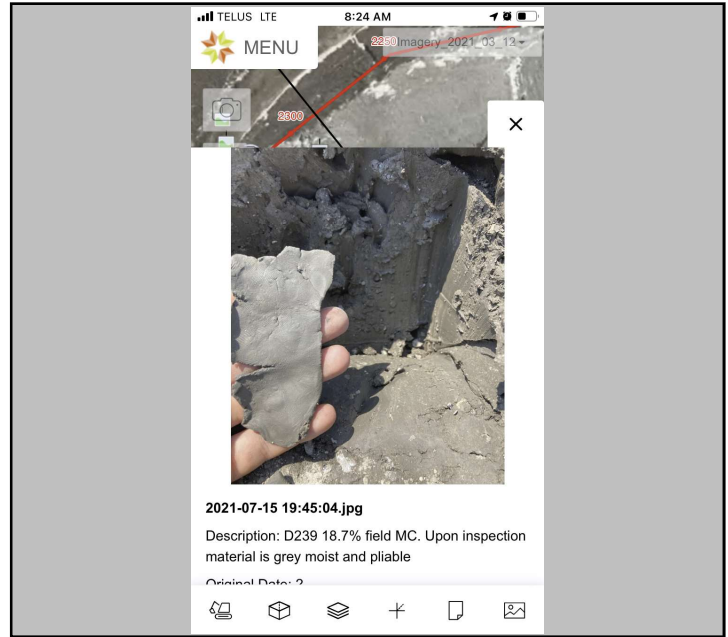
Photo #: 6

D239 w. 18.7% field moisture content. Upon inspection material was grey, moist, and pliable. Pending lab results.

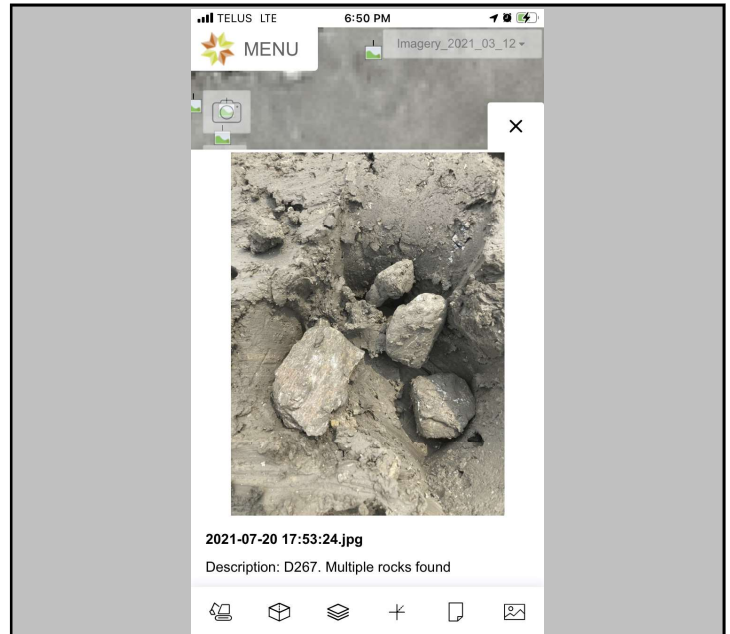
Photo #: 4

P18, L1 stones found next to probe

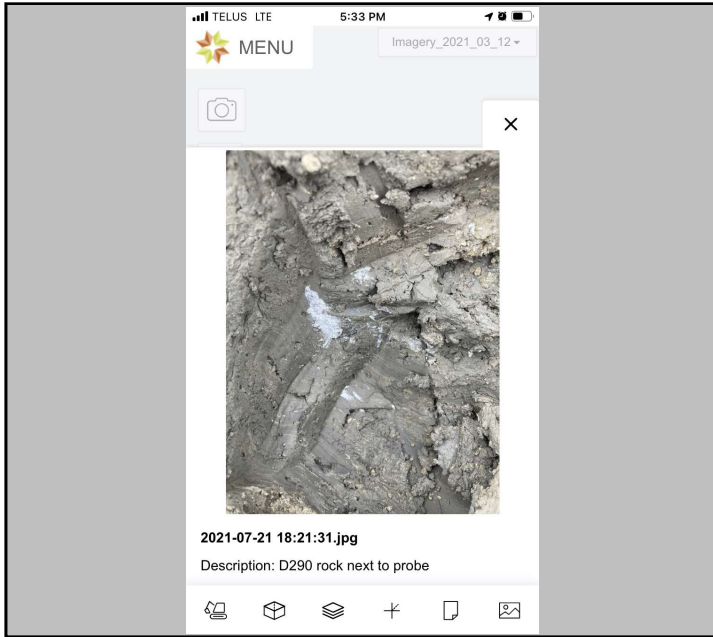
Photo #: 1

D290 rock next to probe

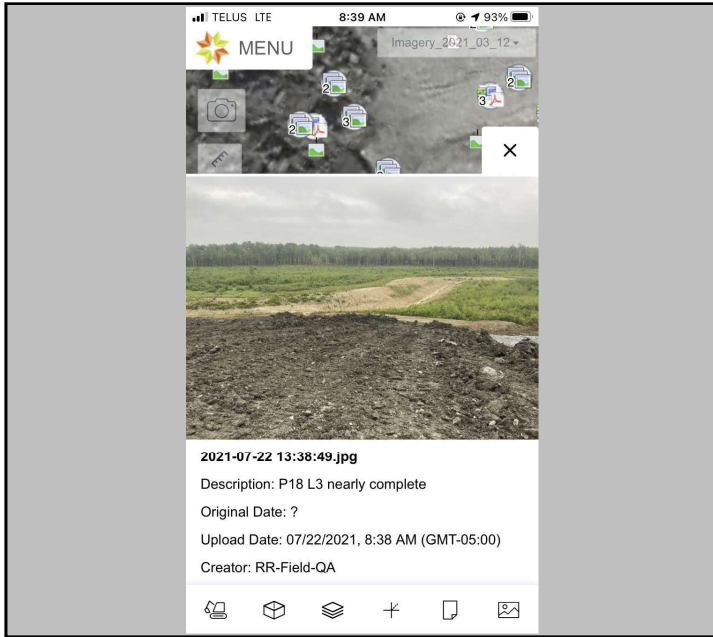
Photo #: 1

P18 L3 material bulked onto slope, to wet to bring to final grade

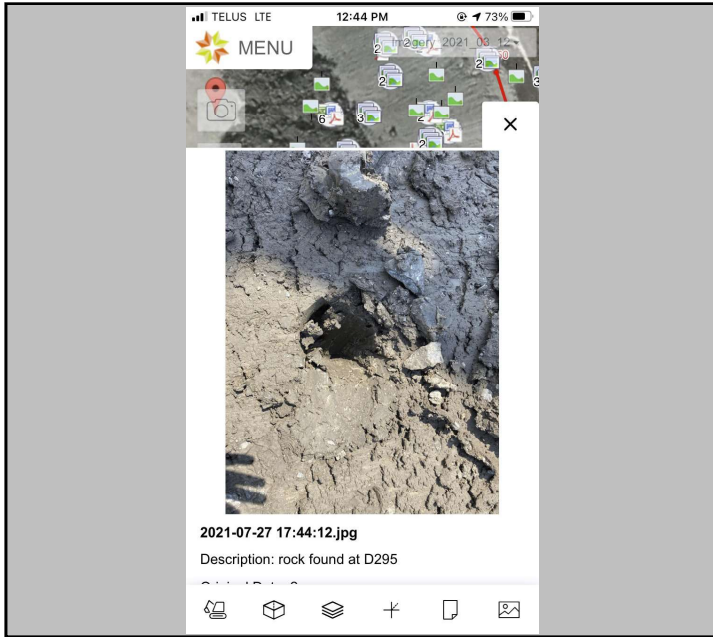
Photo #: 1

Rocks found at D295

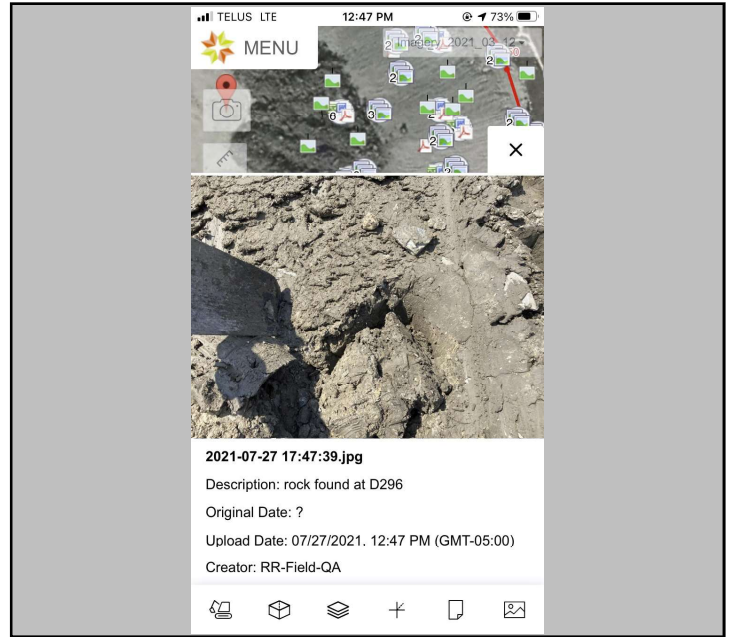
Photo #: 2

Rocks found at D296

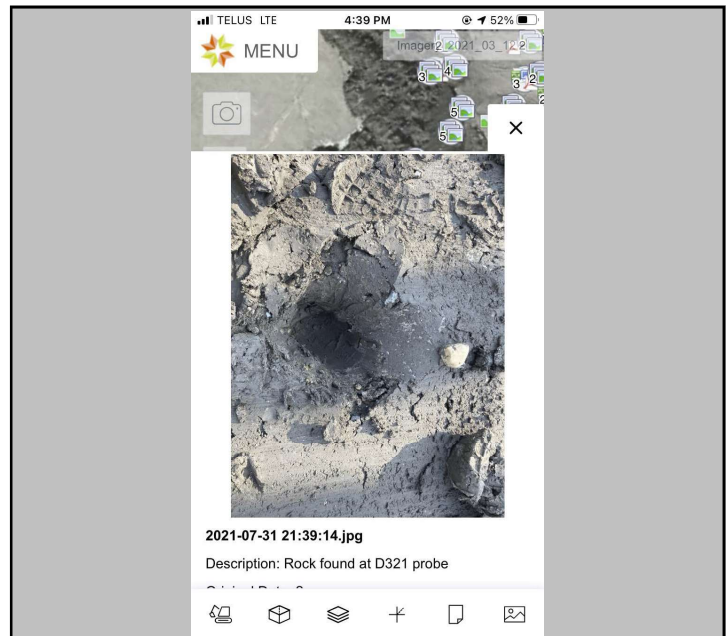
Photo #: 4

Rock found near D321 probe

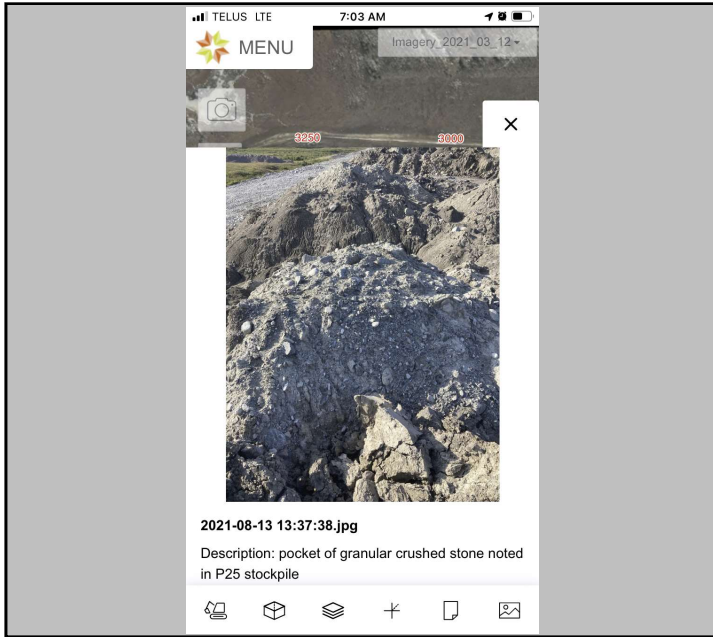
Photo #: 1

Pockets of crushed granular stone noted in P25 stockpile

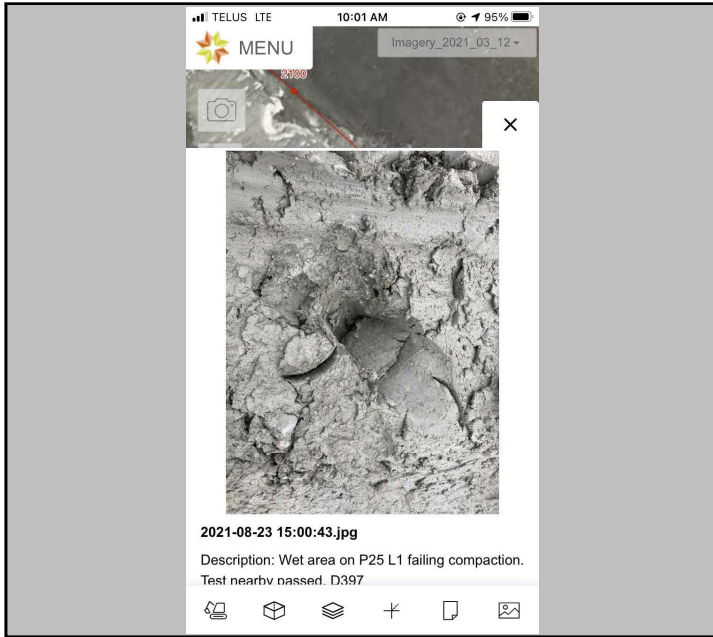
Photo #: 1

Very moist area that failed compaction on P25 L1.
