<b>Date:</b>	June 13, 2022	<b>Owner/Client:</b>	New Gold Inc.
<b>Day:</b>	Monday	<b>Okane Project #:</b>	1003-027
<b>Prepared by:</b>	Blake Weinrauch	<b>Project Location:</b>	Ontario

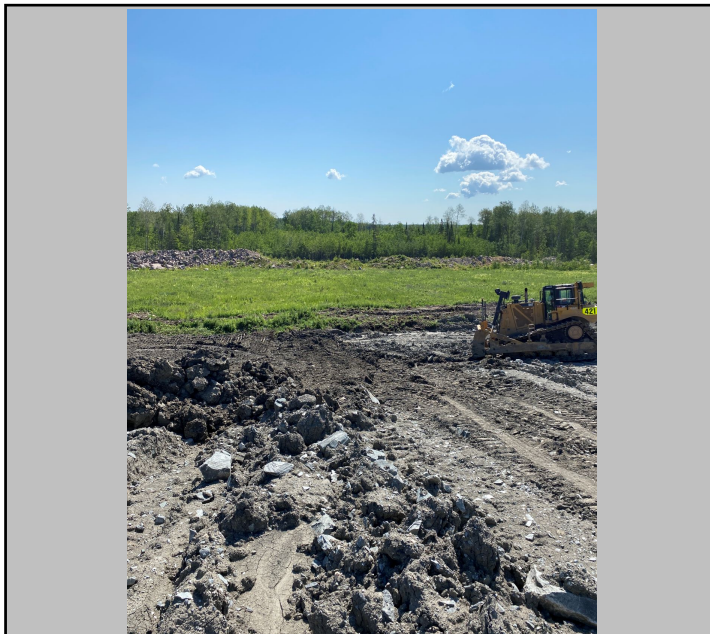
Photo #: 2

South edge of reworked area prior to being extended 1m for tie in

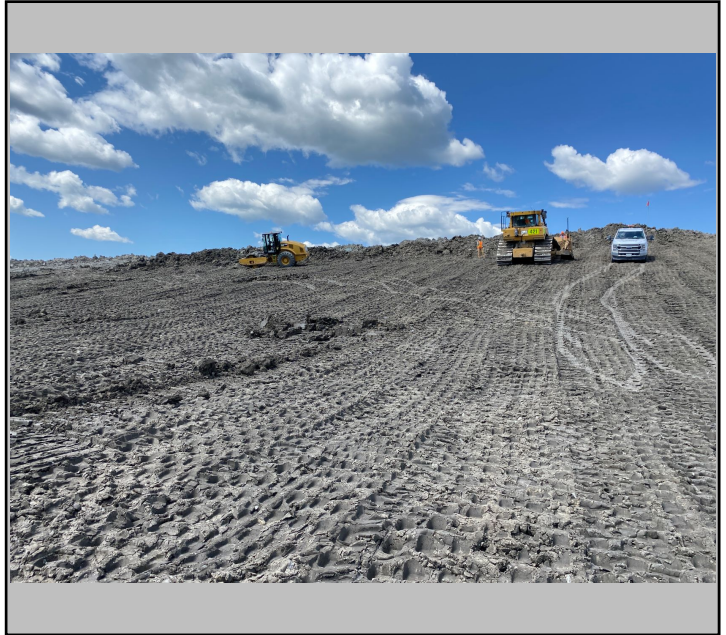
Photo #: 5

D488 material

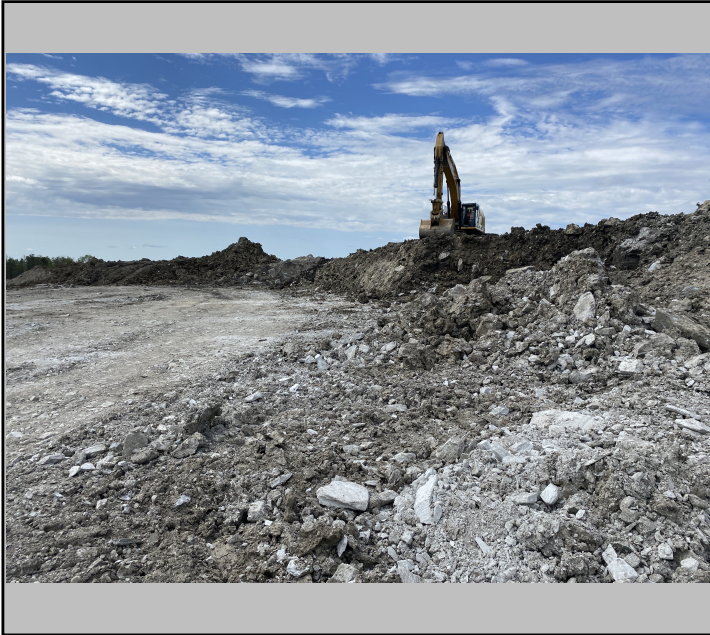
Photo #: 1

Southern borrow area for NCL use

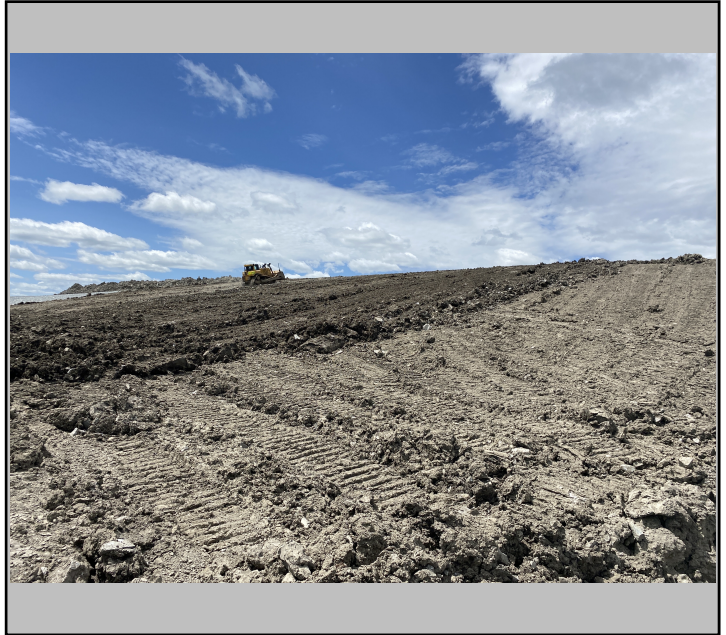
Photo #: 2

P30, L3 placement in progress

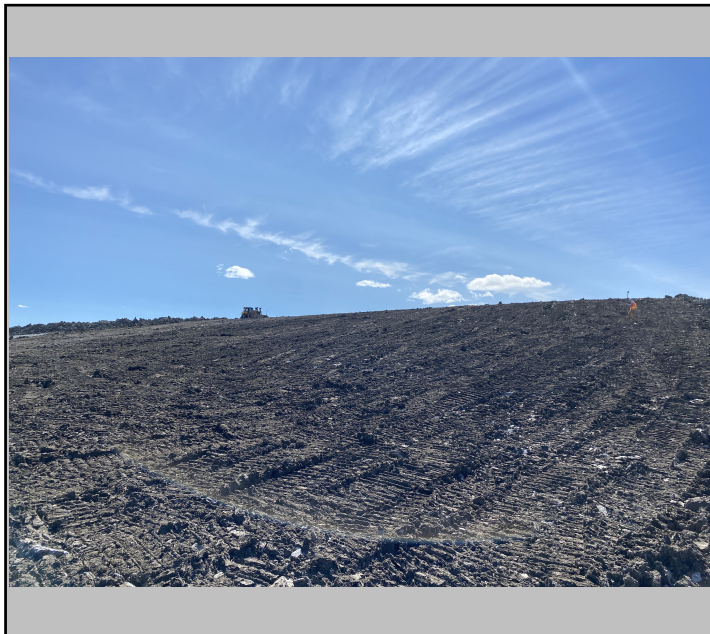
Photo #: 3

P30, L3 placed to grade

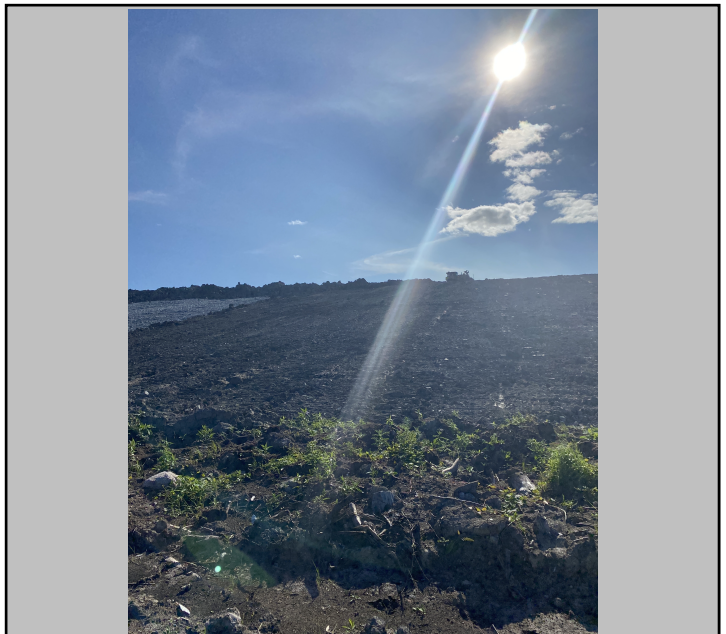
Photo #: 4

P30, L4 placement initiated near end of day

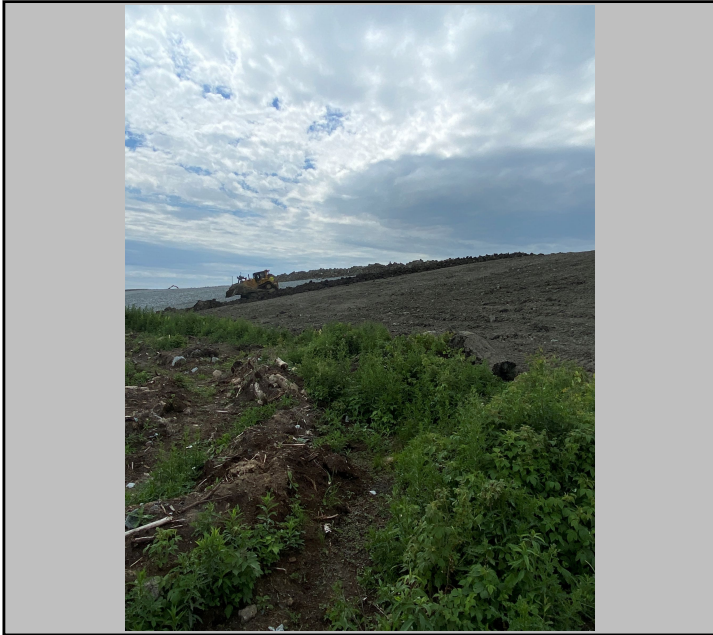
Photo #: 1

P30, L4 placement in progress

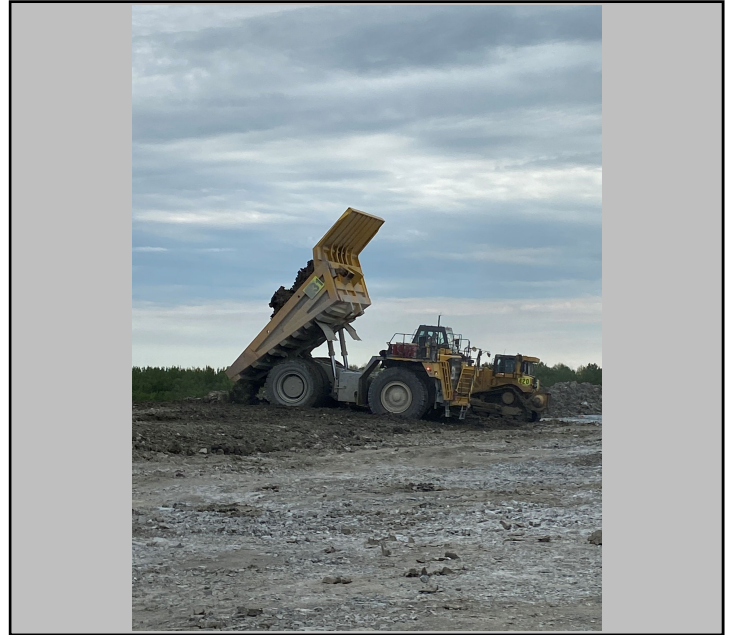
Photo #: 2

P30, L4 material hauled from southern borrow area

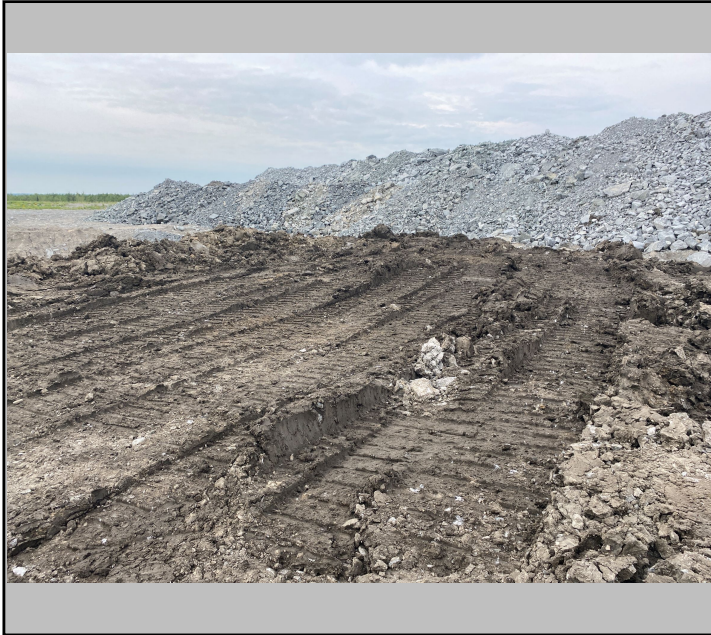
Photo #: 5

Area within southern stockpile with reduced rock content

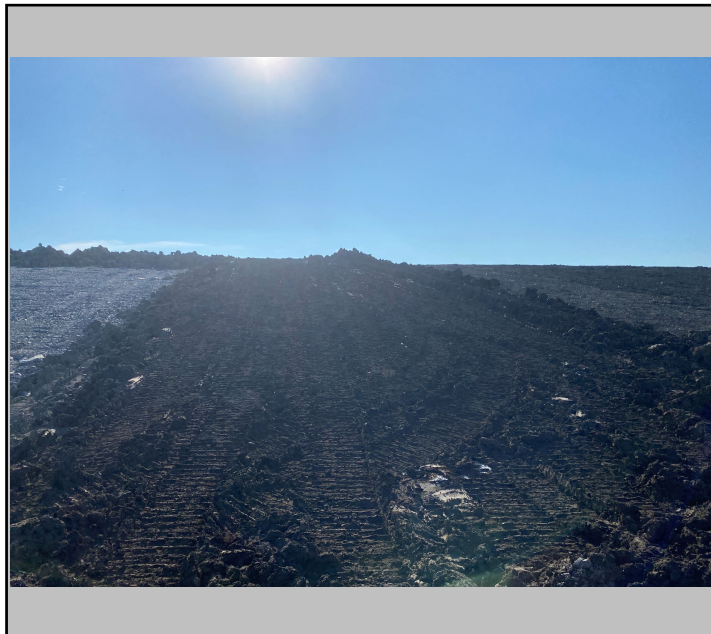
Photo #: 7

P30, L4 at end of day

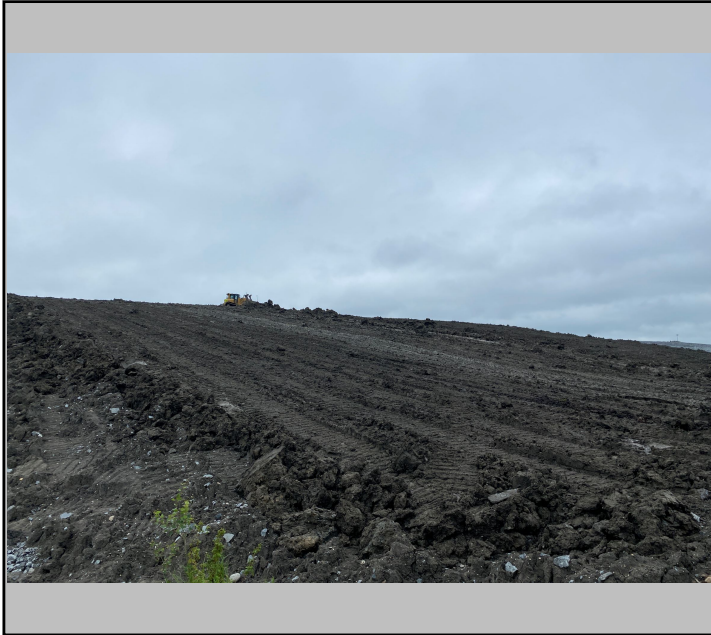
Photo #: 1

P30, L4 in progress

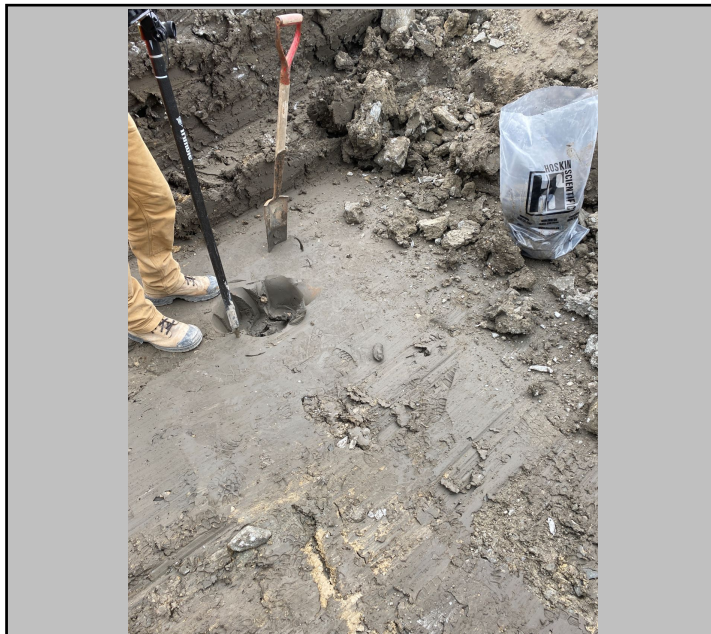
Photo #: 3

S544 sampling location

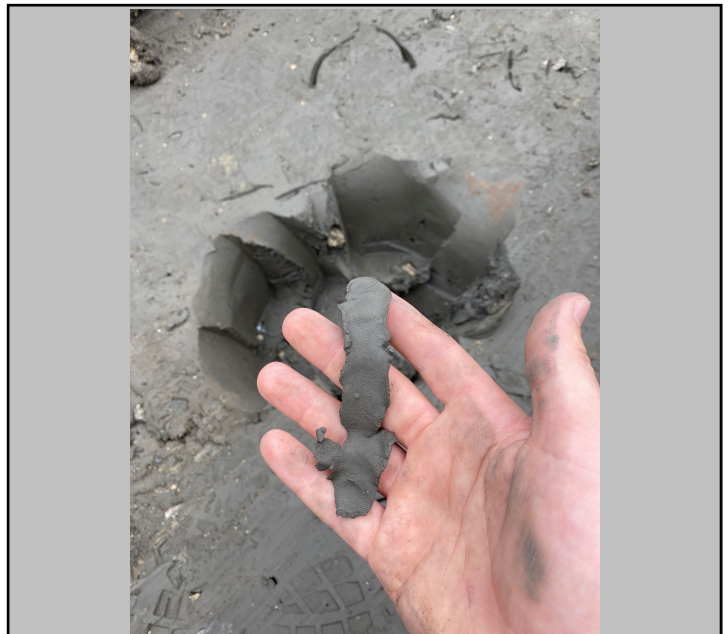
Photo #: 4

S544 material

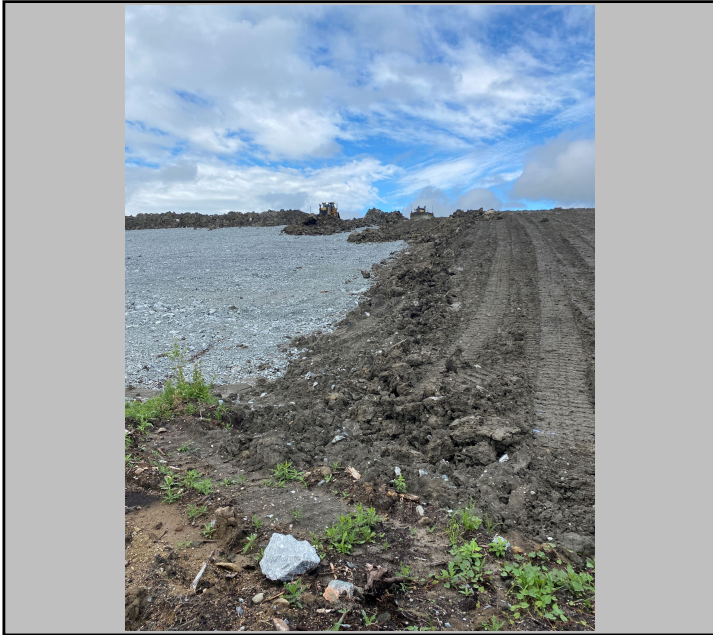
Photo #: 1

P31, L1 tie in with P30

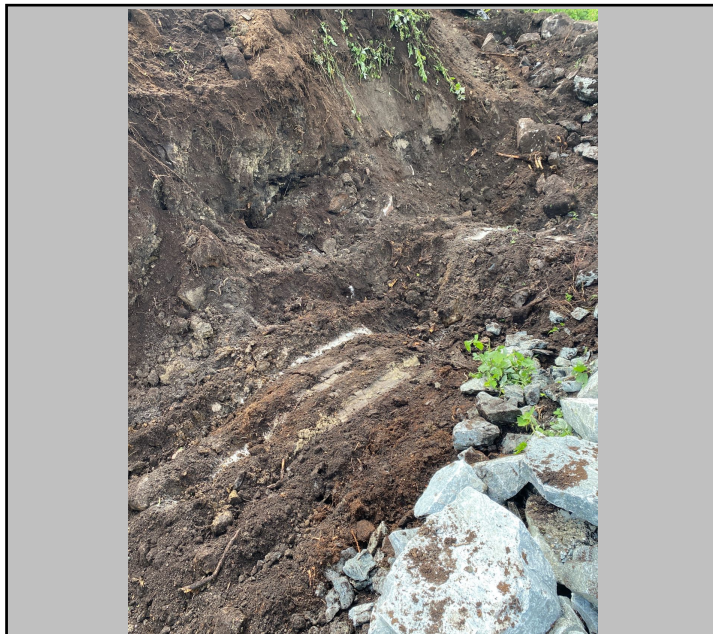
Photo #: 3

Shallow excavation at south end of key trench completed to bedrock

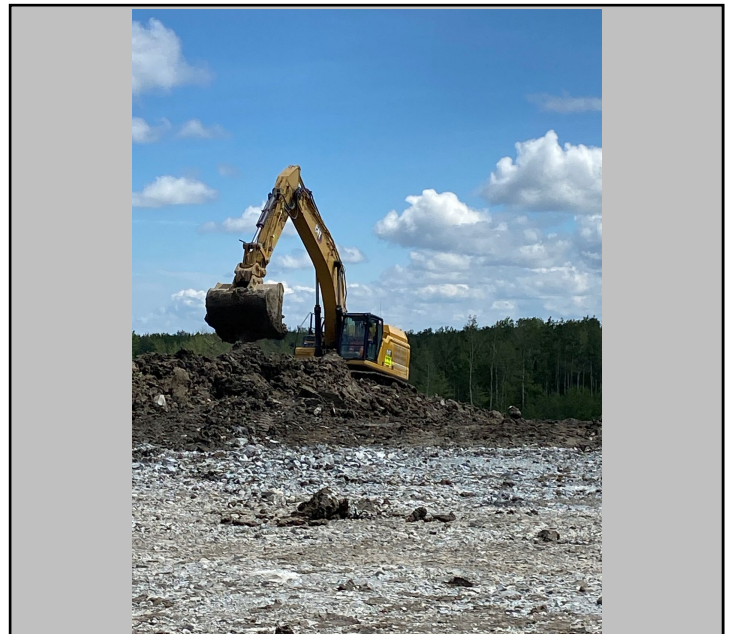
Photo #: 4

Excavator pulling back the bench/crown of P30 to ensure adequate overlap with P31, L1

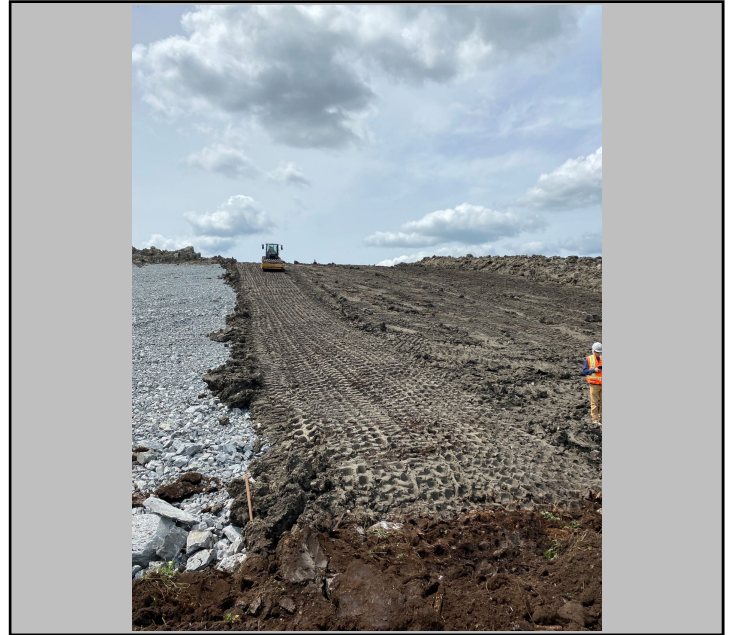
Photo #: 6

P31, L1 compaction

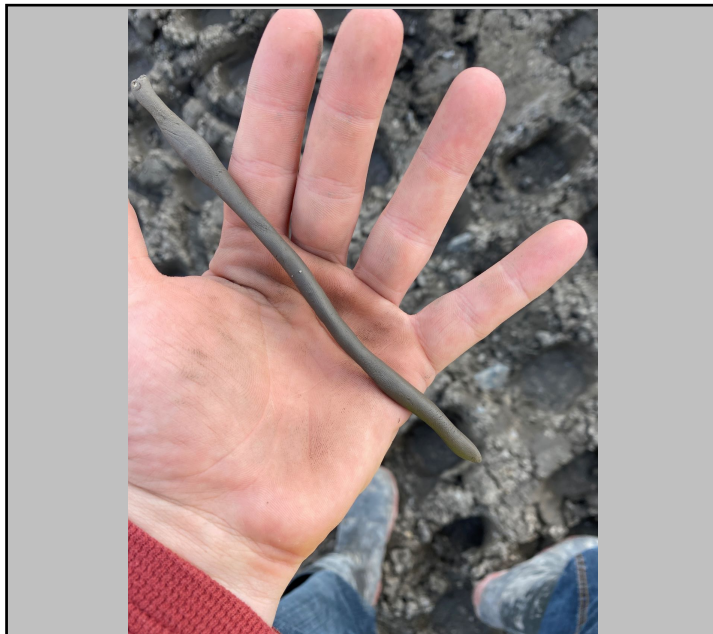
Photo #: 7

D488 material

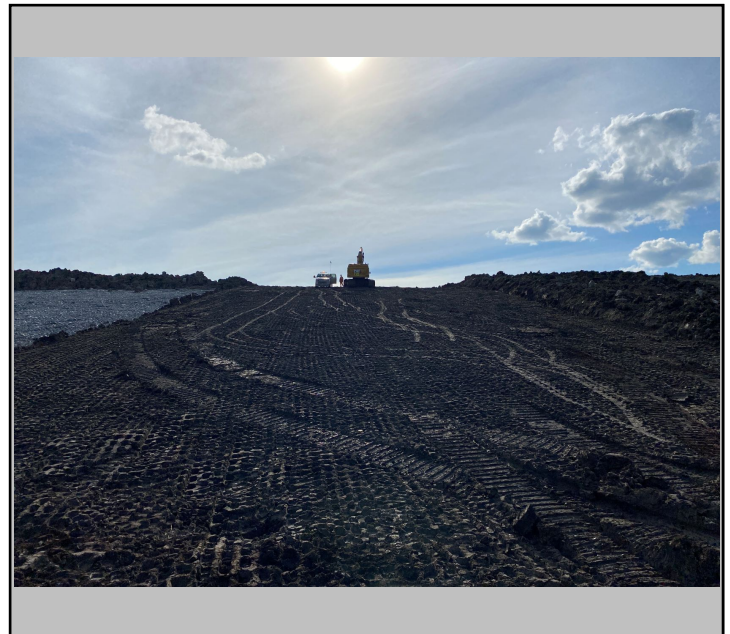
Photo #: 8

P31, L1 completed and tested

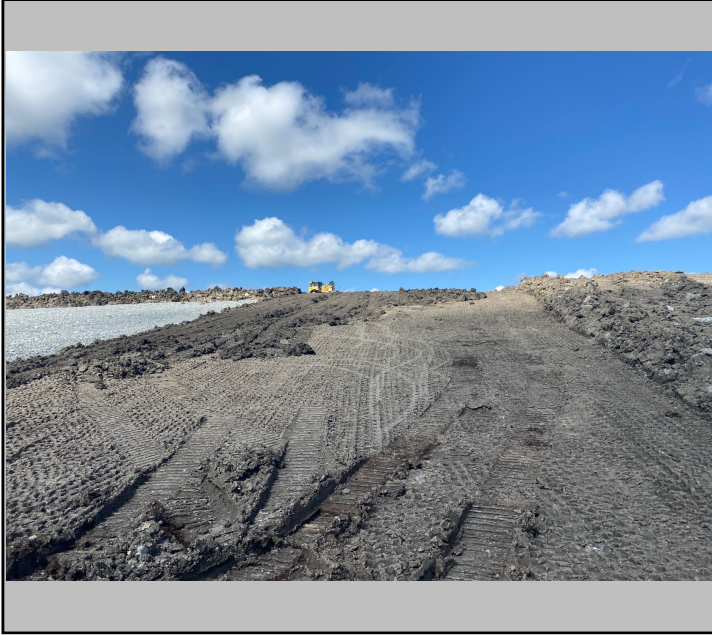
Photo #: 1

P31, L2 initiated with material stockpiled on the bench

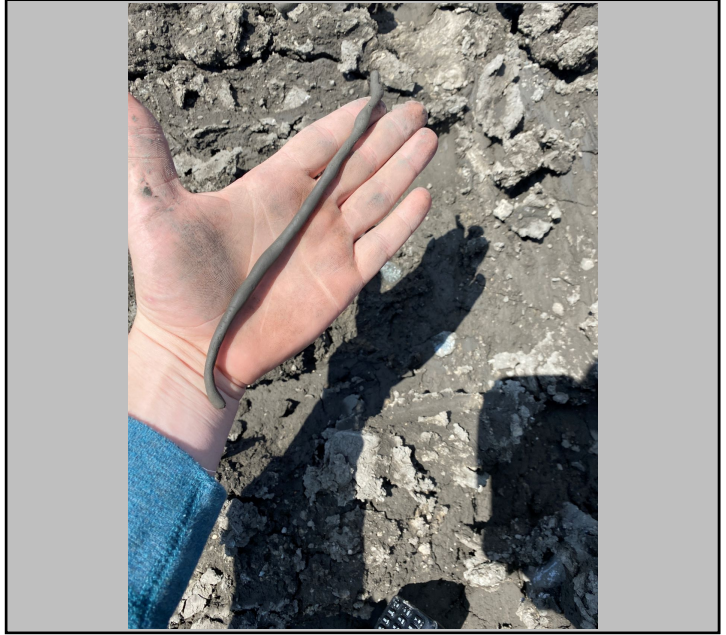
Photo #: 2

material from stockpile on the bench

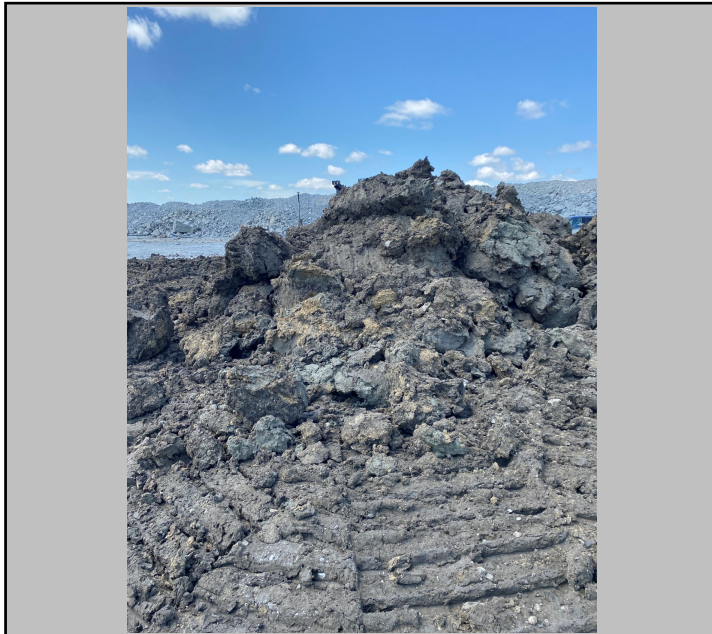
Photo #: 3

Material from from southern borrow area

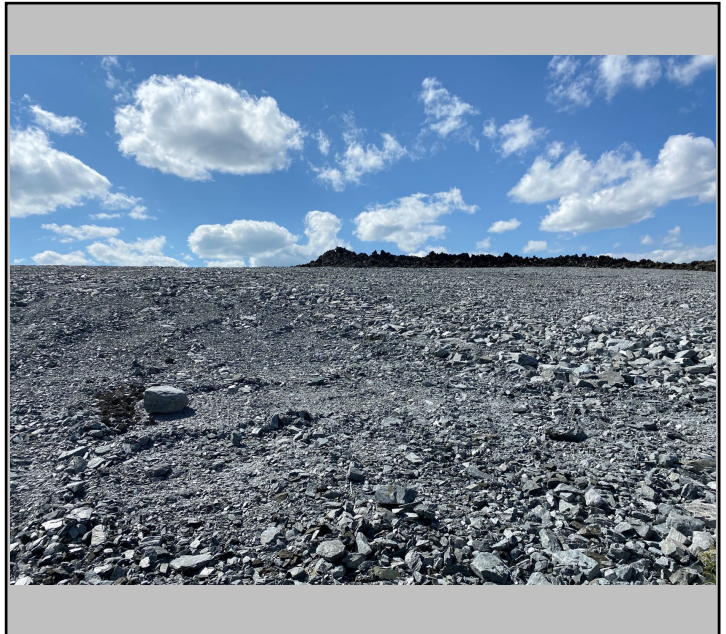
Photo #: 4

Waste rock surface smoothed by excavator prior to Tulloch survey

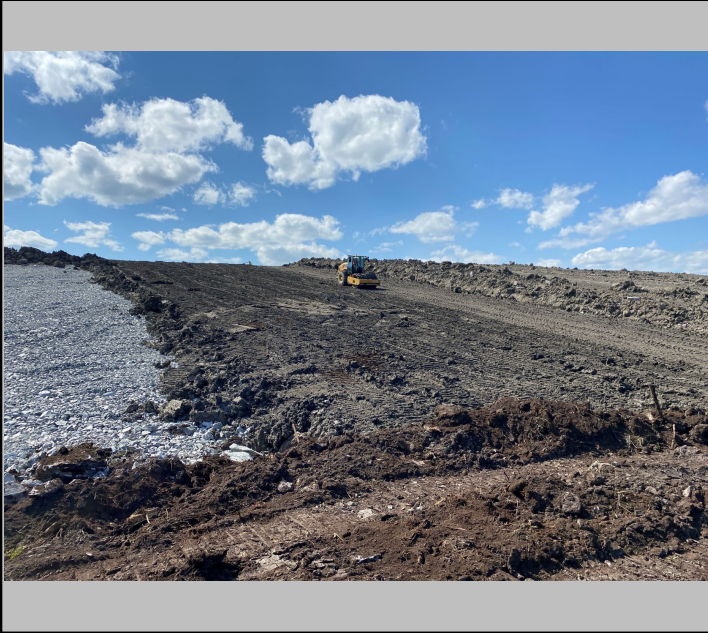
Photo #: 5

P31, L2 compaction in progress

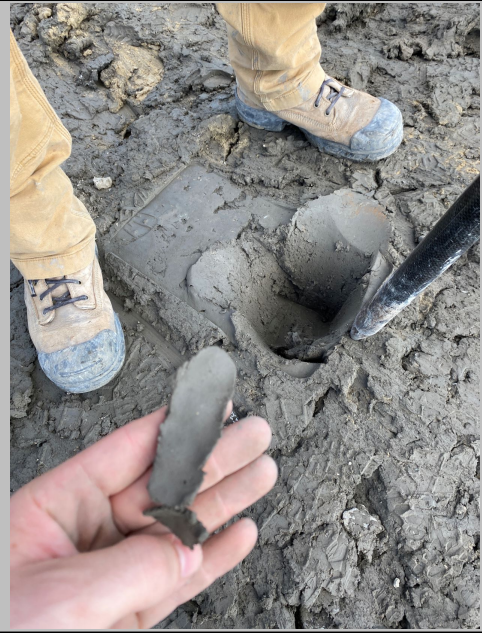
Photo #: 6

D497 material

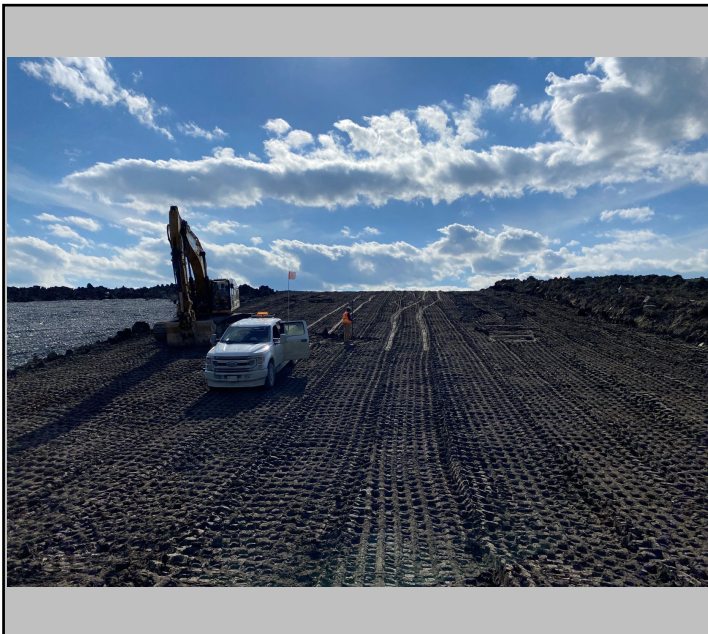
Photo #: 7

P31, L2 completed and tested

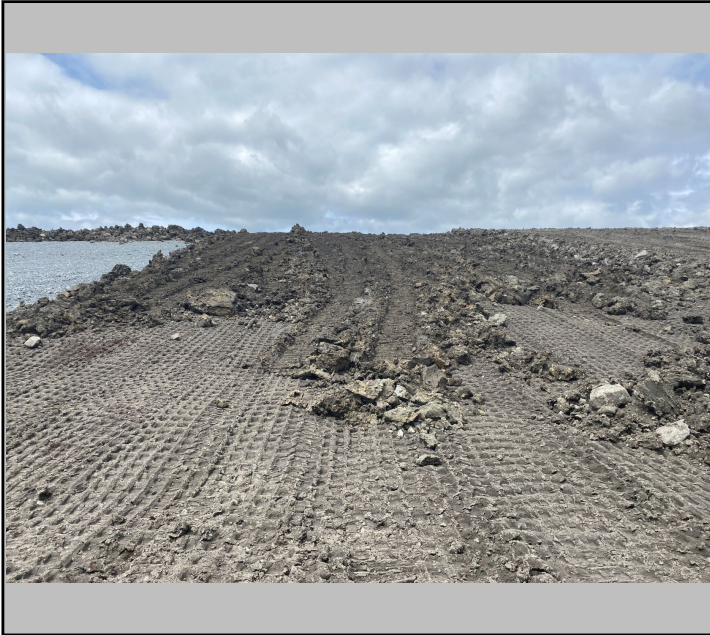
Photo #: 1

P31, L3 placement in progress

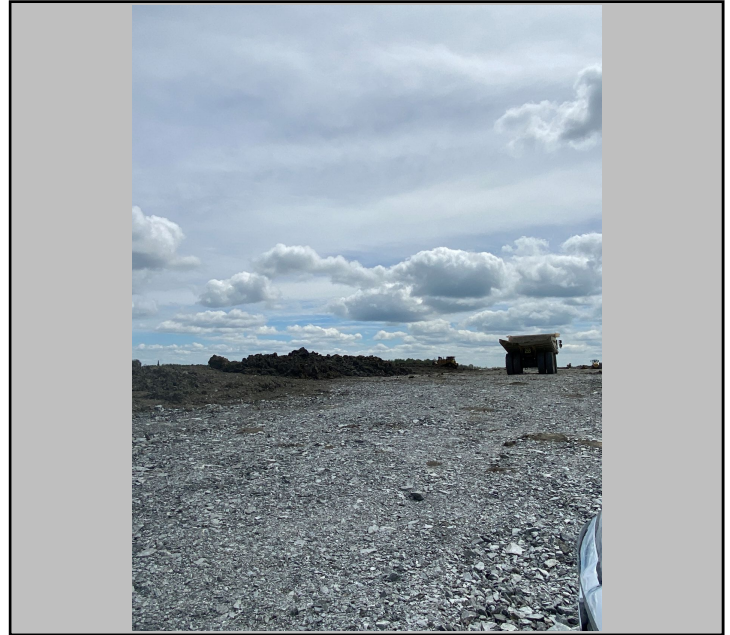
Photo #: 2

NCL material stockpiled on P30 bench  
intermittently

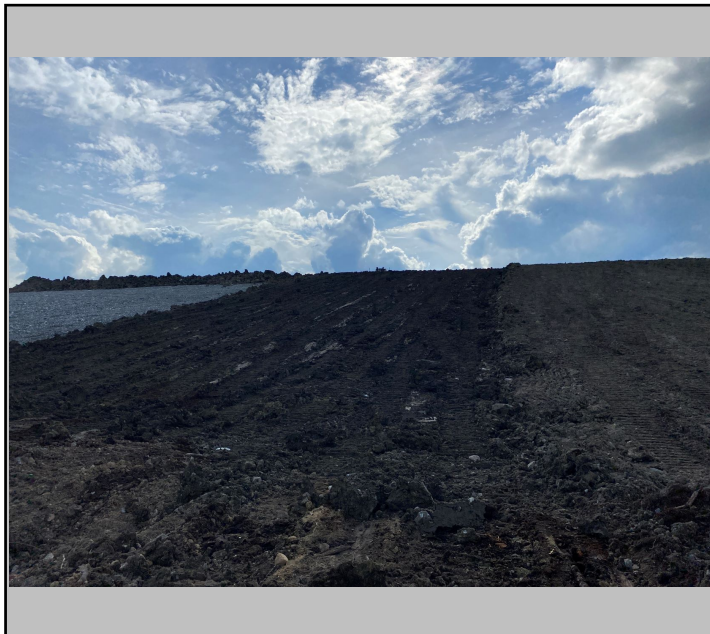
Photo #: 3

P31, L3 placed to grade

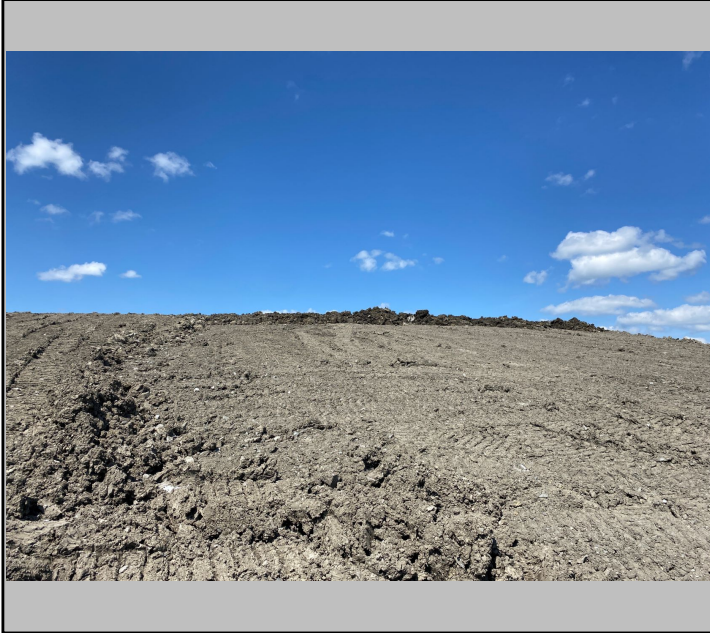
Photo #: 1

P30, L4 in progress

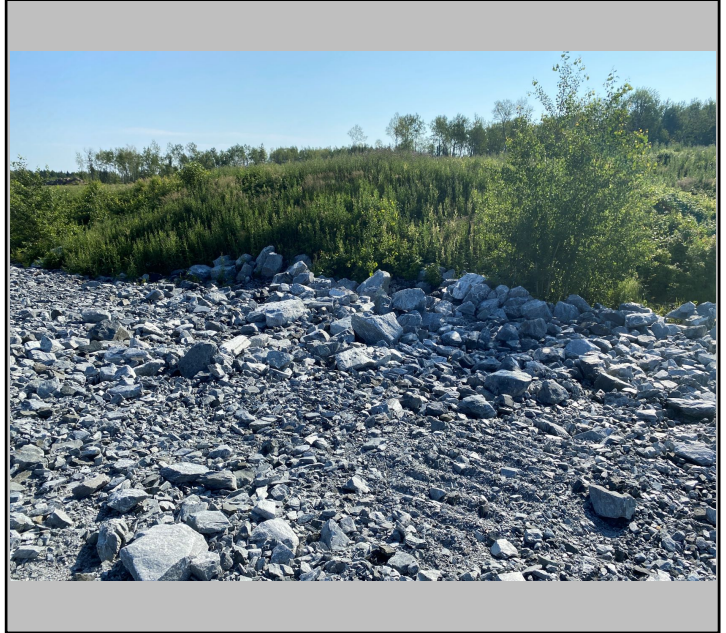
Photo #: 2

Waste rock piled at toe of slope

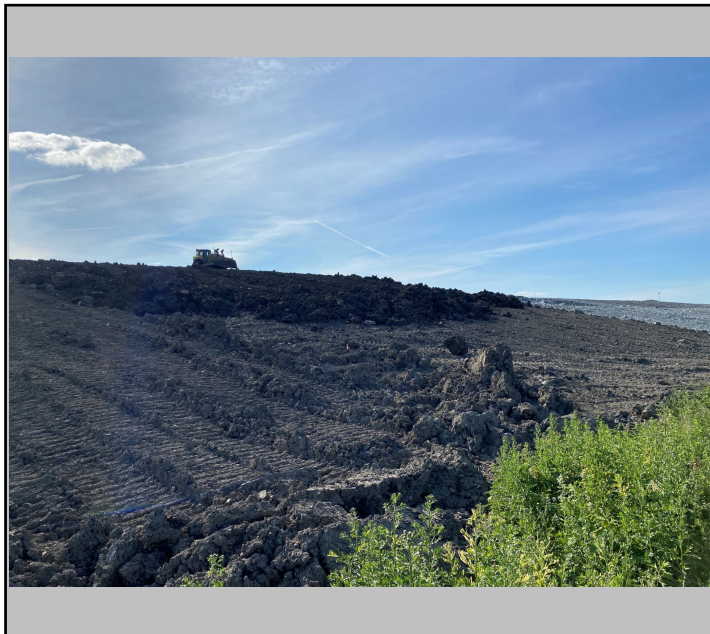
Photo #: 3

P30, L4 at end of day

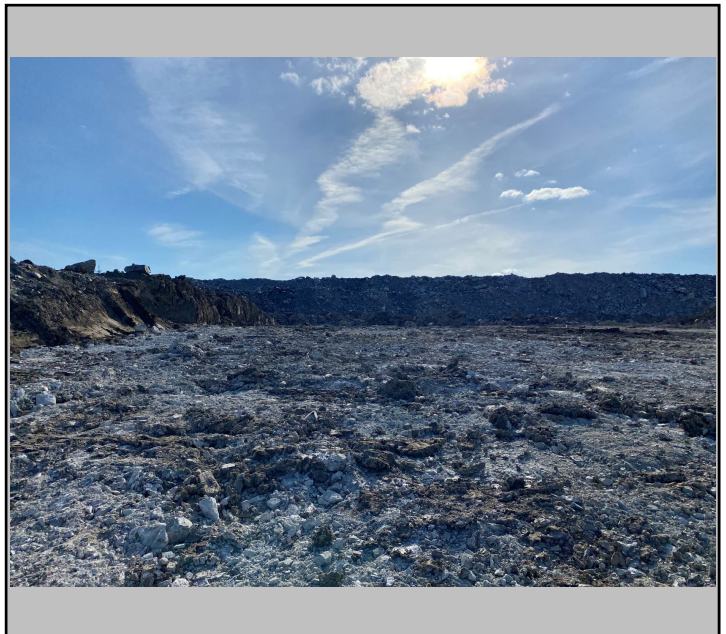
Photo #: 4

Progression into southern borrow source at end of day

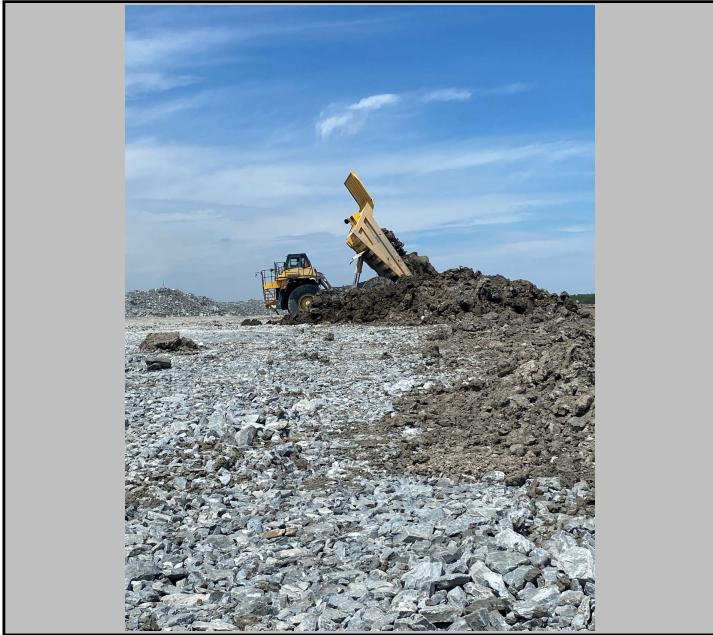
Photo #: 1

Haul truck stockpiling material for P31, L4

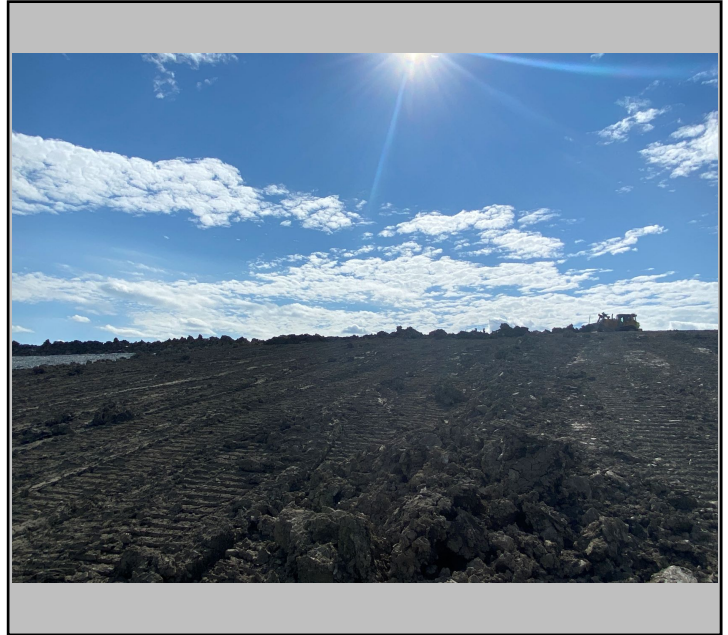
Photo #: 2

P31, L4 placement initiated near end of day

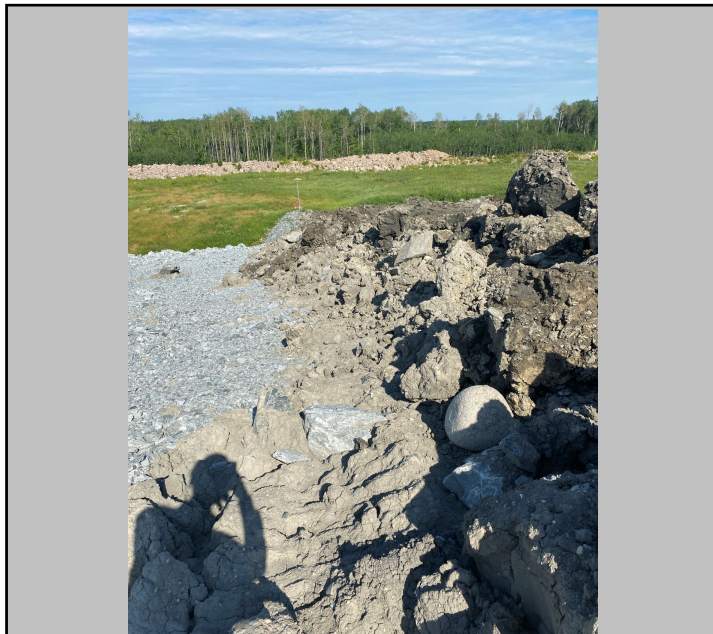
Photo #: 3

North end of P30 prior to coverage

- Met with CQC to discuss P30, L4 following completion to grade. CQA noted areas of raised material at the toe to be flattened and excess coverage required on the north end of P30 to protect CCL material while construction progresses south.
- Elevation of topsoil berm greater than that of L4 in areas resulting in potential difficulty achieving drainage off the cover system. Once the raised material at P30 toe is flattened, P30 is to be monitored to evaluate runoff.

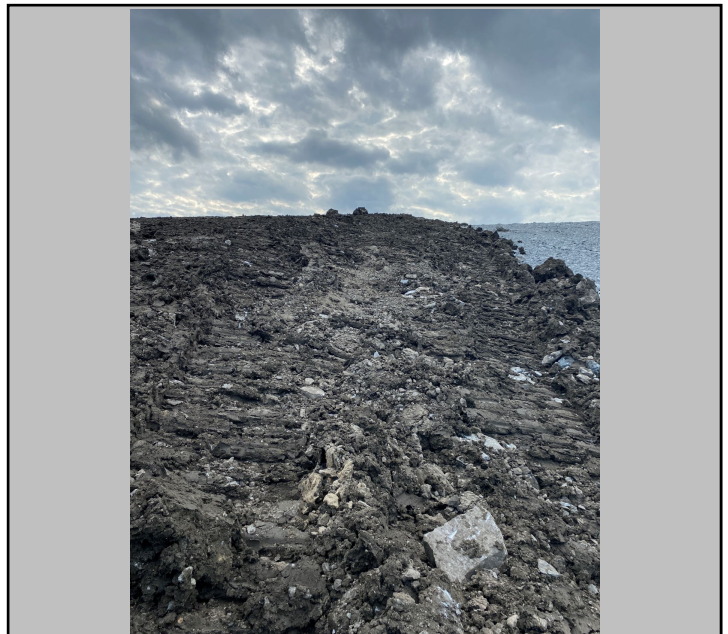
Photo #: 4

North end of P30 following coverage

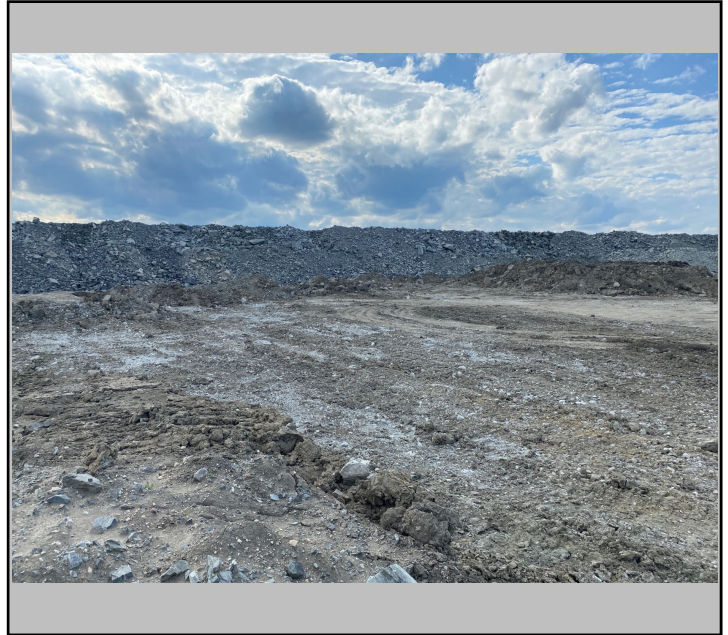
Photo #: 6

Progression into southern borrow area

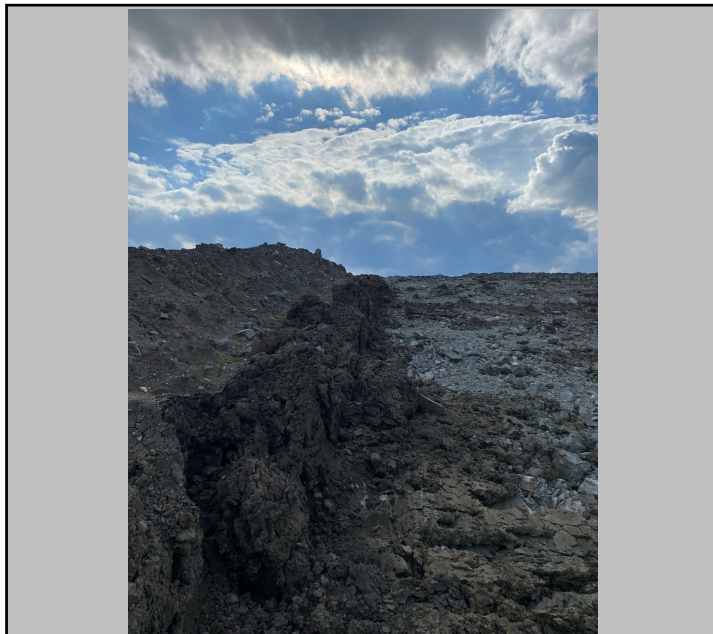
Photo #: 7

Material removed up to edge of P28 fro NCL use

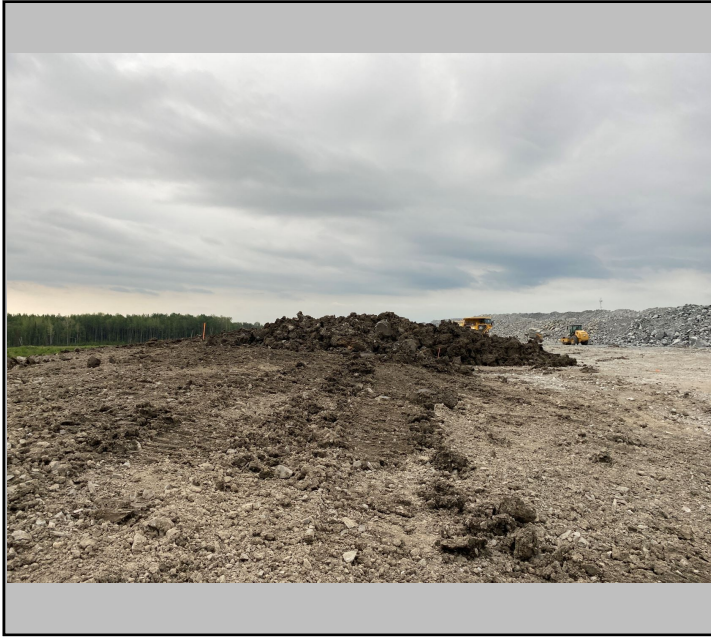
Photo #: 1

Haul truck stockpiling material from P31, L4

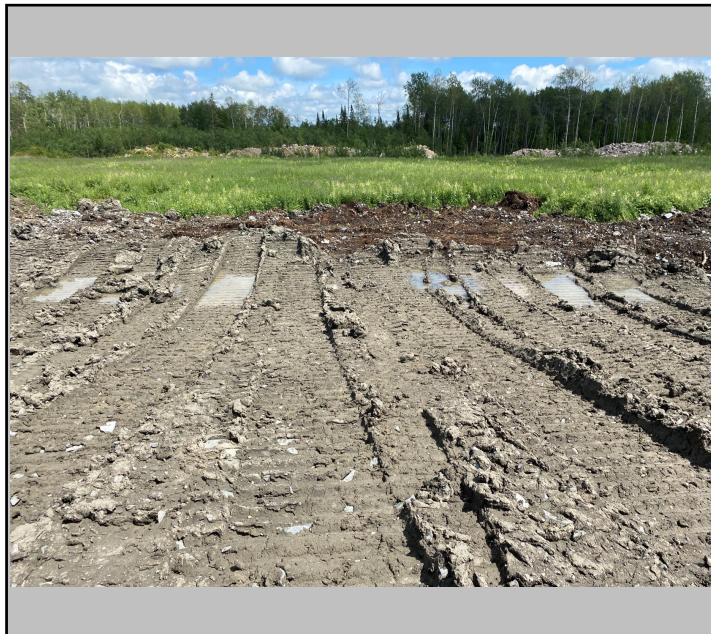
Photo #: 3

Standing water at P31 toe following rain

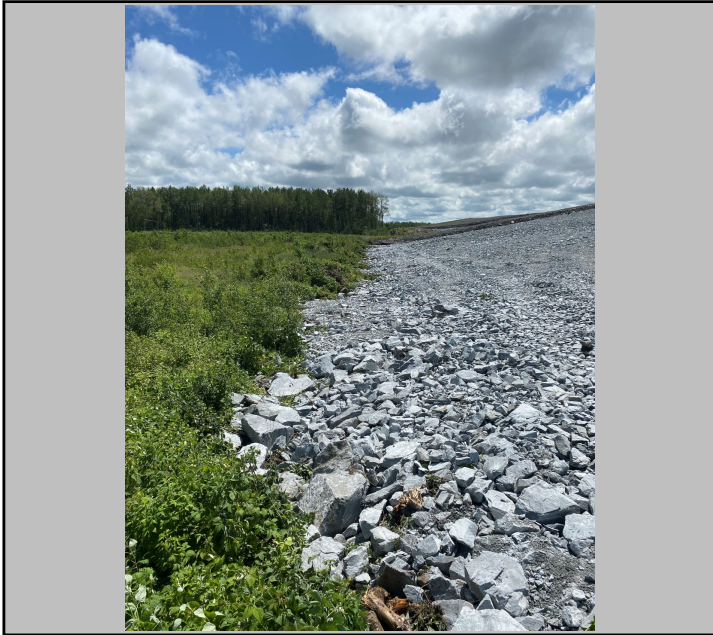
Photo #: 5

Waste rock removed prior to further key trenching

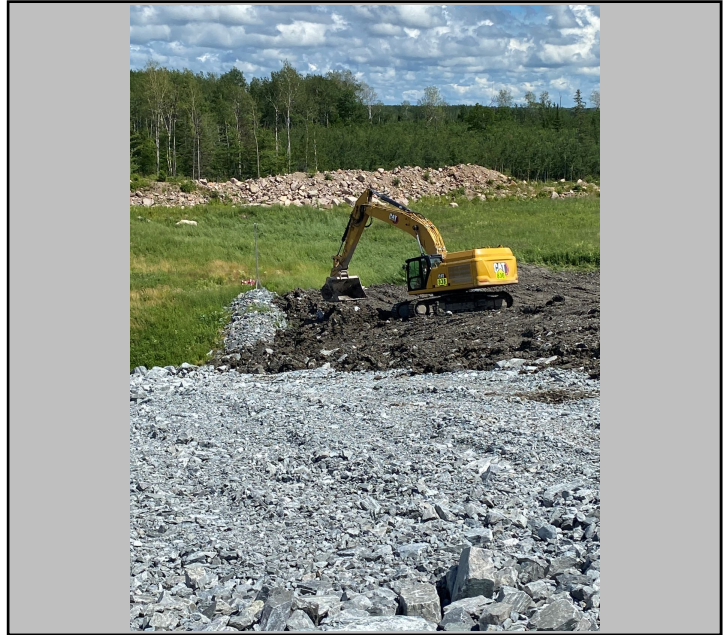
Photo #: 6

Excess material near burrito blended in with excavator

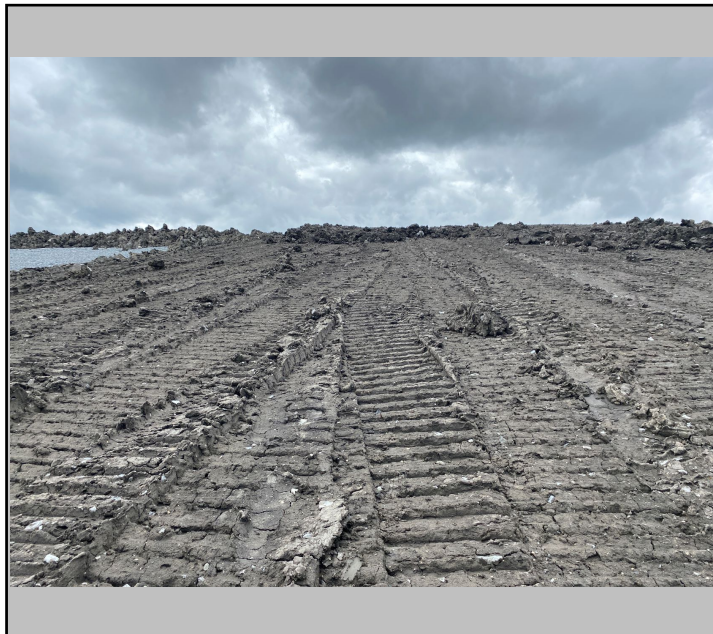
Photo #: 7

P31, L3 after being given time to dry prior to placement

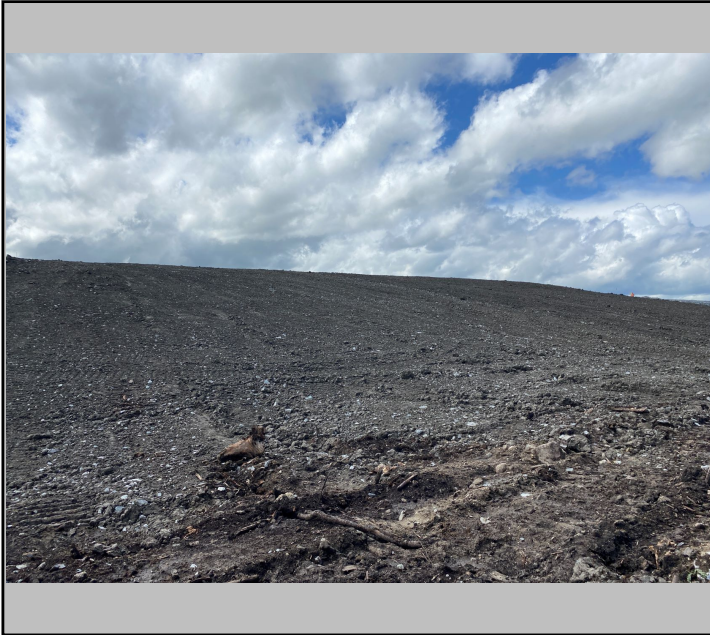
Photo #: 9

P30, L4

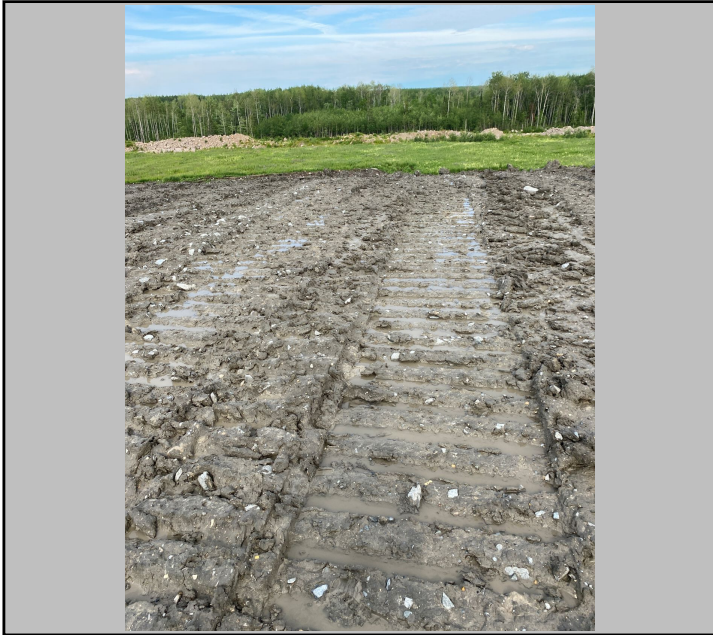
Photo #: 1

P31, L4 at end of day

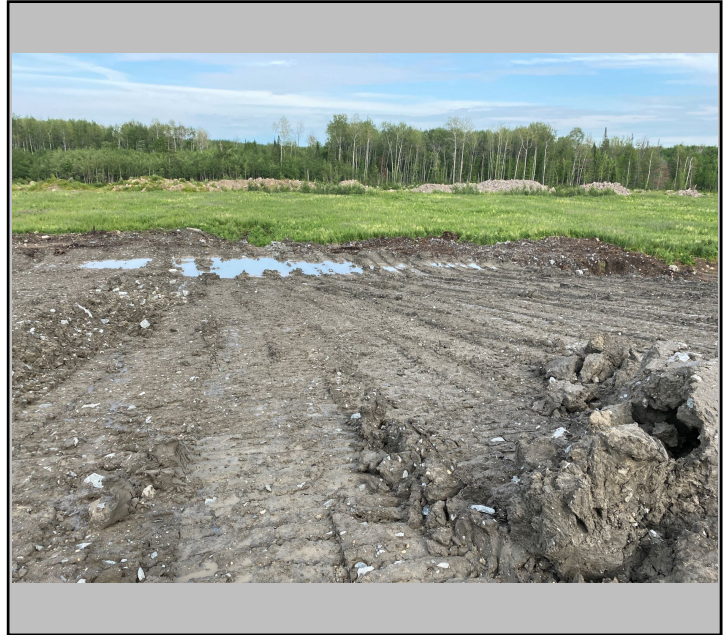
Photo #: 2

P31, L3 at end of day

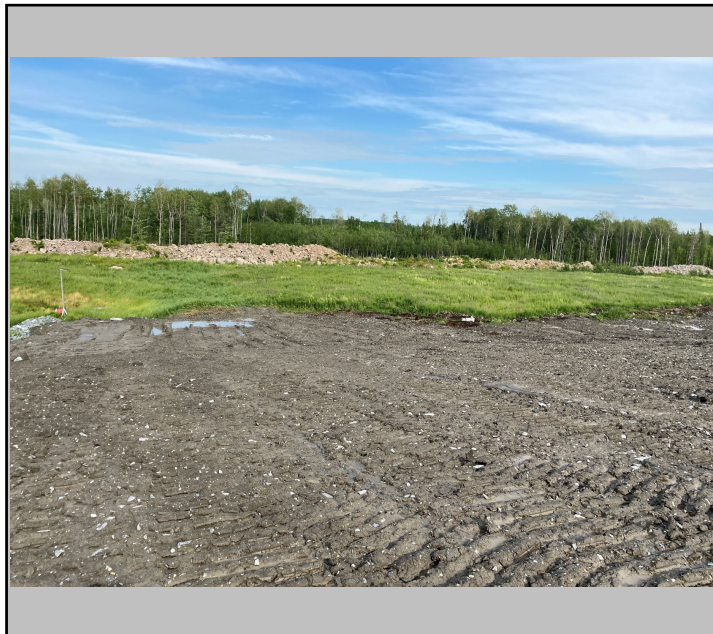
Photo #: 3

P30 toe
