PHOTOGRAPHS

Date:	Sept 24th, 2021	Owner/Client:	New Gold Inc.
Day:	Friday	OKC Project #:	1003-19
Prepared by:	Mitch Siciliano	Project Location:	Rainy River - Ontario

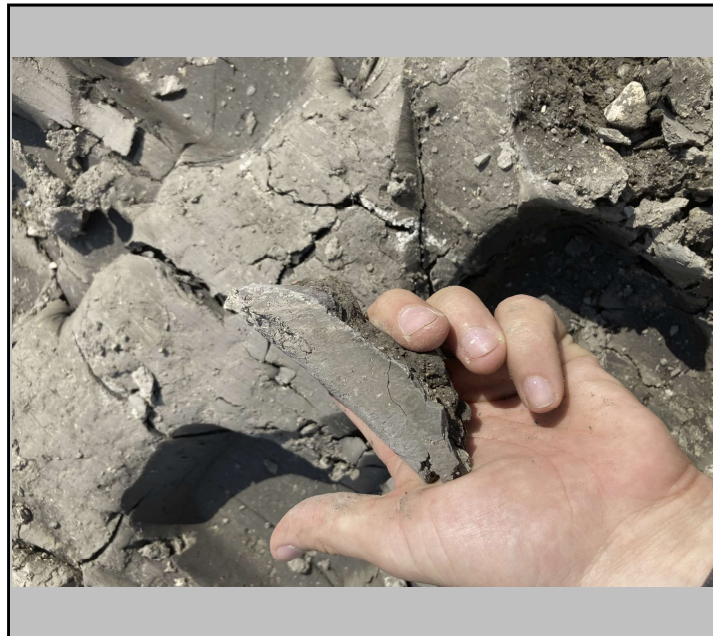
Photo #: 3

Roughly 1" crust forming on P14, L2

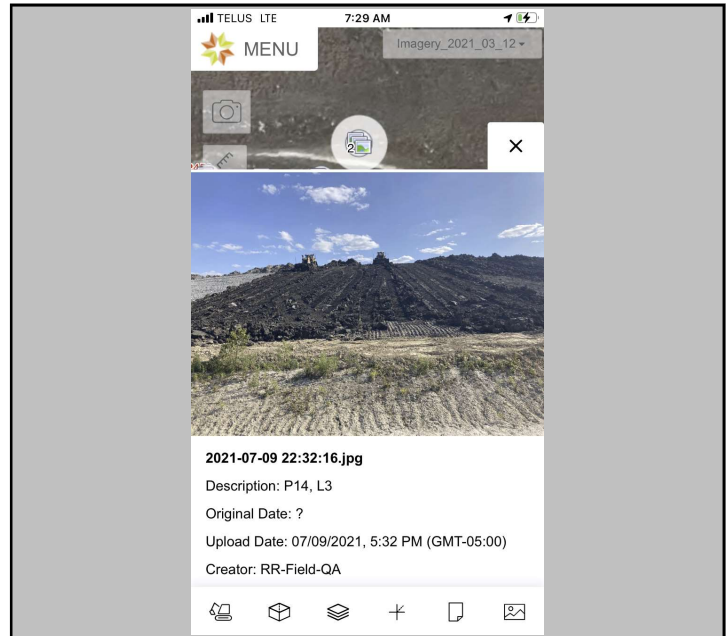
Photo #: 4

P14, L3 covering L2 within 24hr period
